#A252495390: Service Update - Oil Plug Seated Improperly - (Mar 6, 2025)

Subject: A252495390 Oil Plug Seated Improperly

Make	Model	Model Year	
		From	To
Cadillac	CT5-V Blackwing	2025	2025

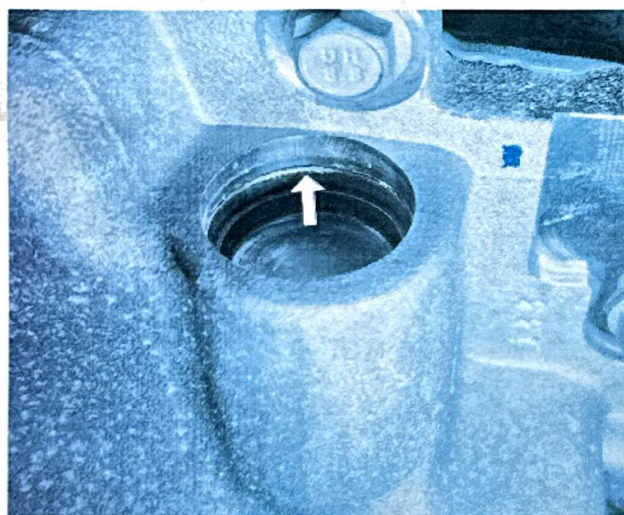
2. Locate the oil pan pickup tube plug on the front of the oil pan (driver's side) as shown.

Important: The depth to which the plug is pressed beyond the counterbore may vary. As long as the counterbore line is visible as indicated above, no further action is required.

3. Inspect the oil pan pickup tube plug.
 - If the plug is pressed to a point where the counterbore line is visible (indicated by white arrow above) no further action is required. Proceed to step 6.
 - If the plug is NOT pressed deep enough to expose the counterbore line, proceed to the next step.
