2017 Cadillac ATS-V: GM TechLink: 3rd Gear Condition on Manual Transmission

GM TechLink

October 3, 2016

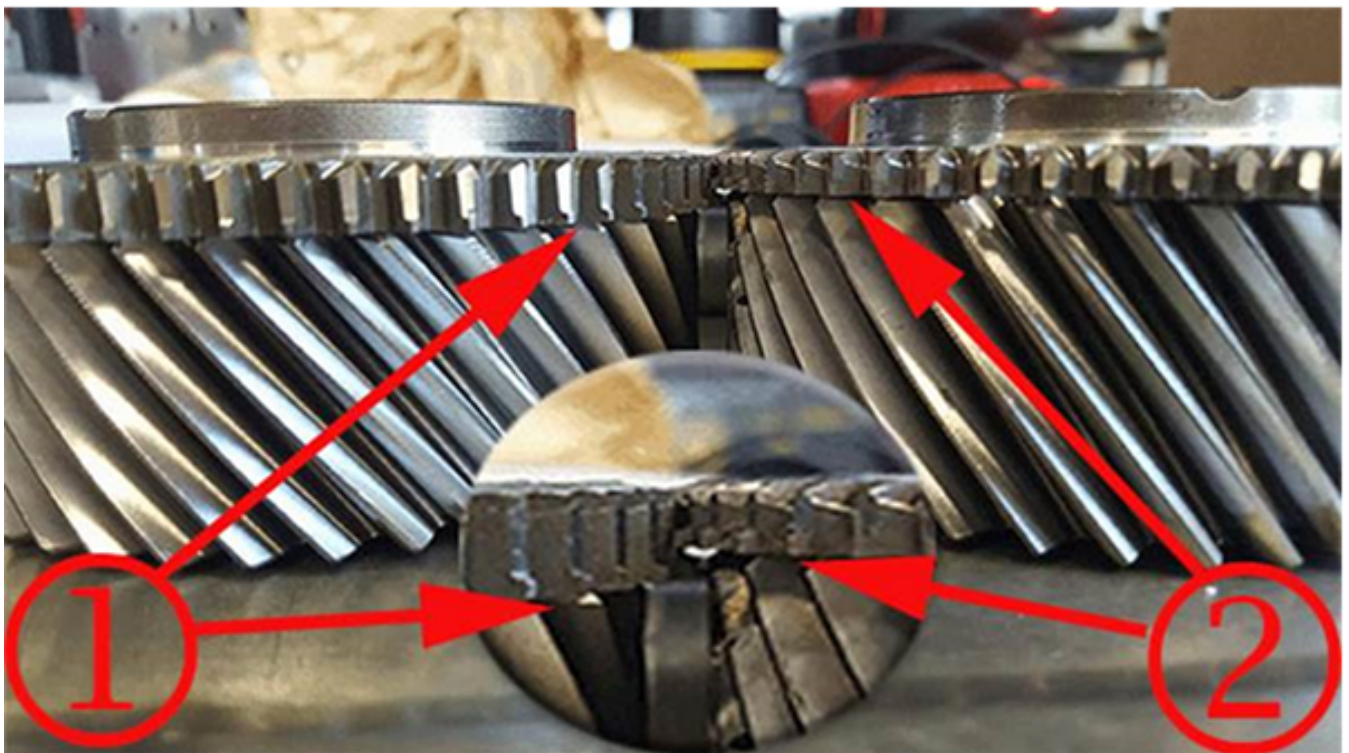
Fig 14

Some 2017 Camaro and ATS-V models equipped with a 6-speed transmission (RPO MM6, MG9) and 2017 Corvette models equipped with a 7-speed transmission (RPO MEP, MEK) may hop out of 3rd gear due to a mis-machined gear. These vehicles will have very low mileage or the condition may be noticed during PDI.

If the transmission does not hop out of 3rd gear, shift back to 2nd gear and repeat the shifting and accelerating procedure 10 times. If the transmission does not hop out of 3rd gear, the transmission has the correctly machined gear. (Fig. 14, #1) If the hop out of 3rd gear is verified, there is a mis-machined gear (Fig. 14, #2) and the 3rd speed gear, synchronizer and shift collar should be replaced.
