# 2017 Cadillac ATS-V: GM TechLink: 3rd Gear Condition on Manual Transmission

GM TechLink

October 3, 2016

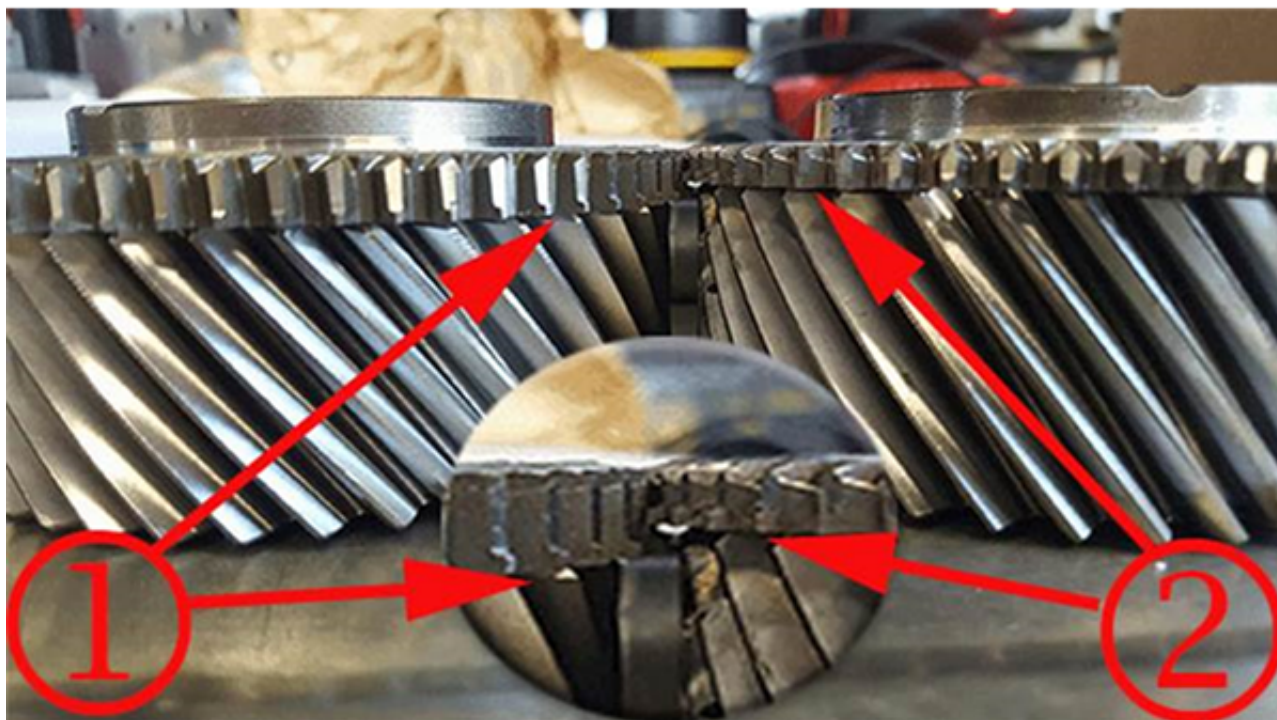
Fig 14

Some 2017 Camaro and ATS-V models equipped with a 6-speed transmission (RPO MM6, MG9) and 2017 Corvette models equipped with a 7-speed transmission (RPO MEP, MEK) may hop out of 3rd gear due to a mis-machined gear. These vehicles will have very low mileage or the condition may be noticed during PDI.

If the transmission does not hop out of 3rd gear, shift back to 2nd gear and repeat the shifting and accelerating procedure 10 times. If the transmission does not hop out of 3rd gear, the transmission has the correctly machined gear. (Fig. 14, #1) If the hop out of 3rd gear is verified, there is a mis-machined gear (Fig. 14, #2) and the 3rd speed gear, synchronizer and shift collar should be replaced.
