2006 Cadillac STS-V: Service Bulletin: #07-07-30-031D: Malfunction Indicator Lamp (MIL) On - Check Engine Light, DTC P0751

#07-07-30-031D: Malfunction Indicator Lamp (MIL)
On - Check Engine Light, DTC P0751 (Diagnose and
Repair as Necessary) - (Feb 20, 2009)

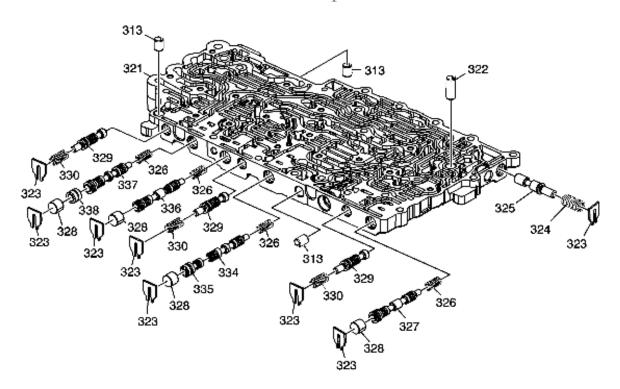
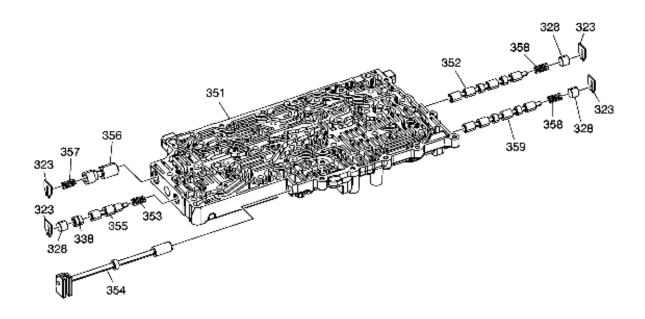
- Inspect transmission filter for any cracks, holes or split seams that may allow air to be sucked into the pump.
- Inspect the check balls for roundness ensuring that there are no flat spots.
- Measure all the valve body bore plugs (328) for diameter. The specification is 11.502 mm +/- 0.004 mm. Undersize bore plugs should be replaced.
- Inspect clutch select valve 2 (352) (Closest to the manual valve) in the lower valve body (351) for freedom of movement and travel.
- Inspect CBR1/ C456 Reg Valve (327) in the upper valve body (321) for freedom of movement and travel.
- Perform Control Solenoid Valve and Transmission Control Module Assembly Solenoid Performance Test (SI Document ID #1618572) to determine if shift solenoid #1 is functioning properly.

Important: The seals included in plate kit, P/N 24236934, should be replaced when the valve body is assembled. Do not reuse the old seals.

• Replace the spacer plate with P/N 24245720. This spacer plate makes use of a revised gasket to help reduce the occurrence of DTC P0751.
