# 2016 - 2019 Cadillac CTS-V: GM TechLink: Low Oil Pressure Conditions

**GM TechLink**

**September 13, 2019**

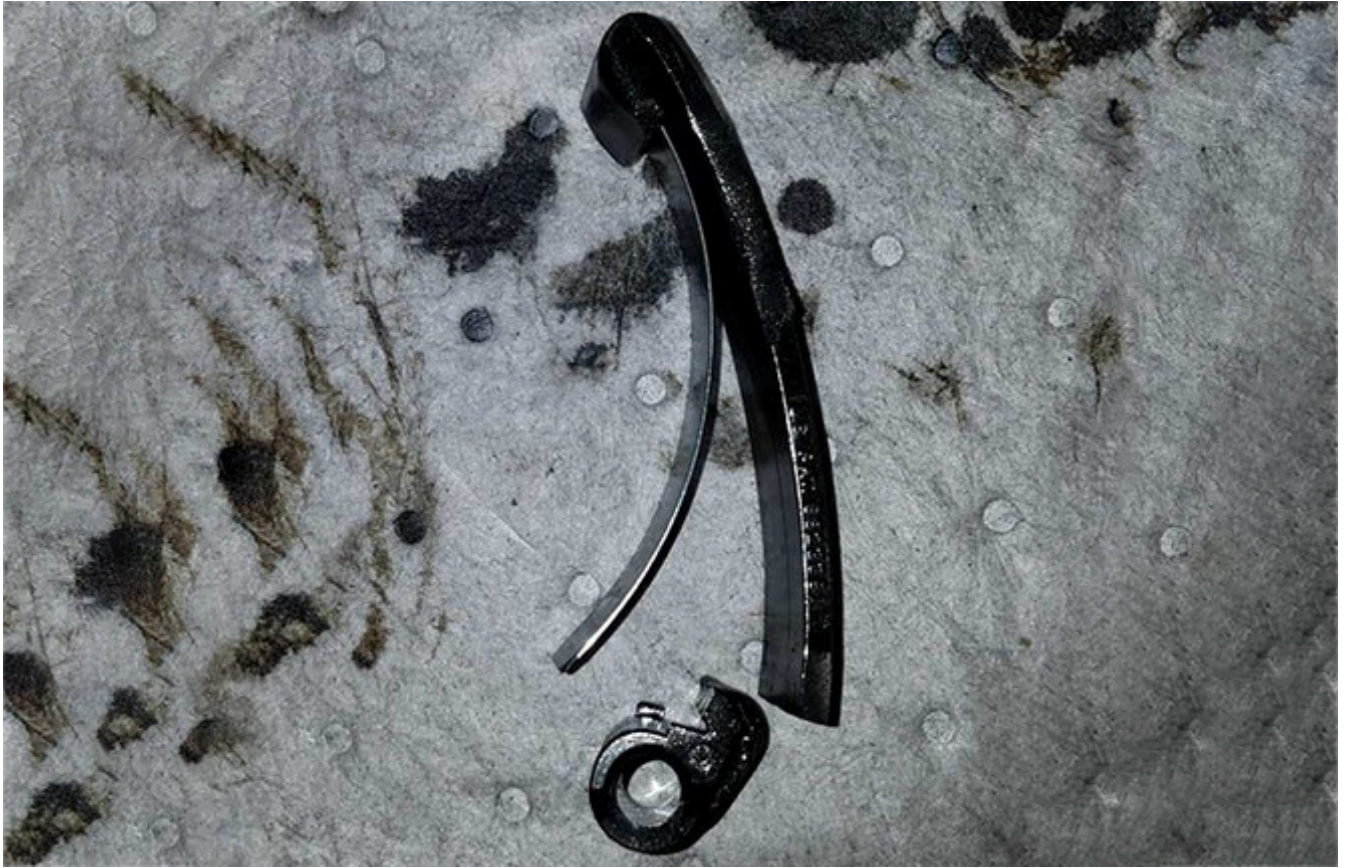
**Fig. 20**

In addition, a broken tensioner shoe (Fig. 20) may allow the spring to rub a hole in the oil pump.

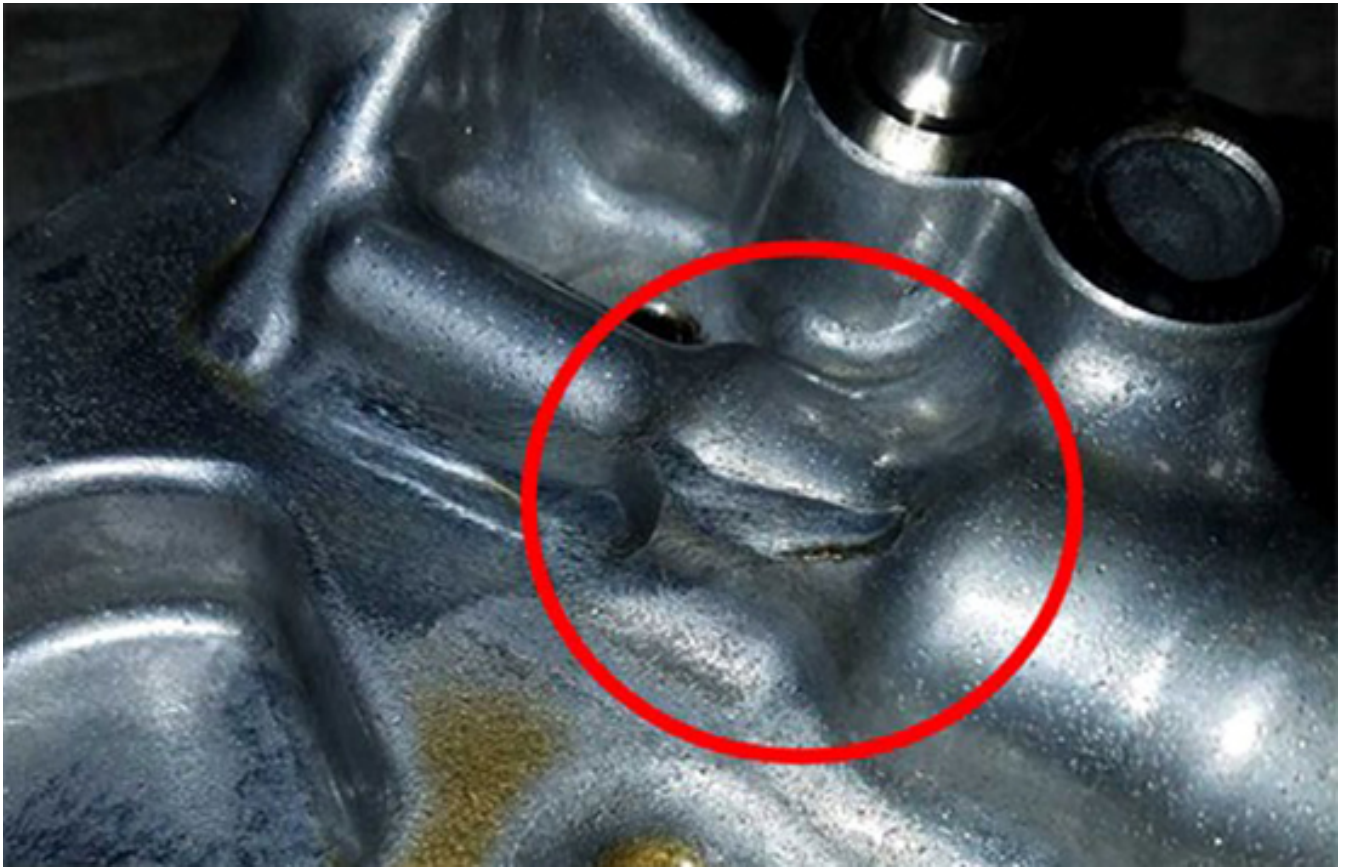
**Fig. 21**

If the oil pump face is damaged or worn, replace the oil pump. (Fig. 21) Also inspect the bearings for damage due to debris from the oil pump.
