2016 - 2019 Cadillac CTS-V: GM TechLink: Low Oil Pressure Conditions

GM TechLink

September 13, 2019

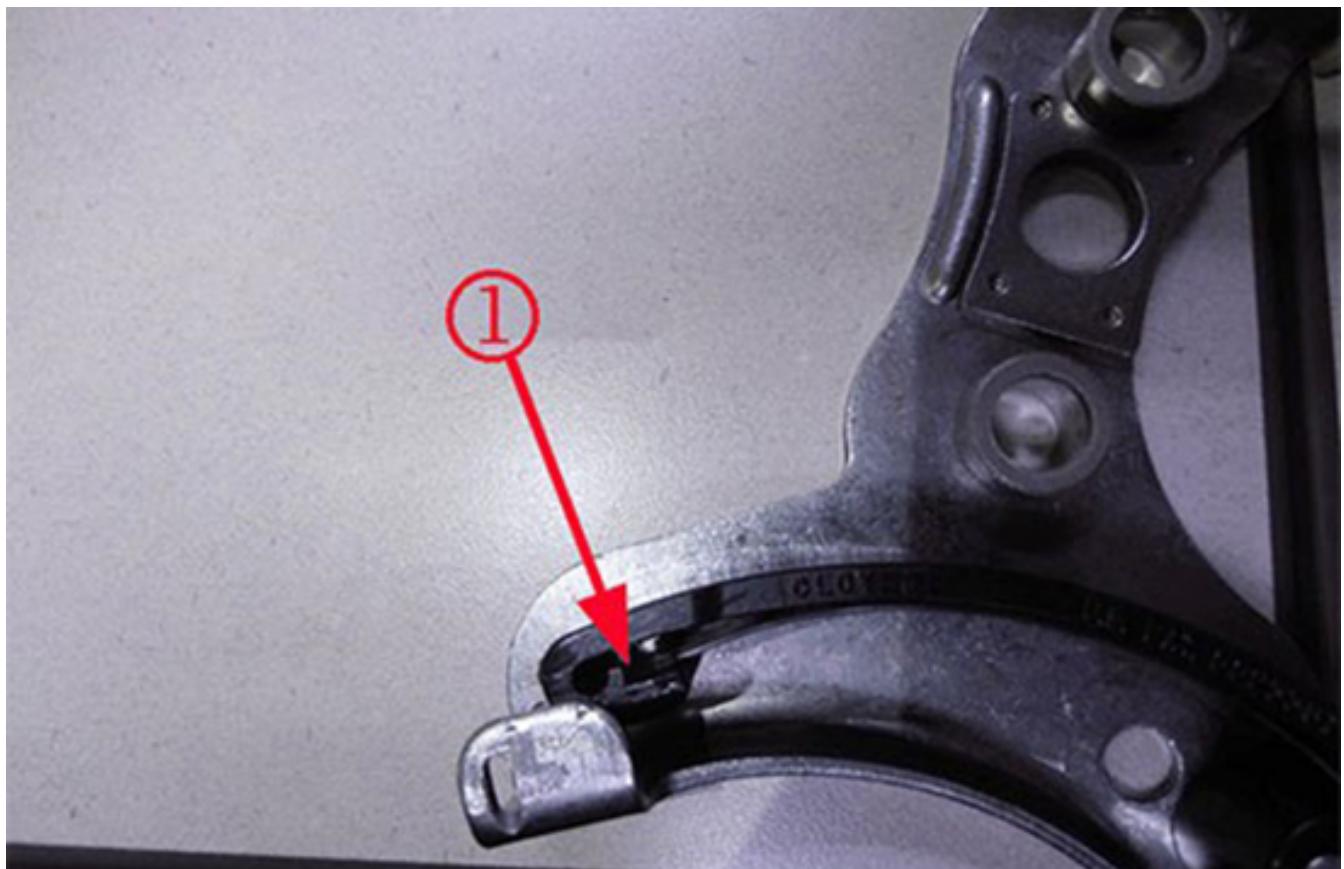
Fig. 19

If these conditions are found, the tensioner spring in the timing chain guide may be "short" and not fully seated into the guide pivot end. (Fig. 19) Cycling the oil pump control valve will not cause any changes in the oil pump response. Replace the timing chain tensioner guide.

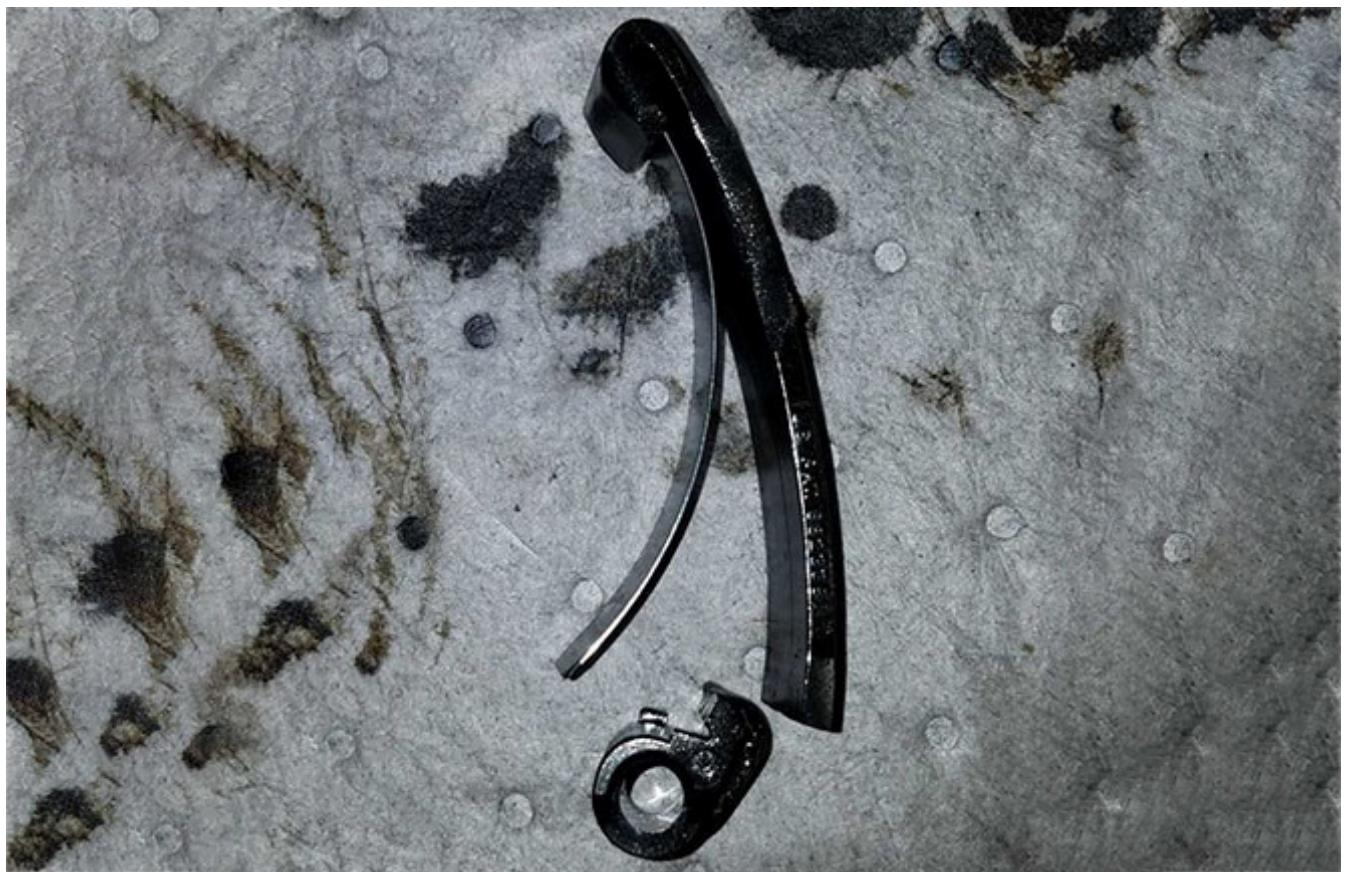
Fig. 20

In addition, a broken tensioner shoe (Fig. 20) may allow the spring to rub a hole in the oil pump.
