2016 - 2019 Cadillac CTS-V: GM TechLink: Coolant Entering Engine Cylinders

GM TechLink

May 17, 2019

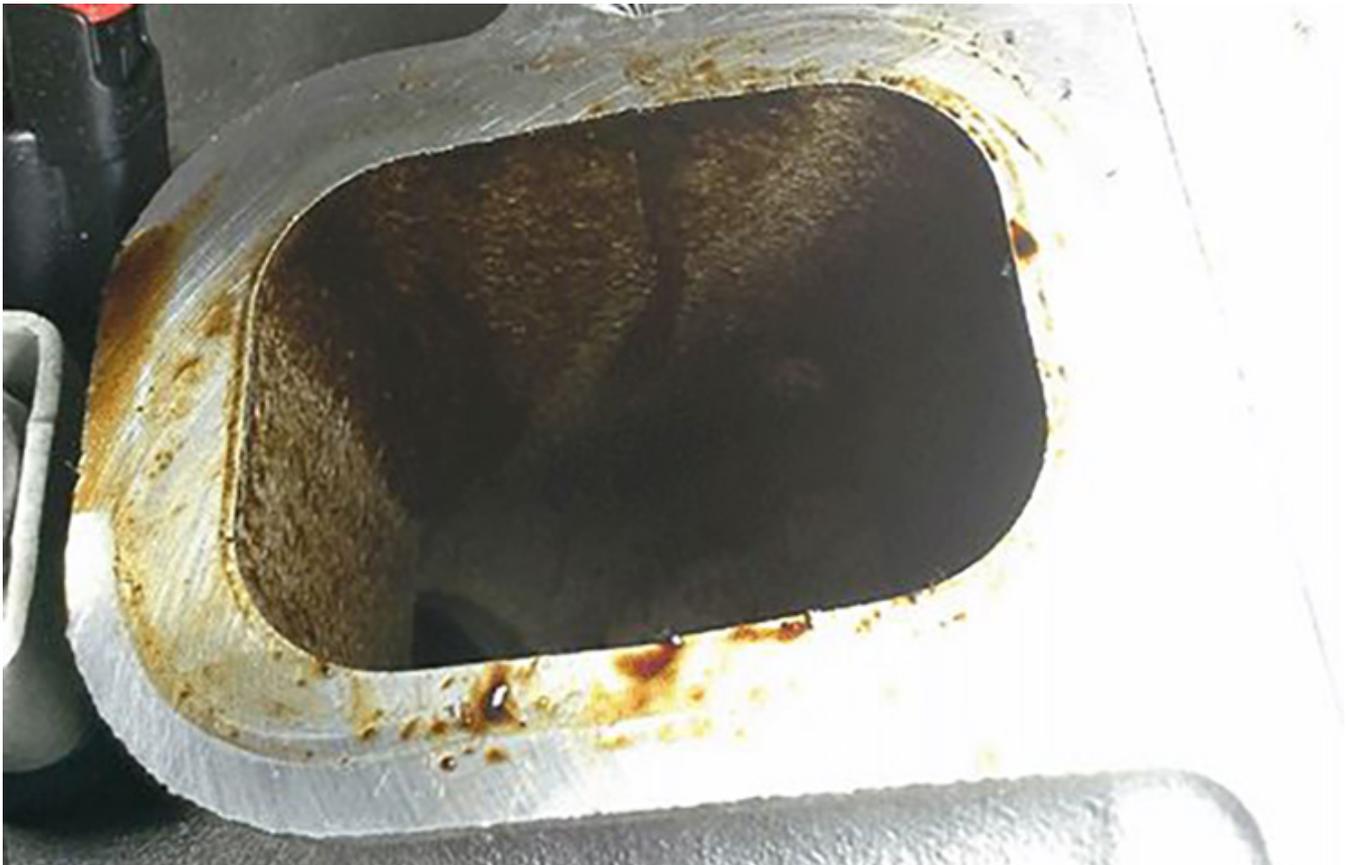
Fig. 13

If the head casting line is the issue, the intake port will be wet with a coolant and oil mix. This condition may cause the running rough while warm concern with or without DTCs set. The location where the coolant is running down in the port will look washed down. If this condition is found, the cylinder head will need to be replaced. (Fig. 13)
