2016 - 2019 Cadillac CTS-V: GM TechLink: Coolant Entering Engine Cylinders

2016 - 2019 Cadillac CTS-V: Coolant Entering Engine Cylinders

GM TechLink
May 17, 2019

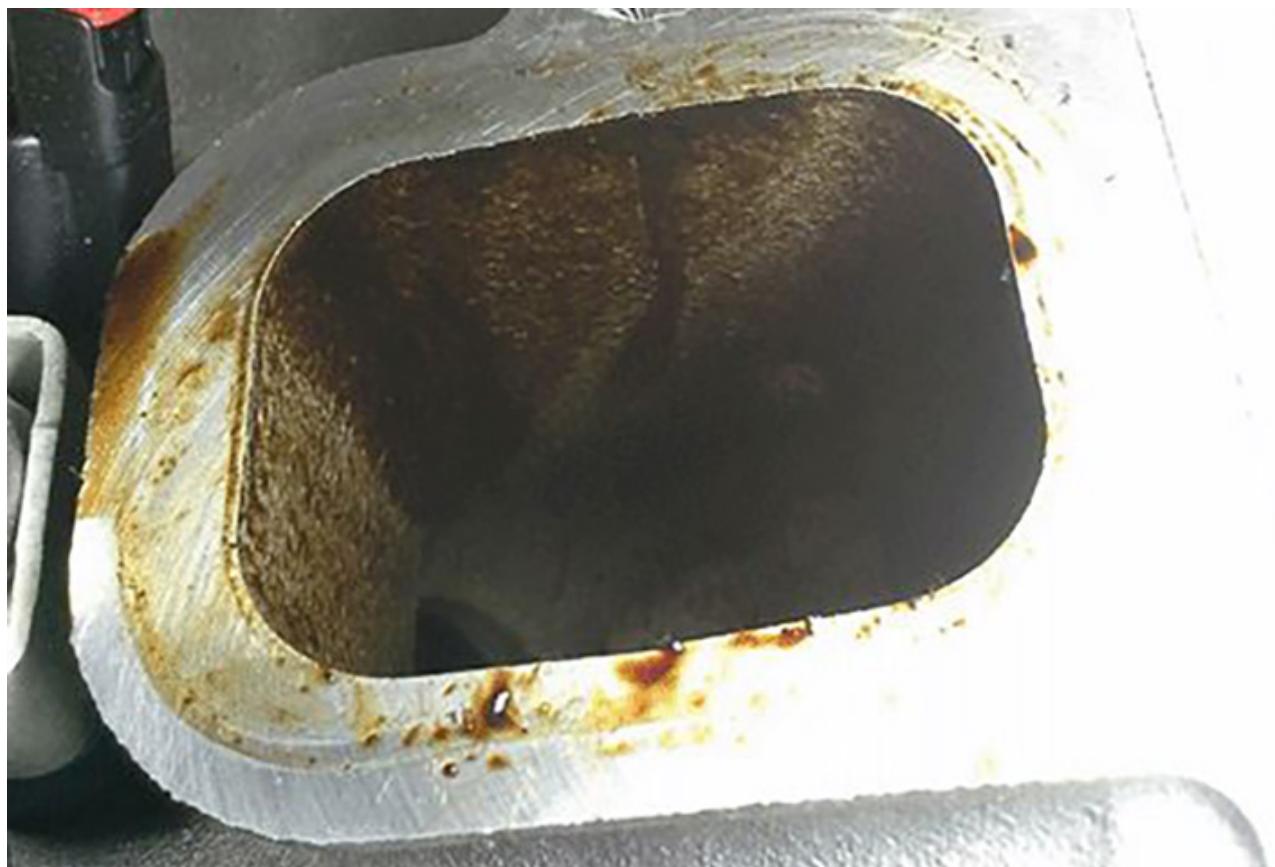
Fig. 13

Misfires on start up only, with high rates always on one cylinder, can be suspect for coolant entry at the liner-to-deck face casting or the casting line in the intake port of the cylinder head.

If the head casting line is the issue, the intake port will be wet with a coolant and oil mix. This condition may cause the running rough while warm concern with or without DTCs set. The location where the coolant is running down in the port will look washed down. If this condition is found, the cylinder head will need to be replaced. (Fig. 13)
