2016 - 2019 Cadillac CTS-V: GM TechLink: Coolant Entering Engine Cylinders

2016 - 2019 Cadillac CTS-V: Coolant Entering Engine Cylinders

GM TechLink May 17, 2019

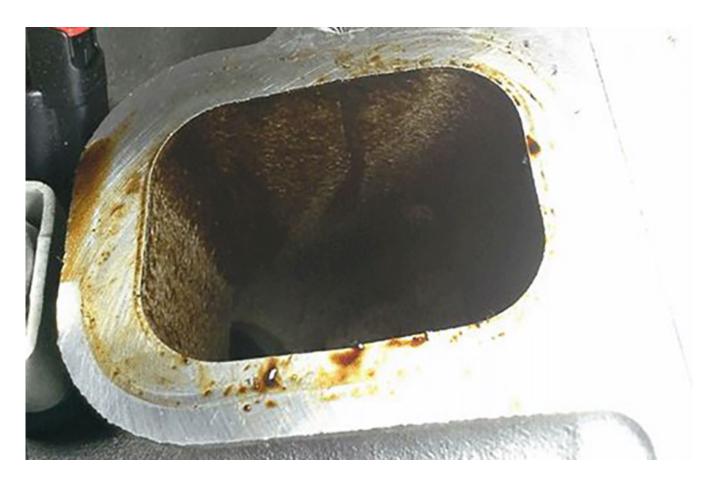
Fig. 13

If the head casting line is the issue, the intake port will be wet with a coolant and oil mix. This condition may cause the running rough while warm concern with or without DTCs set. The location where the coolant is running down in the port will look washed down. If this condition is found, the cylinder head will need to be replaced. (Fig. 13)
