2015 - 2018 Cadillac CTS-V: GM TechLink: Hard Shifting into 1st Gear or Reverse

GM TechLink

June 10, 2017

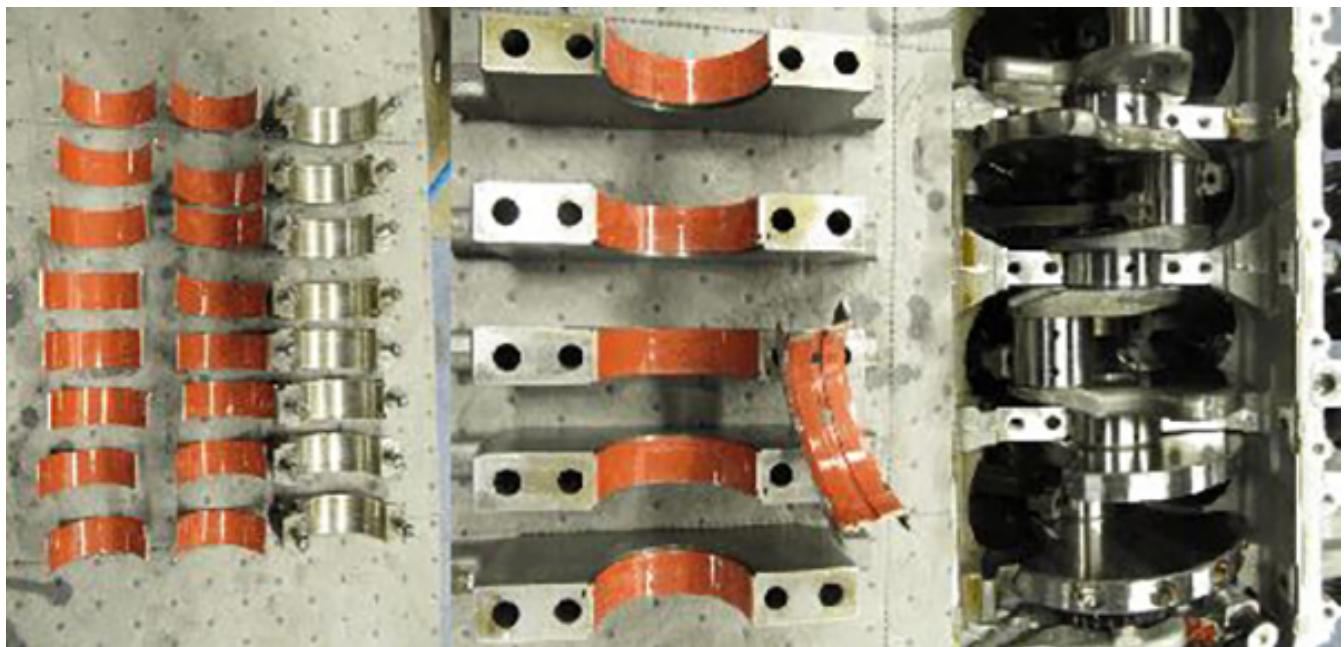
Fig. 10

The hard shifting conditions may require replacement of the crankshaft or thrust bearing. Before replacing any components, check for excessive crankshaft end play. Crankshaft end play clearance should be within a specification of 0.0015–0.0086 in. (0.040–0.220 mm).

If end play is found to be out of specification, remove the engine and check for possible crankshaft thrust bearing or crankshaft wear. The crankshaft and bearings should not show signs of excessive wear. (Fig. 10) Inspect the thrust bearing for wear on one side and the crankshaft on the mating surface.

If wear is evident — the three vertical channels may be worn off — replace the connecting rods, main bearings, thrust bearing and crankshaft.
