# 2018 - 2019 Cadillac ATS-V - CTS-V: Service Bulletin: #20-NA-054: Rear View Camera Guidance Lines Dim After Radio Replacement or Programming

## #20-NA-054: Rear View Camera Guidance Lines Dim After Radio Replacement or Programming - (Mar 3, 2020)

**Subject:** Rear View Camera  
Guidance Lines Dim  
After Radio Replacement  
or Programming

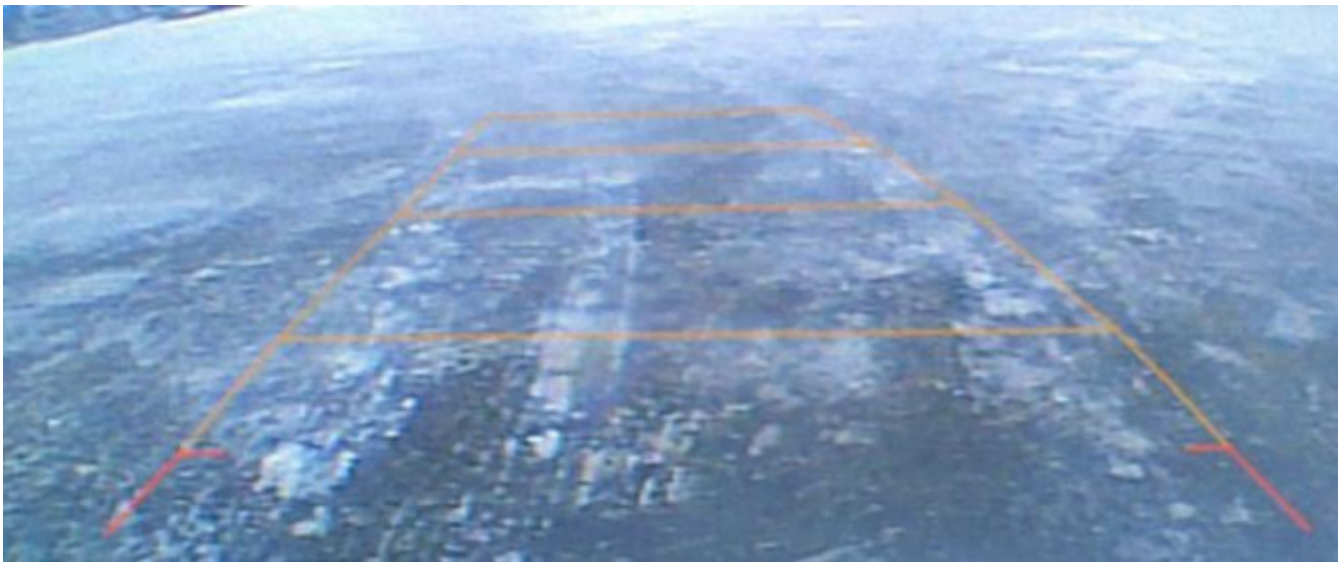
**New design:**

Some customers, after having radio replacement or radio reprogramming, may report that the Rear-View Camera (RVC) guidance lines are not as bold

as previously viewed, that they are faint, see-through, thinner, dim, or translucent; and they used to be more visible. A comparison between similar vehicle models may, or may not, show a difference in rear view camera guidance line appearance.

This may be caused by installing calibration files released in mid-2018 during radio replacement or reprogramming of the radio. The change to increase translucency was done to prevent the lines from

obstructing objects in the field-of-view.

Do not attempt repairs. The thinner, lighter appearance of RVC guidance lines is operating to design intent.
