# 2018 - 2019 Cadillac ATS-V - CTS-V: Service Bulletin: #20-NA-054: Rear View Camera Guidance Lines Dim After Radio Replacement or Programming

## #20-NA-054: Rear View Camera Guidance Lines Dim After Radio Replacement or Programming - (Mar 3, 2020)

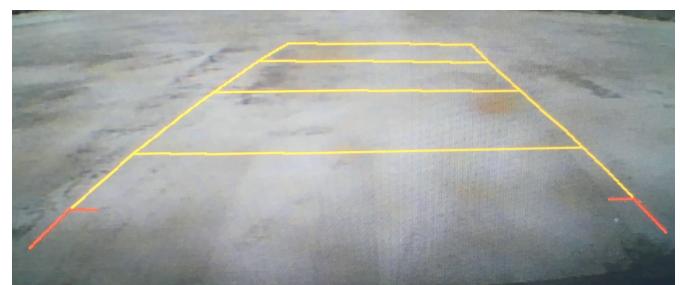
### Original design:

Some customers, after having radio replacement or radio reprogramming, may report that the Rear-View Camera (RVC) guidance lines are not as bold

as previously viewed, that they are faint, see-through, thinner, dim, or translucent; and they used to be more visible. A comparison between similar vehicle models may, or may not, show a difference in rear view camera guidance line appearance.

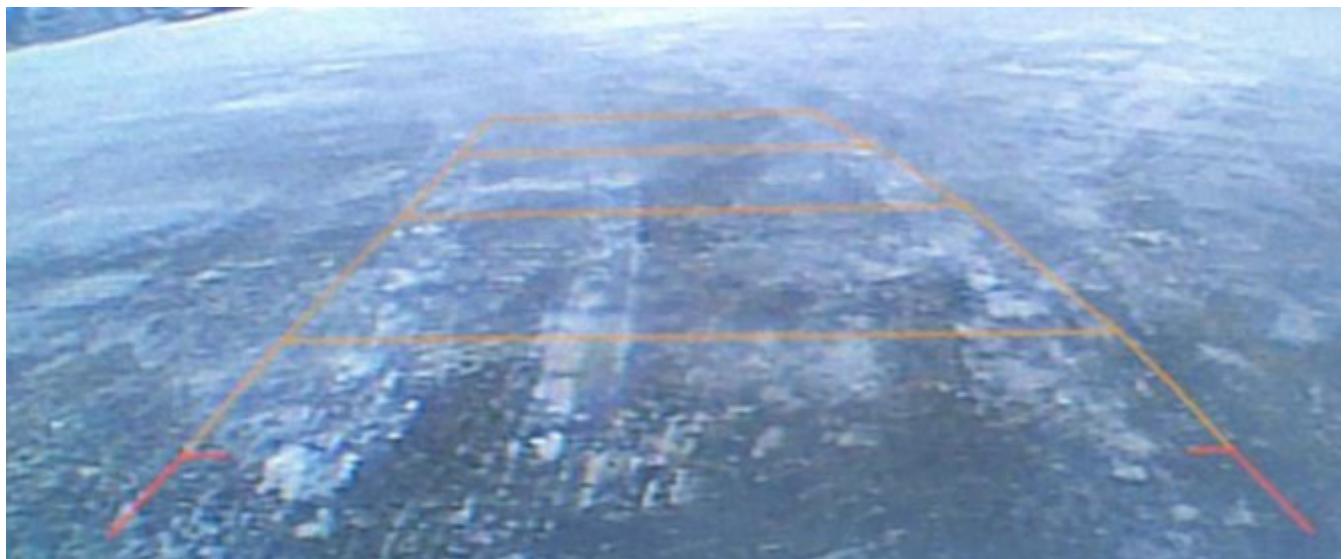
### New design:

This may be caused by installing calibration files released in mid-2018 during radio replacement or reprogramming of the radio. The change to increase translucency was done to prevent the lines from

obstructing objects in the field-of-view.

Do not attempt repairs. The thinner, lighter appearance of RVC guidance lines is operating to design intent.
