# 2018 - 2019 Cadillac ATS-V - CTS-V: Service Bulletin: #20-NA-054: Rear View Camera Guidance Lines Dim After Radio Replacement or Programming

## #20-NA-054: Rear View Camera Guidance Lines Dim After Radio Replacement or Programming - (Mar 3, 2020)

**Subject:** Rear View Camera  
Guidance Lines Dim  
After Radio Replacement  
or Programming

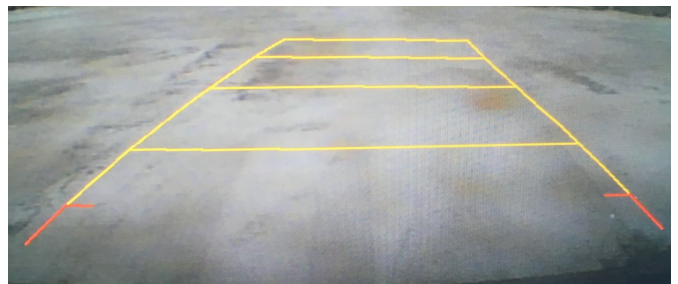
### **Original design:**

Some customers, after having radio replacement or radio reprogramming, may report that the Rear-View Camera (RVC) guidance lines are not as bold

as previously viewed, that they are faint, see-through, thinner, dim, or translucent; and they used to be more visible. A comparison between similar vehicle models may, or may not, show a difference in rear view camera guidance line appearance.

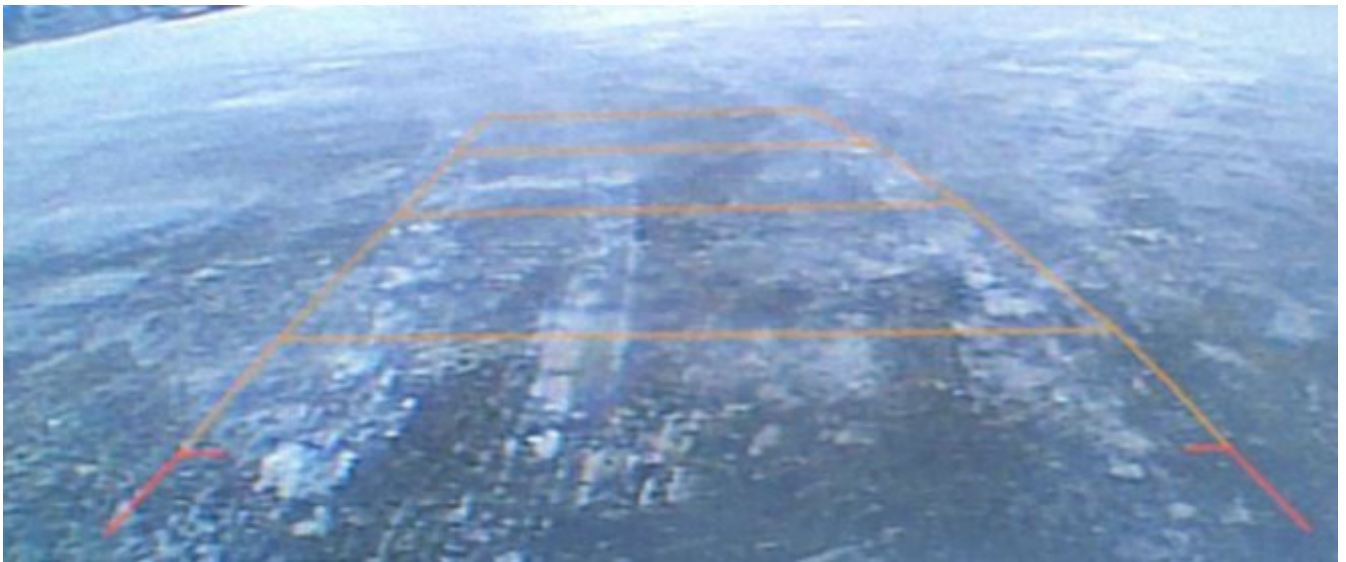
### **New design:**

This may be caused by installing calibration files released in mid-2018 during radio replacement or reprogramming of the radio. The change to increase translucency was done to prevent the lines from

obstructing objects in the field-of-view.

Do not attempt repairs. The thinner, lighter appearance of RVC guidance lines is operating to design intent.
