2018 - 2019 Cadillac ATS-V - CTS-V: Service Bulletin: #20-NA-054: Rear View Camera Guidance Lines Dim After Radio Replacement or Programming

#20-NA-054: Rear View Camera Guidance Lines Dim After Radio Replacement or Programming - (Mar 3, 2020)

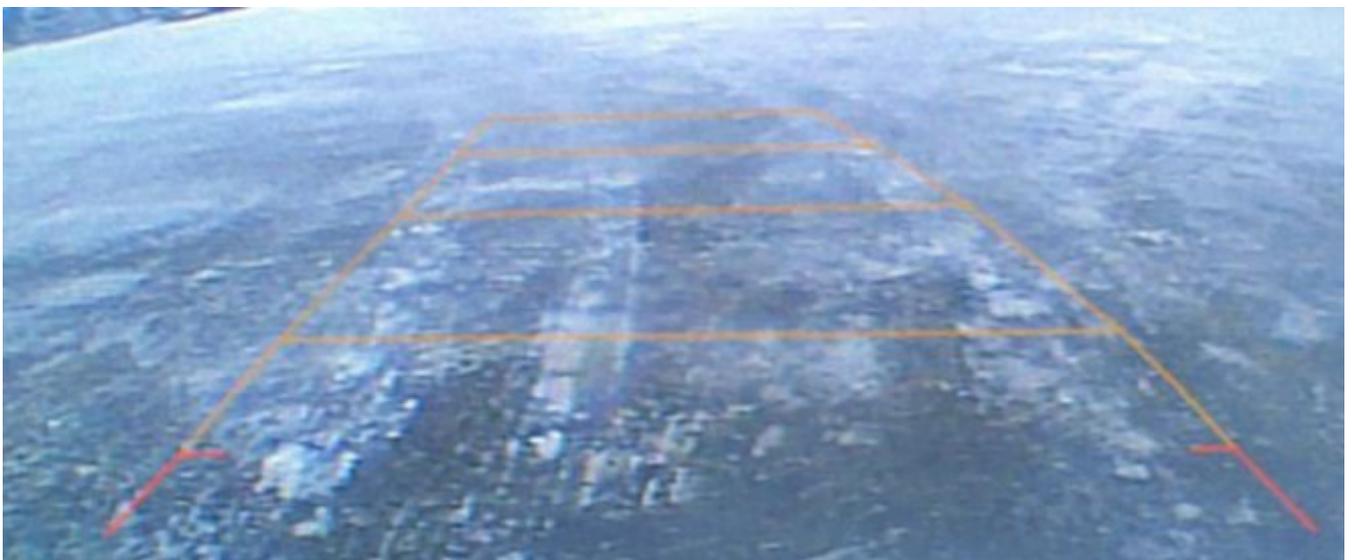
New design:

Some customers, after having radio replacement or radio reprogramming, may report that the Rear-View Camera (RVC) guidance lines are not as bold

as previously viewed, that they are faint, see-through, thinner, dim, or translucent; and they used to be more visible. A comparison between similar vehicle models may, or may not, show a difference in rear view camera guidance line appearance.

This may be caused by installing calibration files released in mid-2018 during radio replacement or reprogramming of the radio. The change to increase translucency was done to prevent the lines from

obstructing objects in the field-of-view.

Do not attempt repairs. The thinner, lighter appearance of RVC guidance lines is operating to design intent.
