2018 - 2019 Cadillac ATS-V - CTS-V: Service Bulletin: #20-NA-054: Rear View Camera Guidance Lines Dim After Radio Replacement or Programming

#20-NA-054: Rear View Camera Guidance Lines Dim After Radio Replacement or Programming - (Mar 3, 2020)

Brand:	Model:	Model Year:		VIN:		Engine:	Transmission:
		from	to	from	to		
Cadillac	ATS	2018	2019				
	CTS						
	XTS						
GMC	Terrain	2018	2018

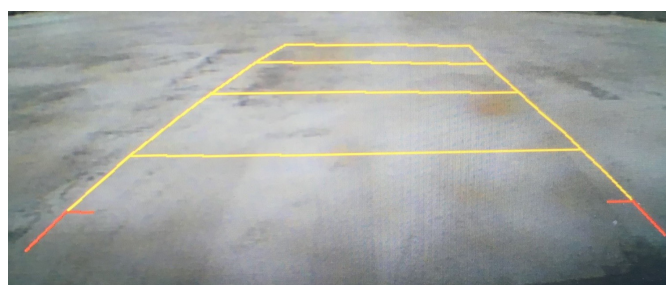
Original design:

Some customers, after having radio replacement or radio reprogramming, may report that the Rear-View Camera (RVC) guidance lines are not as bold as previously viewed, that they are faint, see-through, thinner, dim, or translucent; and they used to be more visible. A comparison between similar vehicle models may, or may not, show a difference in rear view camera guidance line appearance.

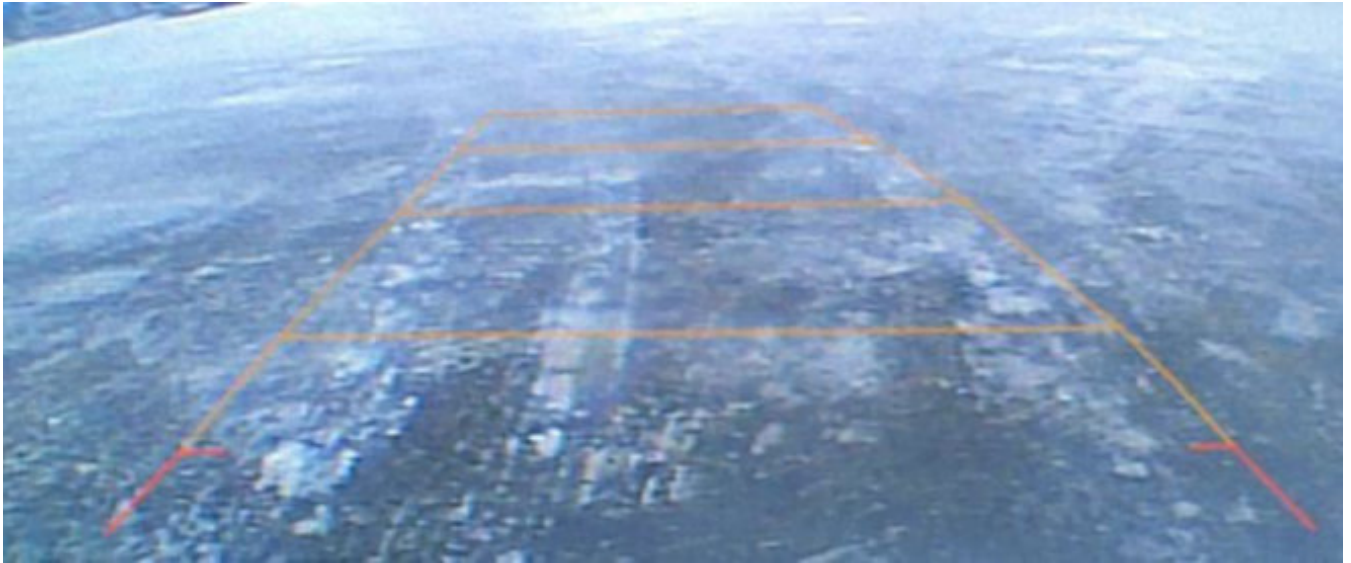
New design:

This may be caused by installing calibration files released in mid-2018 during radio replacement or reprogramming of the radio. The change to increase translucency was done to prevent the lines from obstructing objects in the field-of-view.

Do not attempt repairs. The thinner, lighter appearance of RVC guidance lines is operating to design intent.
