2009 - 2015 Cadillac CTS-V: GM TechLink: Poor Ground Connection at G110

GM TechLink

January 29, 2016

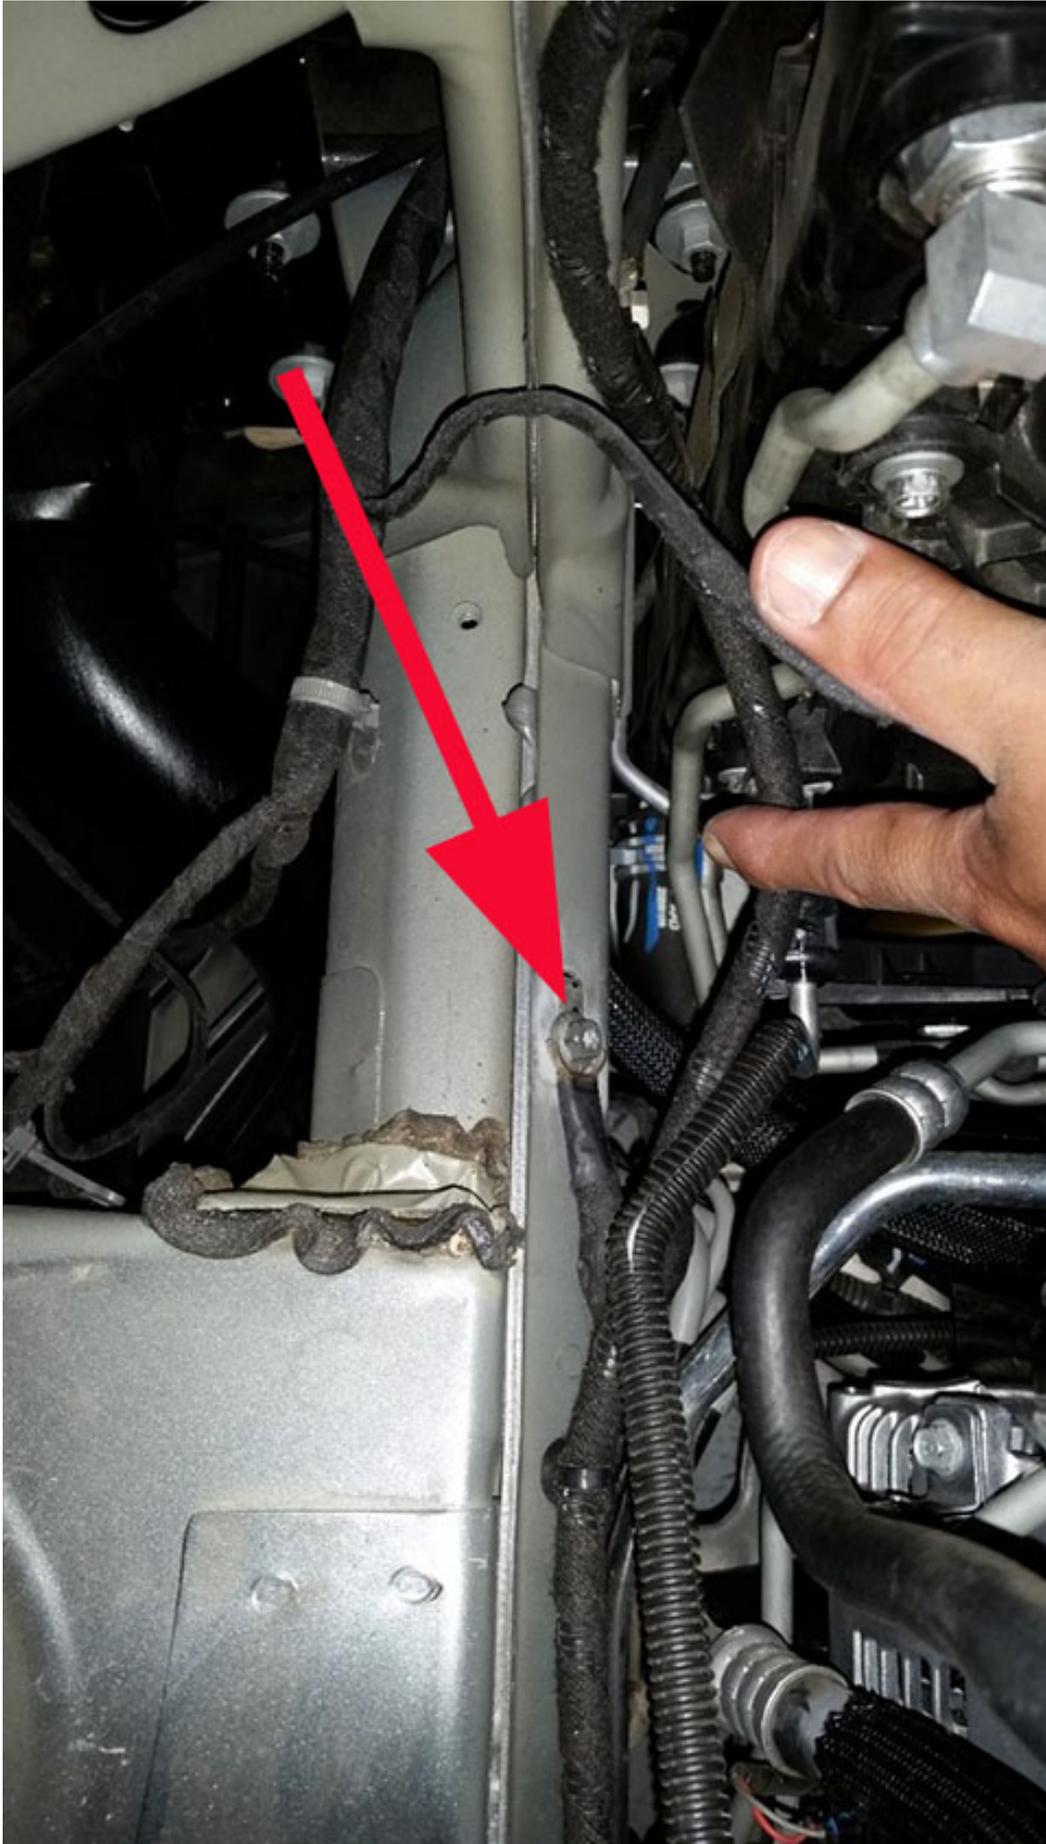
Fig. 23

If any of these conditions are found, check for an aftermarket Cold Air Intake (CAI) assembly installed on the vehicle. Certain aftermarket CAI manufacturers use Ground 110 (G110) (Fig. 23) as a bracket mounting point (Fig. 24), which causes a poor ground connection on the vehicle.

TIP: G110 should not be used to attach any aftermarket accessories.
