2009 - 2015 Cadillac CTS-V: Poor Ground Connection at G110

GM TechLink

January 29, 2016

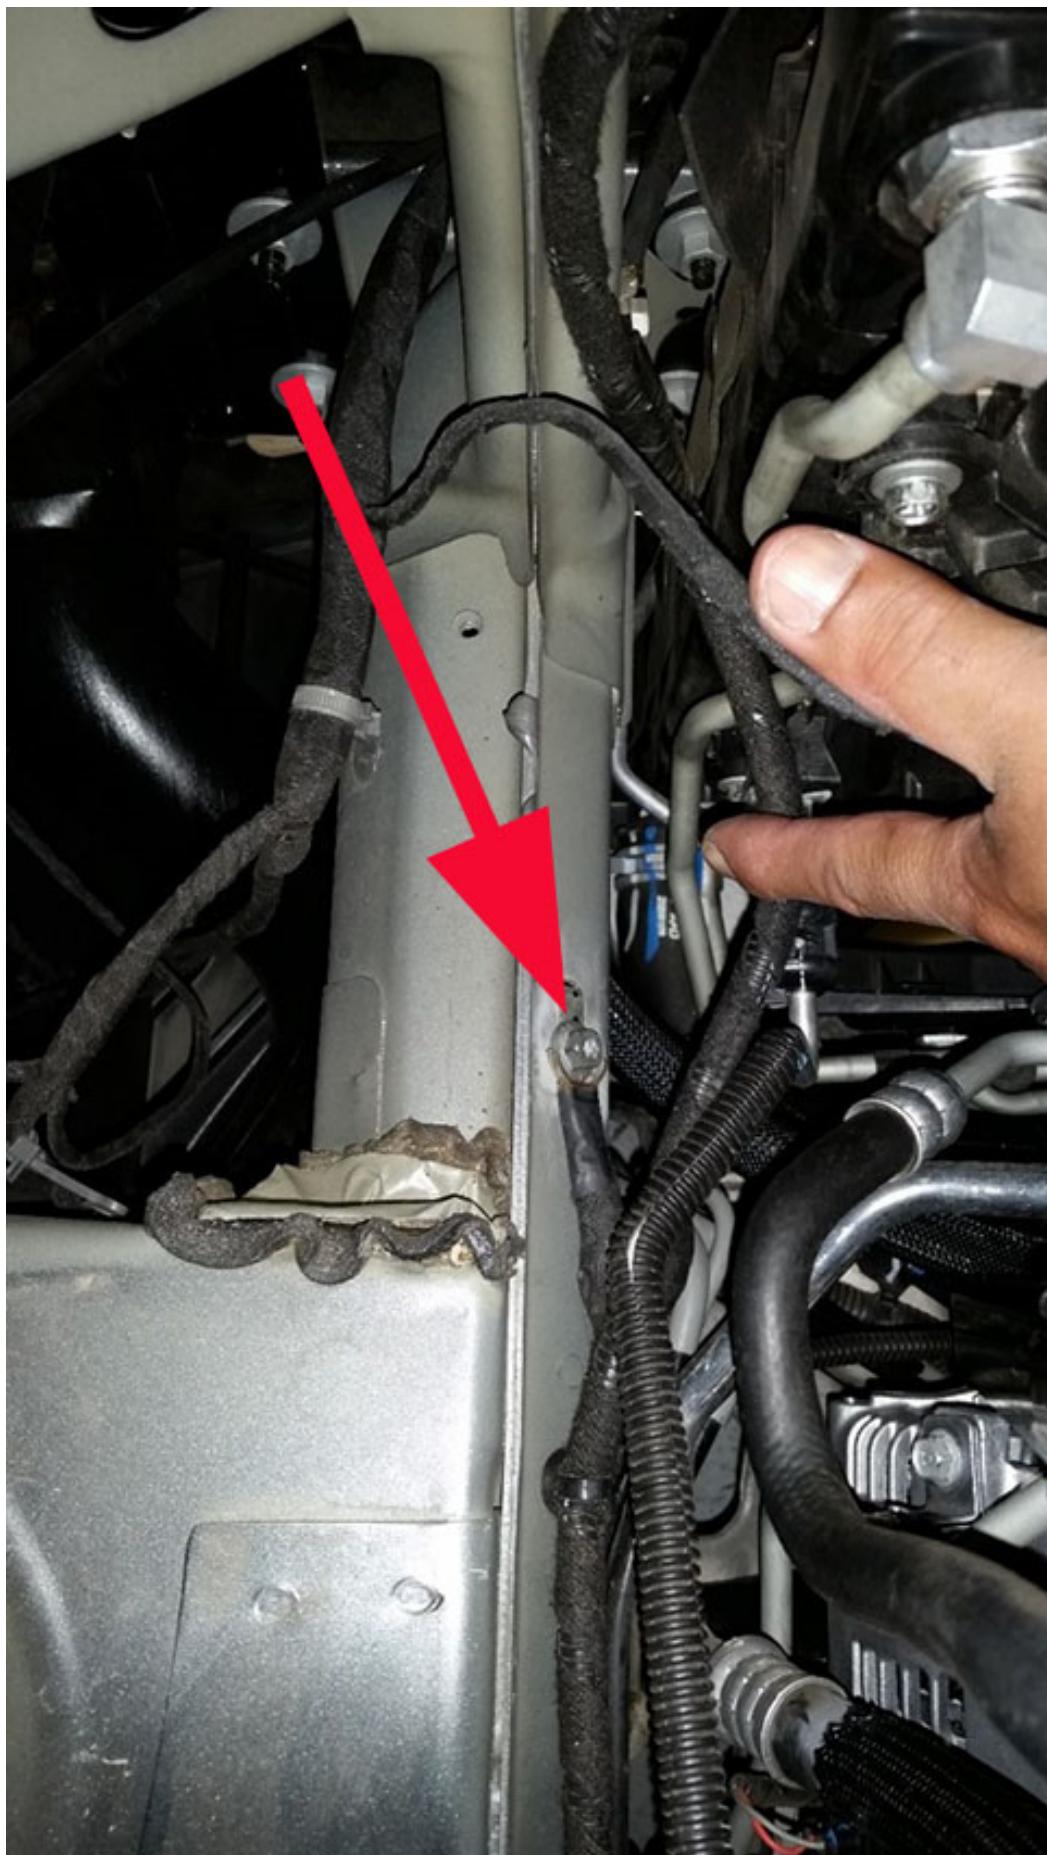
Fig. 23

If any of these conditions are found, check for an aftermarket Cold Air Intake (CAI) assembly installed on the vehicle. Certain aftermarket CAI manufacturers use Ground 110 (G110) (Fig. 23) as a bracket mounting point (Fig. 24), which causes a poor ground connection on the vehicle.

TIP: G110 should not be used to attach any aftermarket accessories.
