# **2009 - 2015 Cadillac CTS-V: GM TechLink: Poor Ground Connection at G110**

**GM TechLink**

**January 29, 2016**

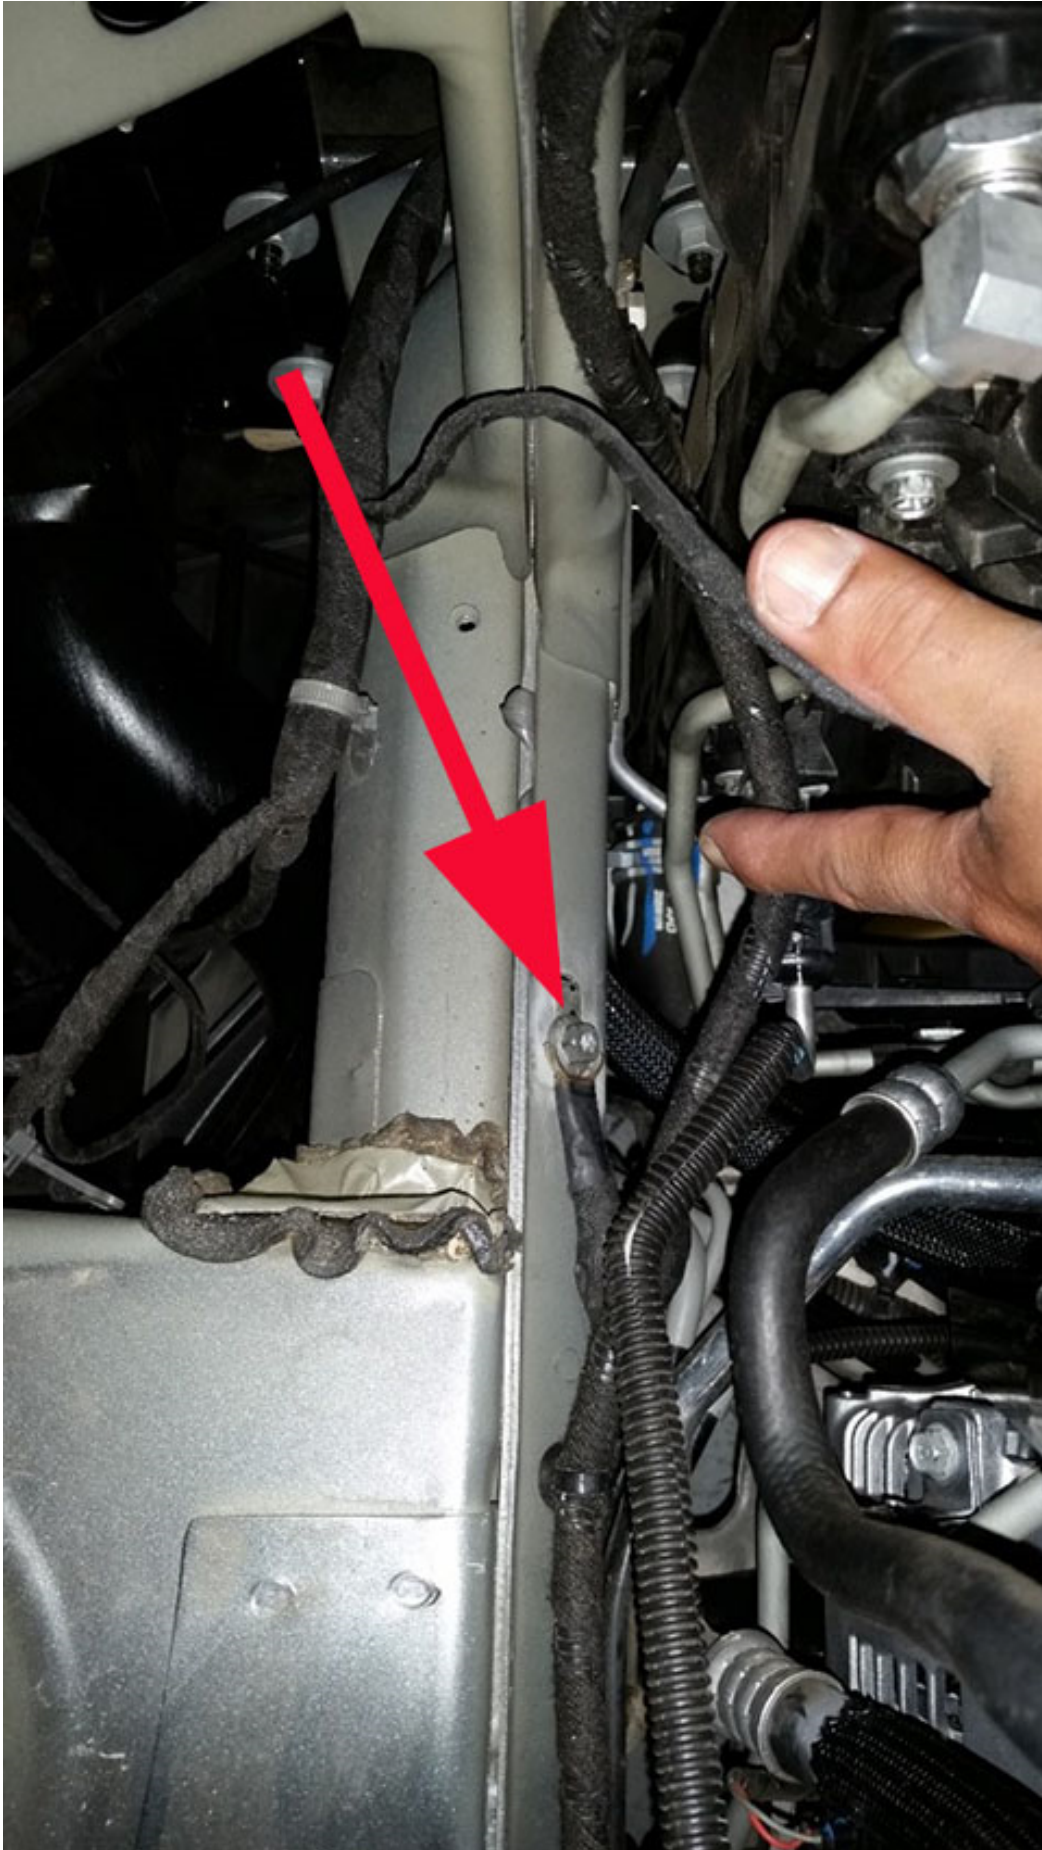
On some 2009 - 2015 Cadillac CTS-V models, several intermittent conditions may be present, including a Service Power Steering message, reduced power steering assist, and illuminated ABS, traction control and electronic stability control (StabiliTrak) warning lamps on the instrument cluster.

In addition, DTCs C0450 (Steering Assist Control Actuator Circuit), C0899 (Device Voltage Low), U0121 (Lost Communication with Electronic Brake Control Module), U0123 (Lost Communication with Yaw Rate Sensor Module), or U0126 (Lost Communication with Steering Wheel Angle Sensor Module) may be set.

If any of these conditions are found, check for an aftermarket Cold Air Intake (CAI) assembly installed on the vehicle. Certain aftermarket CAI manufacturers use Ground 110 (G110) (Fig. 23) as a bracket mounting point (Fig. 24), which causes a poor ground connection on the vehicle.

**TIP:** G110 should not be used to attach any aftermarket accessories.
