# **2016 - 2017 Cadillac CTS-V: GM TechLink: Harsh Shift and Rough Idle Conditions**

**GM TechLink**

**October 9, 2016**

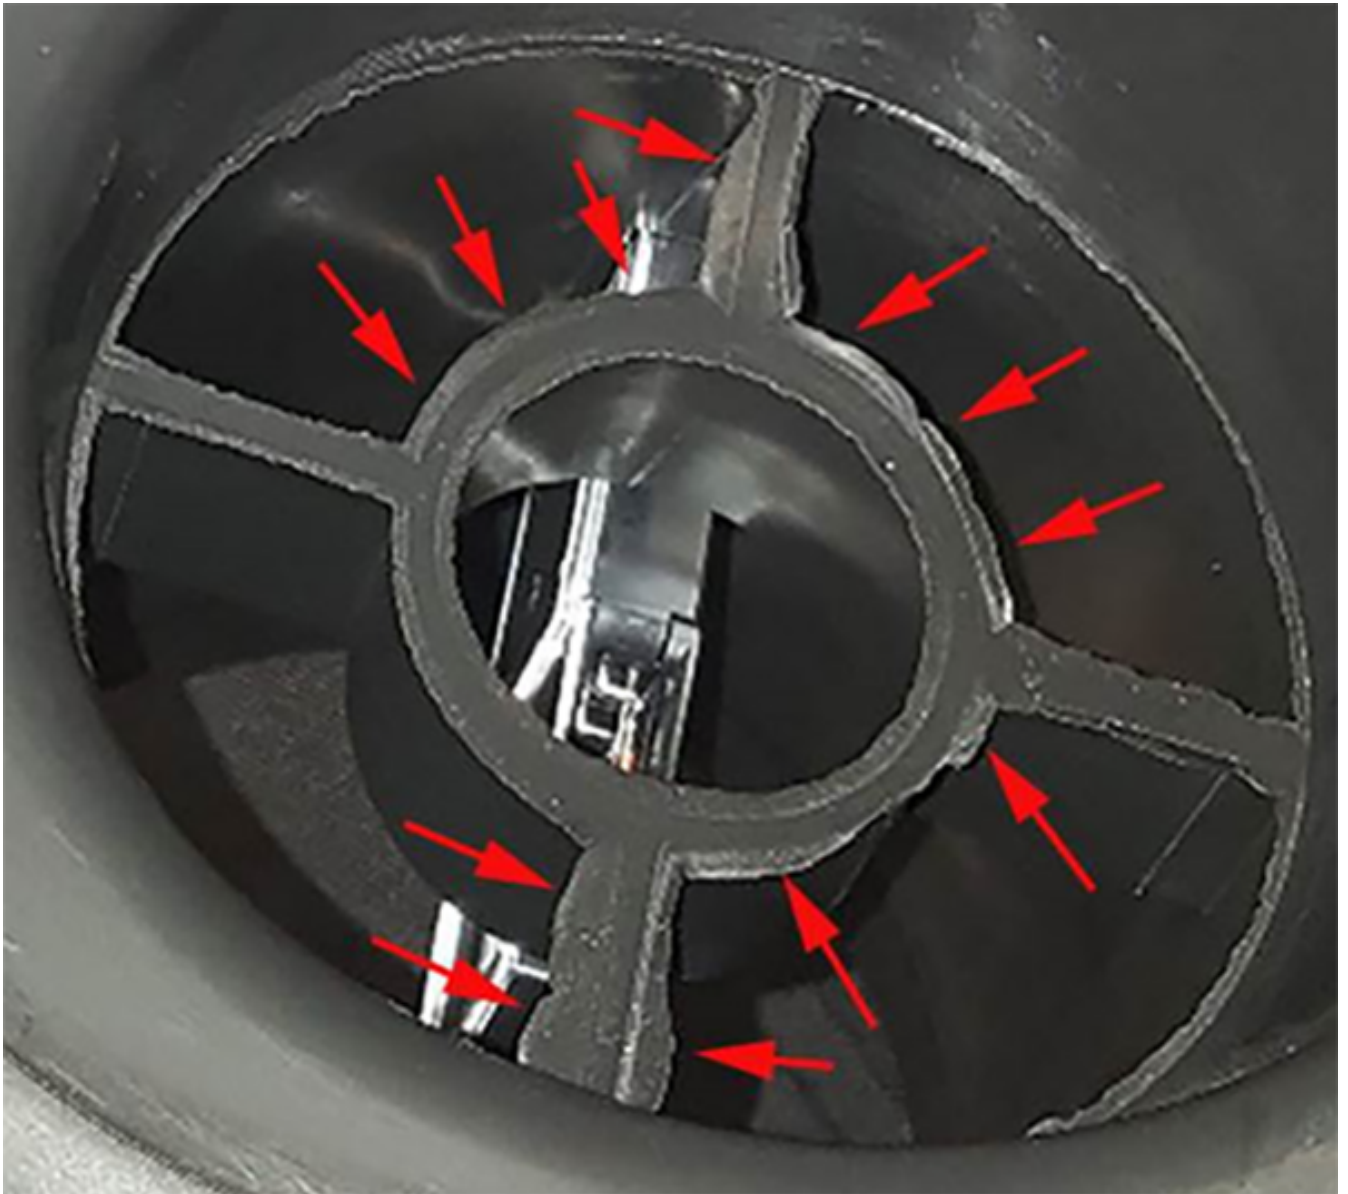
**Fig. 11**

The harsh shift may be felt on the 1/2 and 2/3 shift along with a sputter when applying the throttle between 0% and 30% and a rough idle. DTCs P0101 (MAF Sensor Performance), P0171 (Fuel Trim System Lean Bank 1), P0172 (Fuel Trim System Rich Bank 1), P0174 (Fuel Trim System Lean Bank 2) and P0175 (Fuel Trim System Rich Bank 2) may be set.

Inspect for cast flashing in the air filter housing near the Mass Air Flow (MAF) sensor for excessive flashing. (Fig. 11) If excessive flashing is found, replace the air filter housing lid. Be sure to check the flashing in the new lid as well.
