# 2016 - 2017 Cadillac CTS-V: GM TechLink: Harsh Shift and Rough Idle Conditions

GM TechLink

October 9, 2016

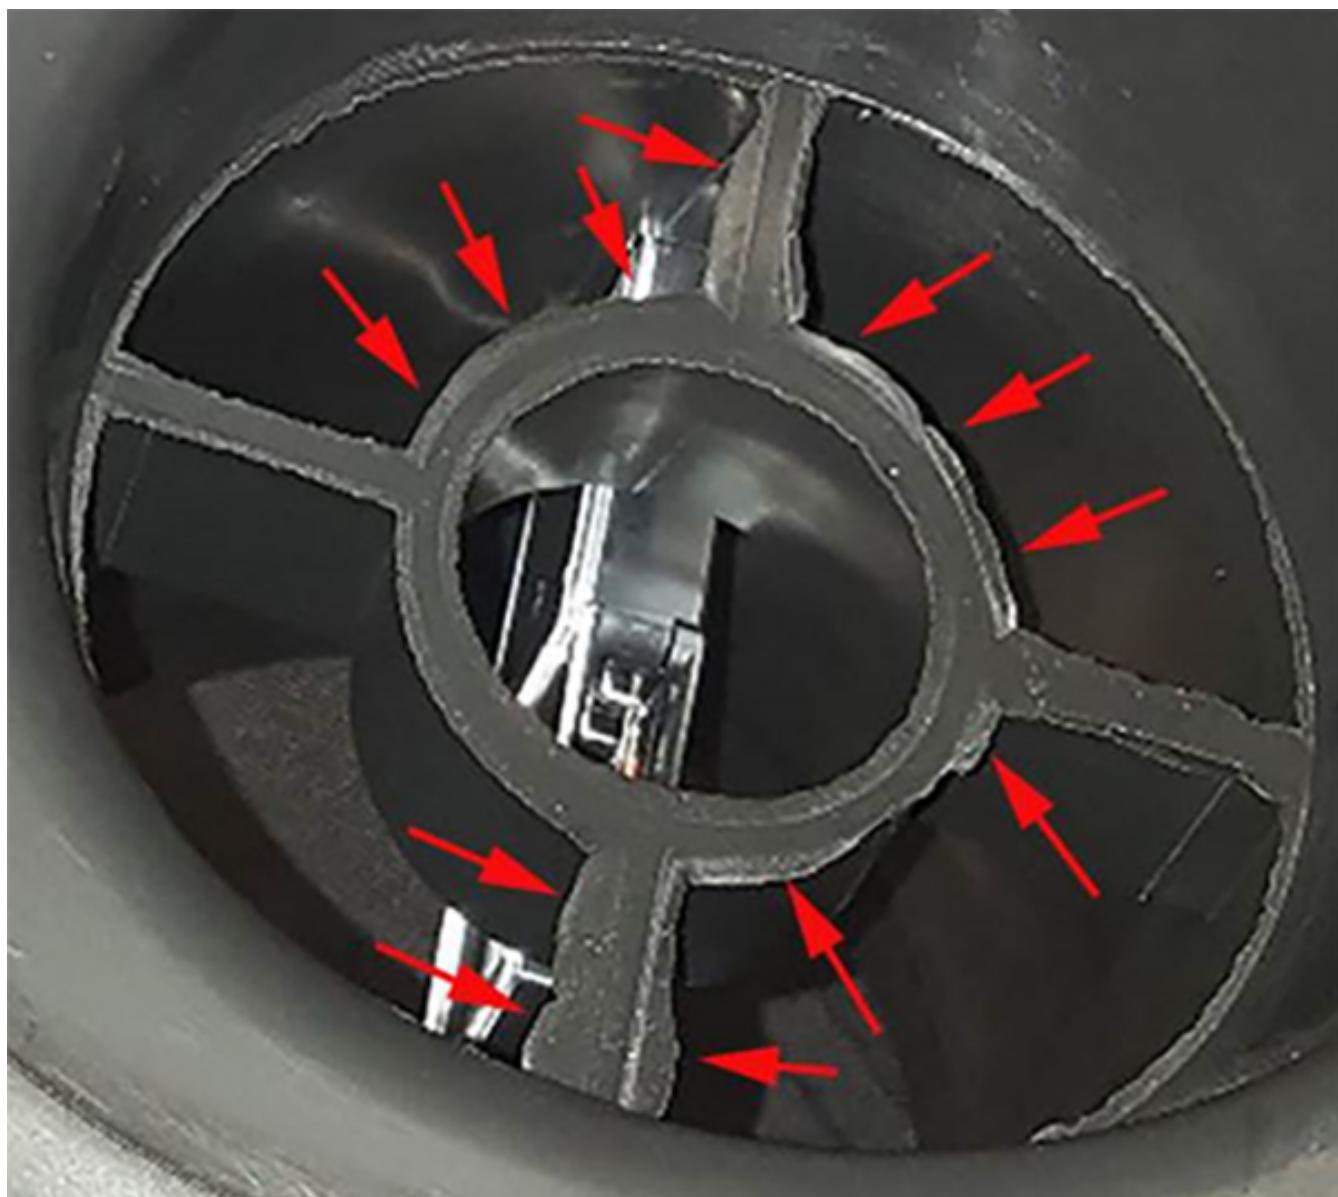
**Fig. 11**

The harsh shift may be felt on the 1/2 and 2/3 shift along with a sputter when applying the throttle between 0% and 30% and a rough idle. DTCs P0101 (MAF Sensor Performance), P0171 (Fuel Trim System Lean Bank 1), P0172 (Fuel Trim System Rich Bank 1), P0174 (Fuel Trim System Lean Bank 2) and P0175 (Fuel Trim System Rich Bank 2) may be set.

Inspect for cast flashing in the air filter housing near the Mass Air Flow (MAF) sensor for excessive flashing. (Fig. 11) If excessive flashing is found, replace the air filter housing lid. Be sure to check the flashing in the new lid as well.
