2016 - 2017 Cadillac CTS-V: Harsh Shift and Rough Idle Conditions

GM TechLink

October 9, 2016

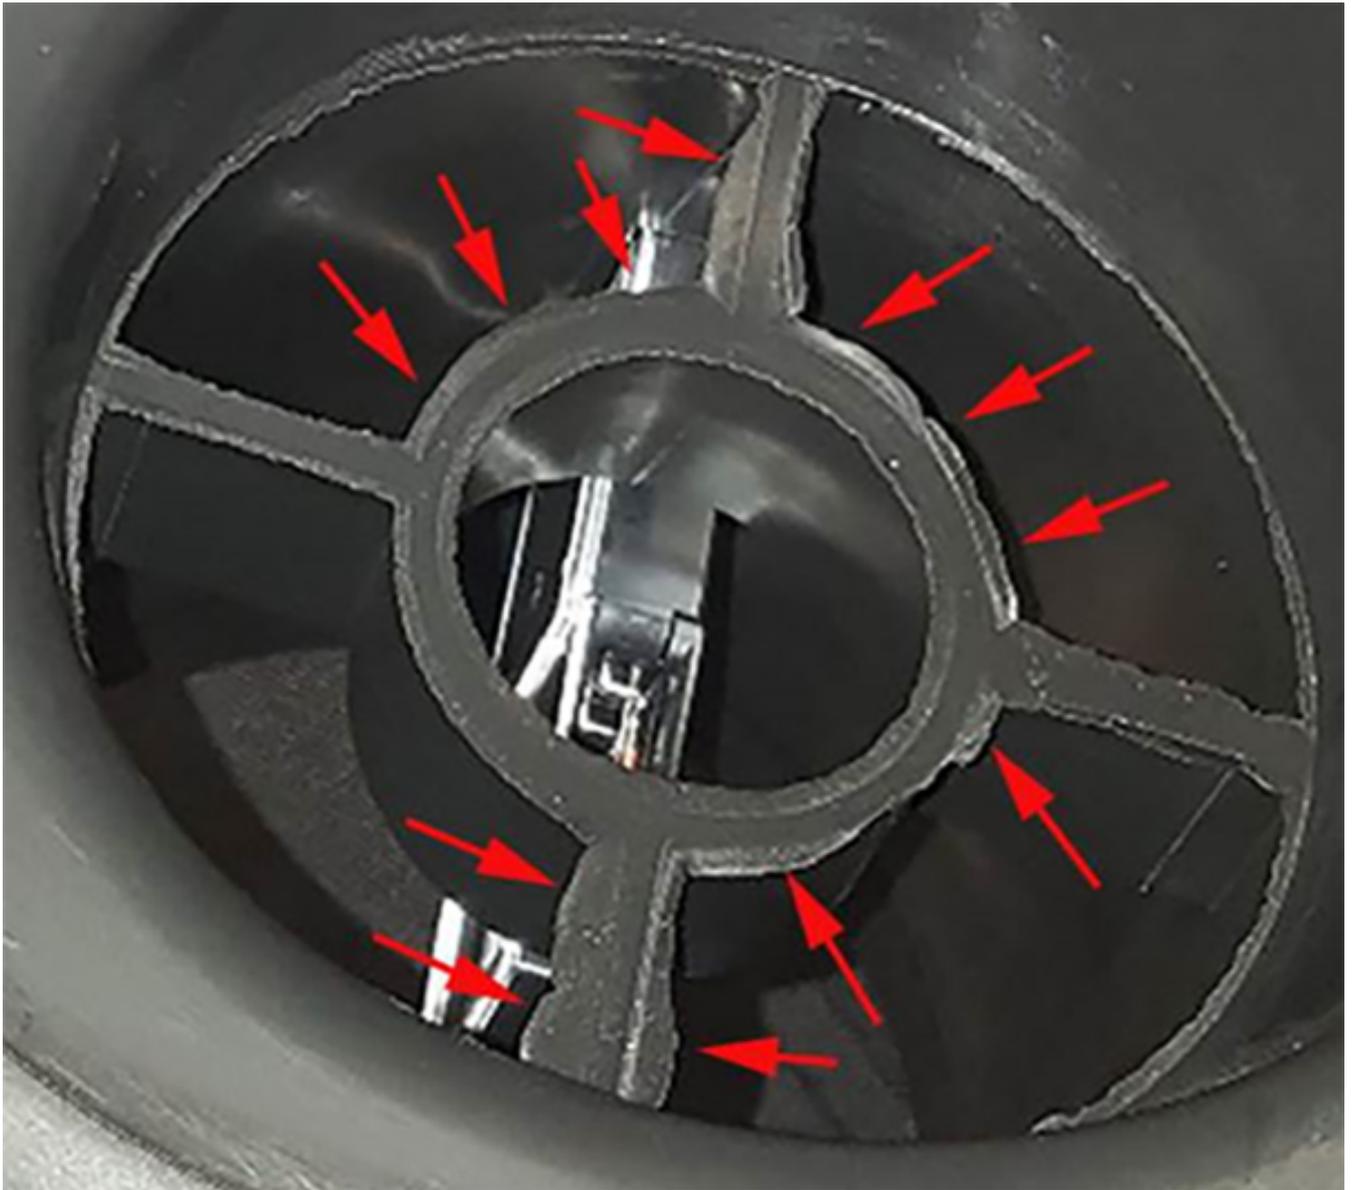
Fig. 11

The harsh shift may be felt on the 1/2 and 2/3 shift along with a sputter when applying the throttle between 0% and 30% and a rough idle. DTCs P0101 (MAF Sensor Performance), P0171 (Fuel Trim System Lean Bank 1), P0172 (Fuel Trim System Rich Bank 1), P0174 (Fuel Trim System Lean Bank 2) and P0175 (Fuel Trim System Rich Bank 2) may be set.

Inspect for cast flashing in the air filter housing near the Mass Air Flow (MAF) sensor for excessive flashing. (Fig. 11) If excessive flashing is found, replace the air filter housing lid. Be sure to check the flashing in the new lid as well.
