2016 - 2019 Cadillac CTS-V: Service Bulletin: #15-06-01-002K: Engine Misfire/Tick Noise, Malfunction Indicator Lamp (MIL) Illuminated - DTC P0300 Set - (Dec 17, 2020)

#15-06-01-002K: Engine Misfire/Tick Noise, Malfunction Indicator Lamp (MIL) Illuminated - DTC P0300 Set - (Dec 17, 2020)

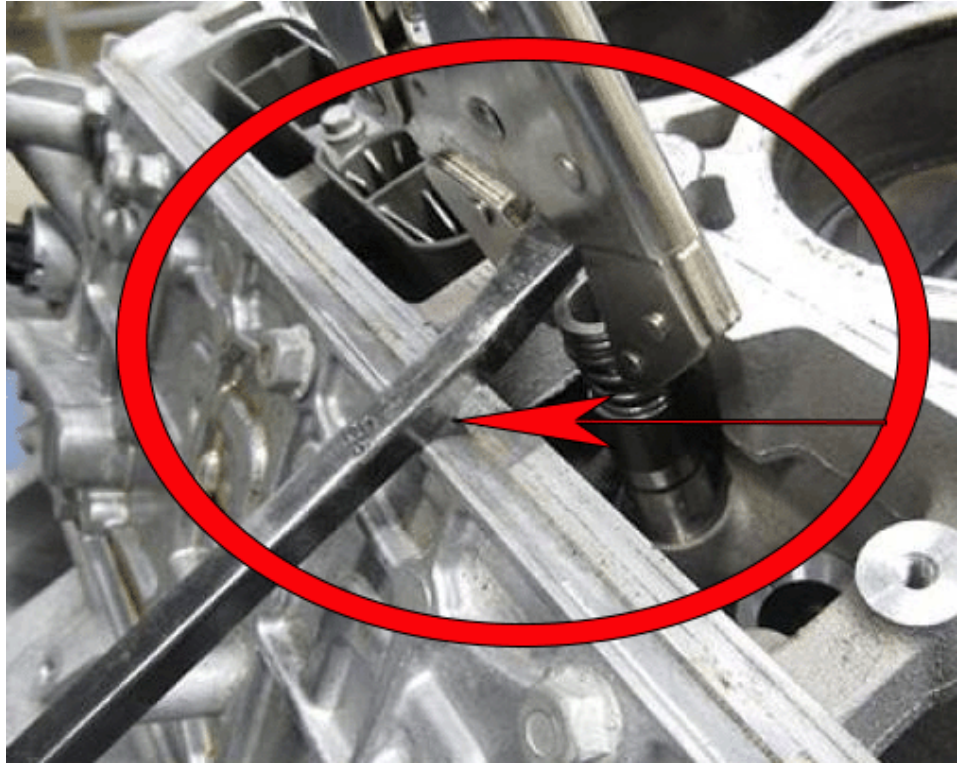
Note: Be sure *NOT* to pry on the sealing surface of the block, as shown in the illustration above.

1. Use vice grips with a small pry bar.
