2016 - 2019 Cadillac CTS-V: Service Bulletin: #15-06-01-002K: Engine Misfire/Tick Noise, Malfunction Indicator Lamp (MIL) Illuminated - DTC P0300 Set - (Dec 17, 2020)

#15-06-01-002K: Engine Misfire/Tick Noise, Malfunction Indicator Lamp (MIL) Illuminated - DTC P0300 Set - (Dec 17, 2020)

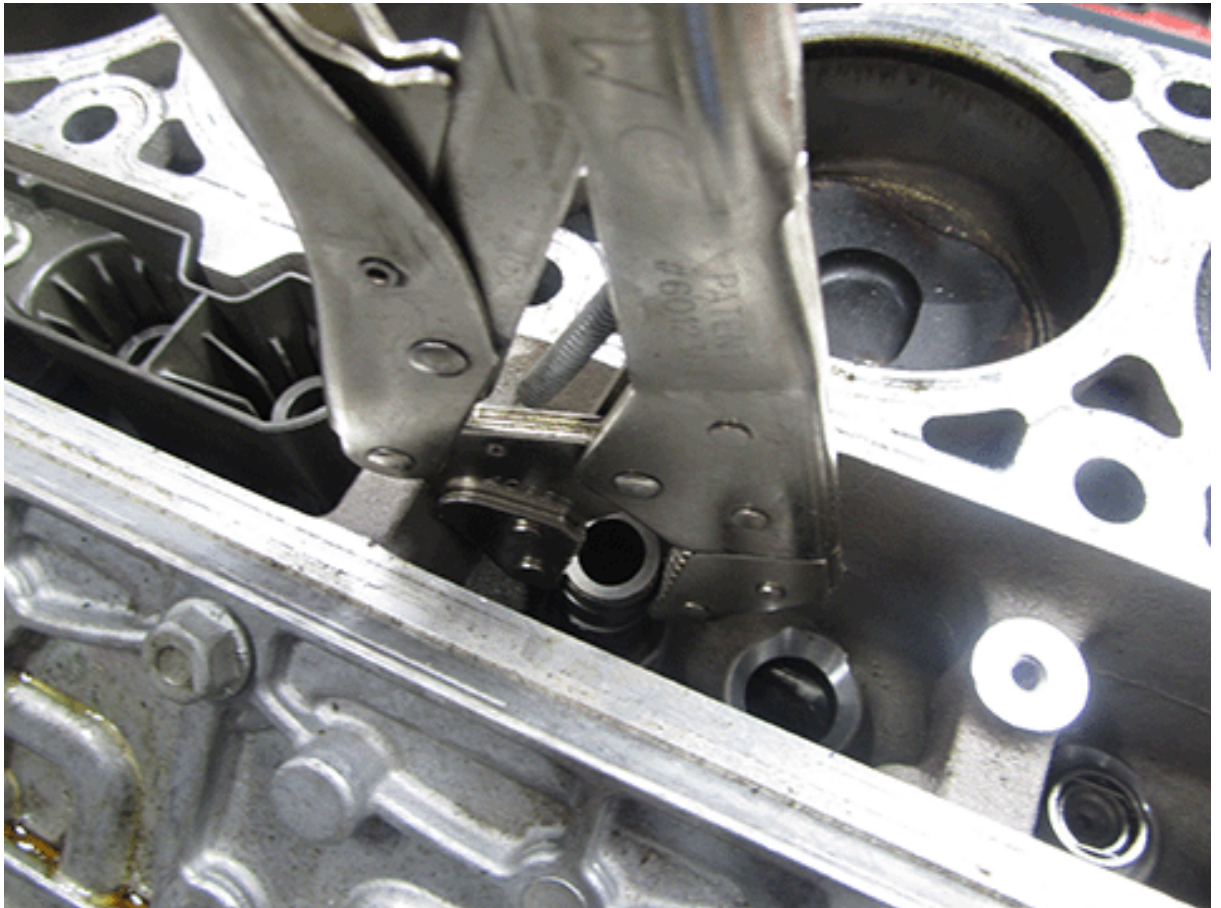
- Active fuel management (AFM) lifter that is mechanically collapsed and/or stuck all of the time.
- Internal locking pin damage in the lifter, due to oil aeration.
- Lifter that has collapsed and is stuck in the lifter bore.

1. Use vice grips with a slide hammer.
