2016 - 2019 Cadillac CTS-V: Service Bulletin: #15-06-01-002K: Engine Misfire/Tick Noise, Malfunction Indicator Lamp (MIL) Illuminated - DTC P0300 Set - (Dec 17, 2020)

Subject: Engine Misfire/Tick Noise,

Malfunction Indicator Lamp (MIL)

Illuminated - DTC P0300 Set

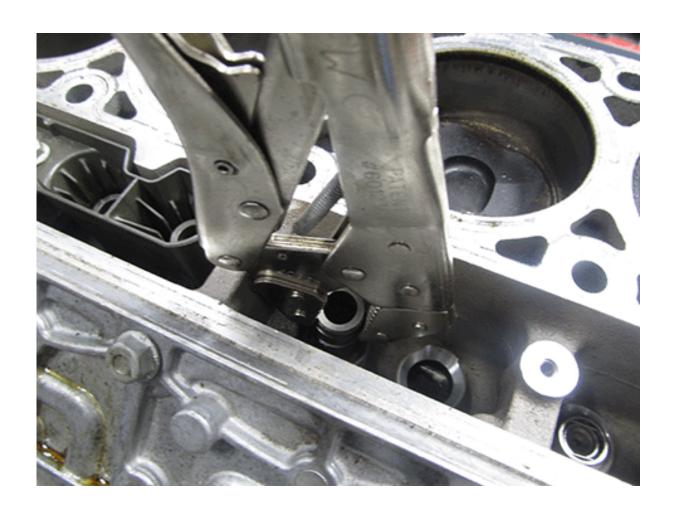
There are two approved processes for removing the lifter when stuck in the bore.

1. Use vice grips with a slide hammer.

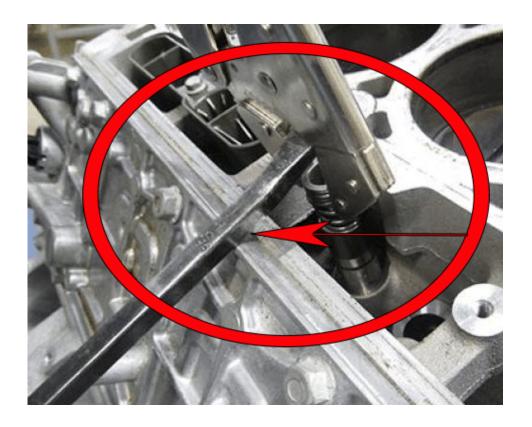
Note: Be sure *NOT* to pry on the sealing surface of the block, as shown in the illustration above.

1. Use vice grips with a small pry bar.
