2016 - 2019 Cadillac CTS-V: Service Bulletin: #15-06-01-002K: Engine Misfire/Tick Noise, Malfunction Indicator Lamp (MIL) Illuminated - DTC P0300 Set - (Dec 17, 2020)

Subject: Engine Misfire/Tick Noise,
Malfunction Indicator Lamp (MIL)
Illuminated - DTC P0300 Set

Equipped with 5.3L Engine (RPOs L83, L8B) or 6.2L Engine (RPOs L86, LT1, LT4)

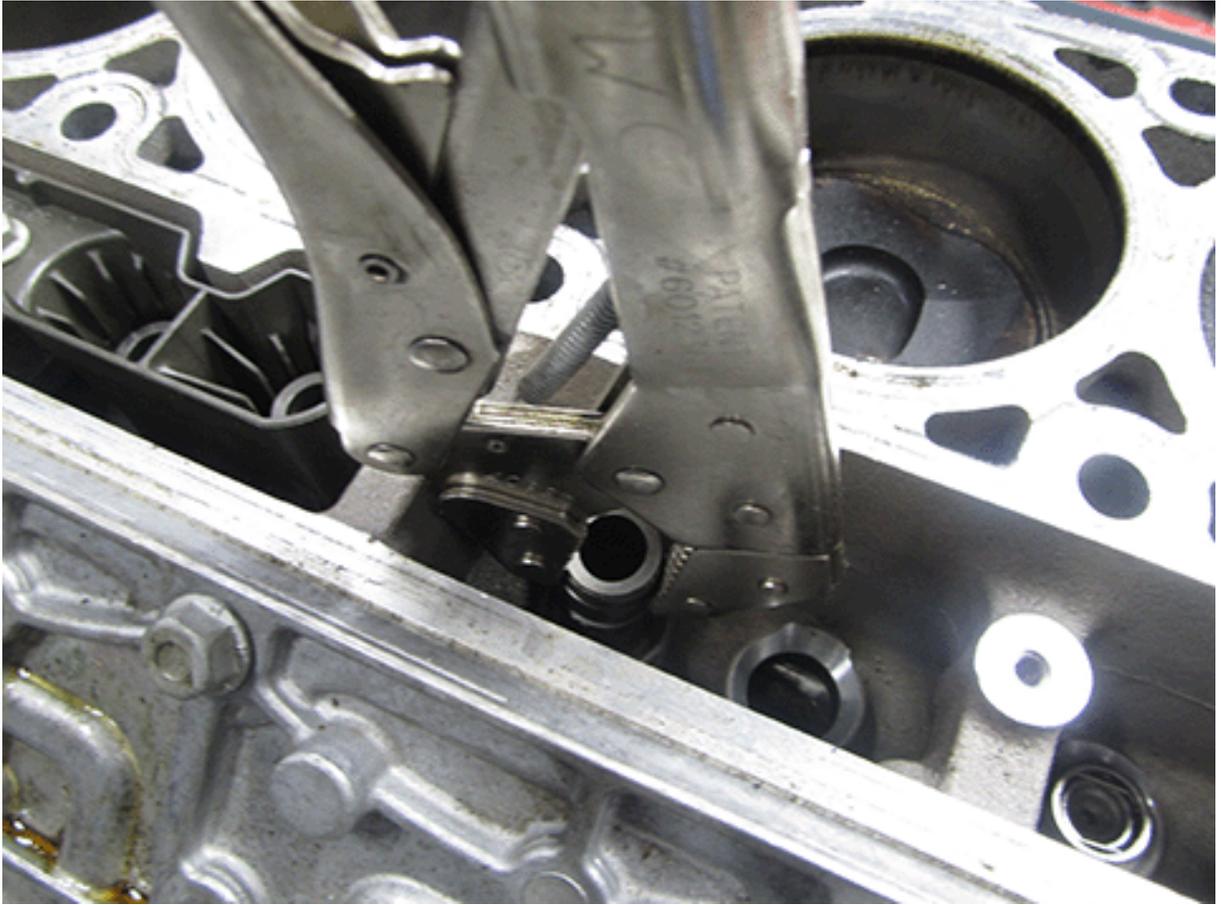
There are two approved processes for removing the lifter when stuck in the bore.

1. Use vice grips with a slide hammer.
