2016 - 2019 Cadillac CTS-V: Service Bulletin: #15-06-01-002K: Engine Misfire/Tick Noise, Malfunction Indicator Lamp (MIL) Illuminated - DTC P0300 Set - (Dec 17, 2020)

Subject: Engine Misfire/Tick Noise, Malfunction Indicator
Lamp (MIL) Illuminated - DTC P0300 Set

Models: 2015-2019 Cadillac Escalade
2016 - 2019 Cadillac CTS-V
2014 Chevrolet Silverado 1500
2014 - 2019 Chevrolet Corvette
2015-2018 Chevrolet Silverado
2015-2019 Chevrolet Suburban, Tahoe
2016-2019 Chevrolet Camaro
2019 Chevrolet Silverado LD
2014 GMC Sierra 1500
2015-2018 GMC Sierra
2015-2019 GMC Yukon, Yukon XL
2019 GMC Sierra Limited
Equipped with 5.3L Engine (RPOs L83, L8B) or
6.2L Engine (RPOs L86, LT1, LT4)

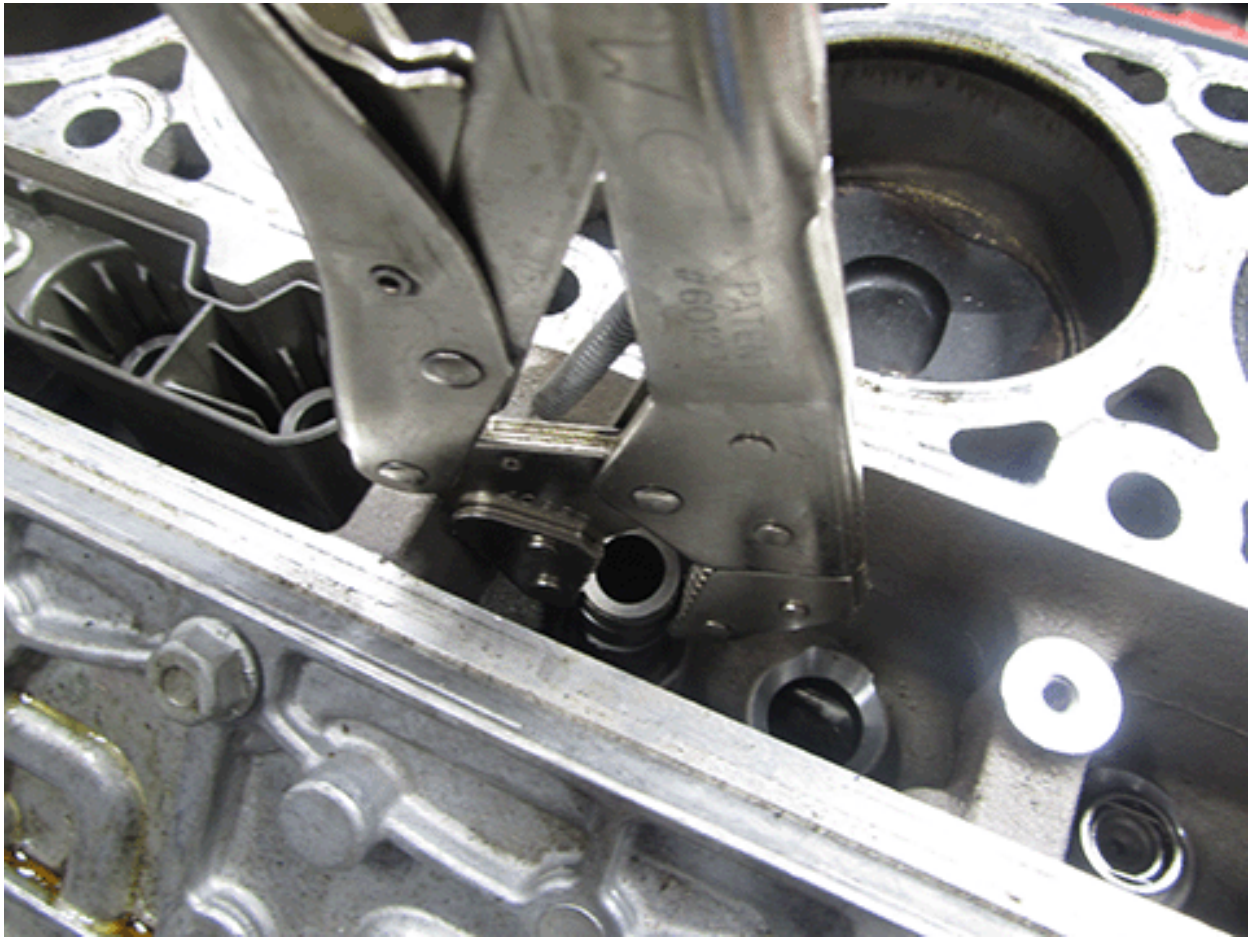
There are two approved processes for removing the lifter when stuck in the bore.

1. Use vice grips with a slide hammer.

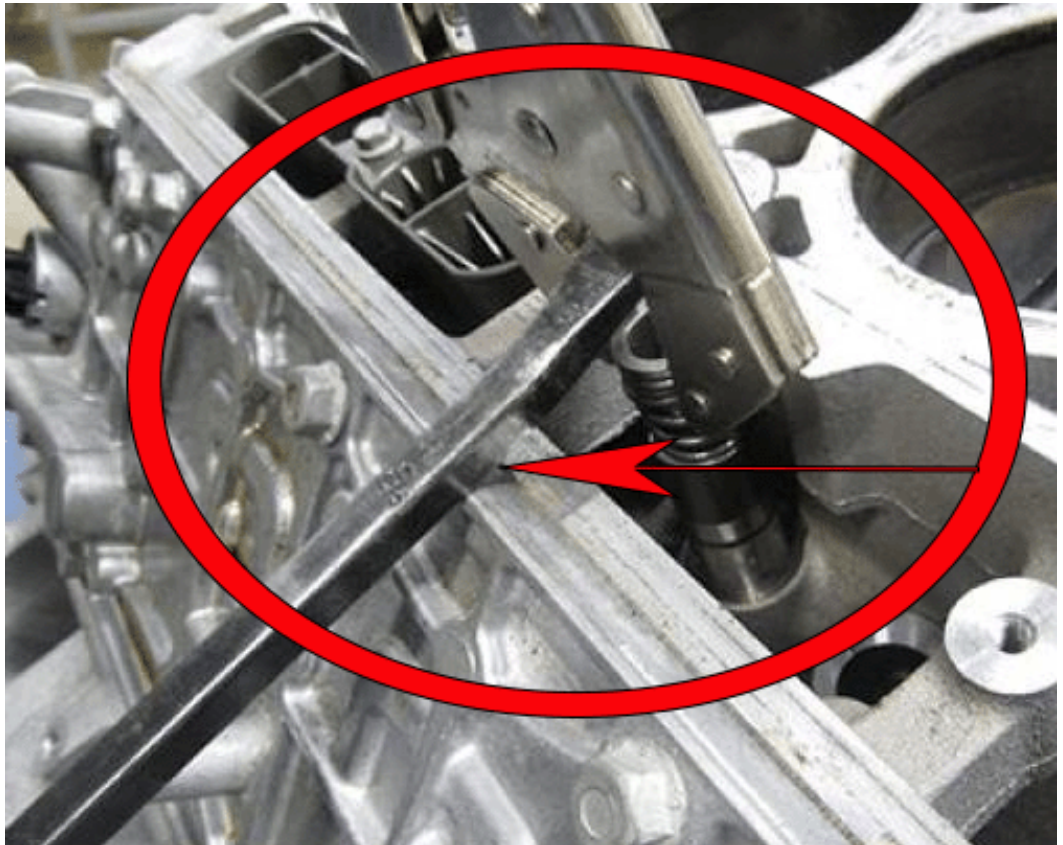
Note: Be sure *NOT* to pry on the sealing surface of the block, as shown in the illustration above.

1. Use vice grips with a small pry bar.
