# 2014 - 2019 Cadillac ATS-V - CTS V-Sport: Service Bulletin: #19-NA-256: Diagnostic Tips for Knocking, Rattle, Squeak and/or Squeal Type Noise from Engine

#19-NA-256: Diagnostic Tips for Knocking, Rattle, Squeak and/or Squeal Type Noise from Engine - Engine Replacement Recommendations for HFV6 Gen 1 and Gen 2 - (Jan 14, 2021)

**Subject:** Diagnostic Tips for Knocking, Rattle, Squeak and/or Squeal Type Noise from Engine – Engine Replacement Recommendations for HFV6 Gen 1 and Gen 2

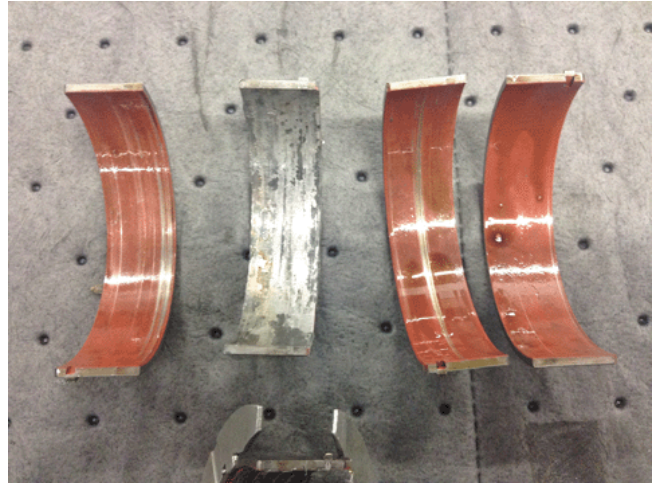
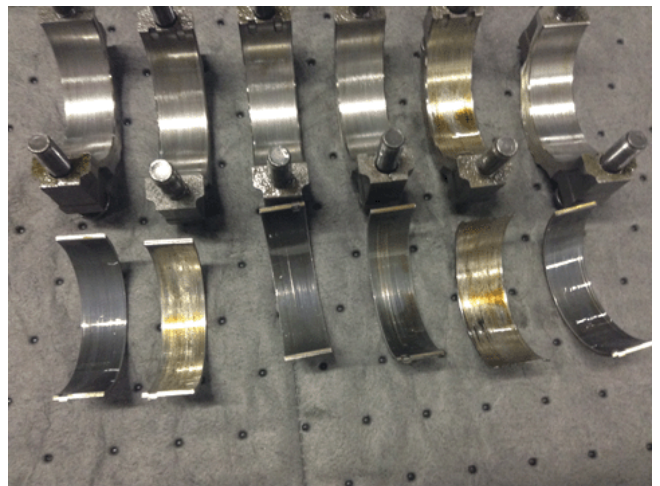
1. Verify there is metal in the engine oil by removing the oil pan.
2. Remove the main or rod bearing caps:
  - If the main and/or rod bearing are not the cause of the debris, refer to SI for further diagnostics.

- If the main and/or rod bearings are found to be the cause of the debris, before

deciding whether to replace the engine or repair it, refer to the Service Procedure below before making that determination.

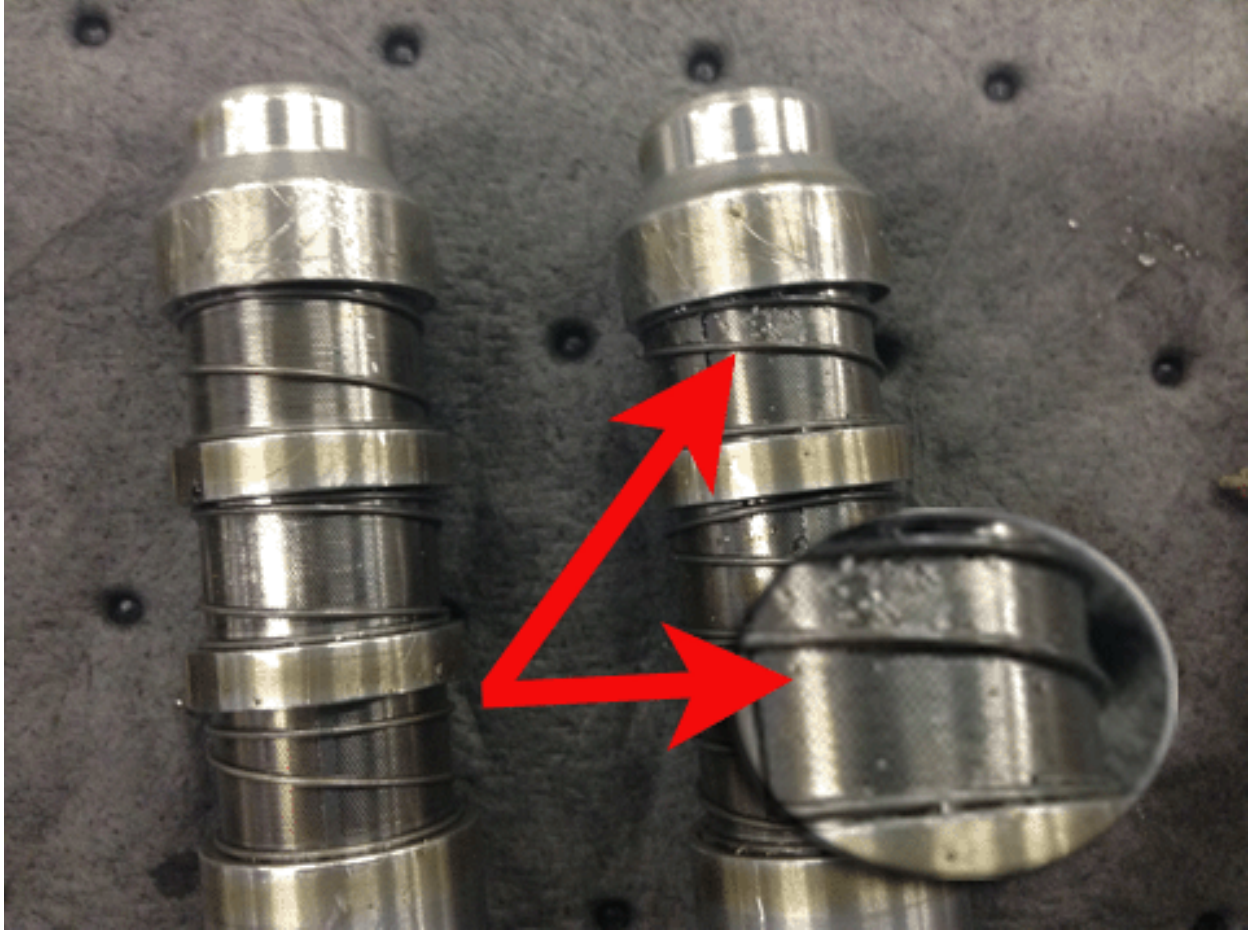
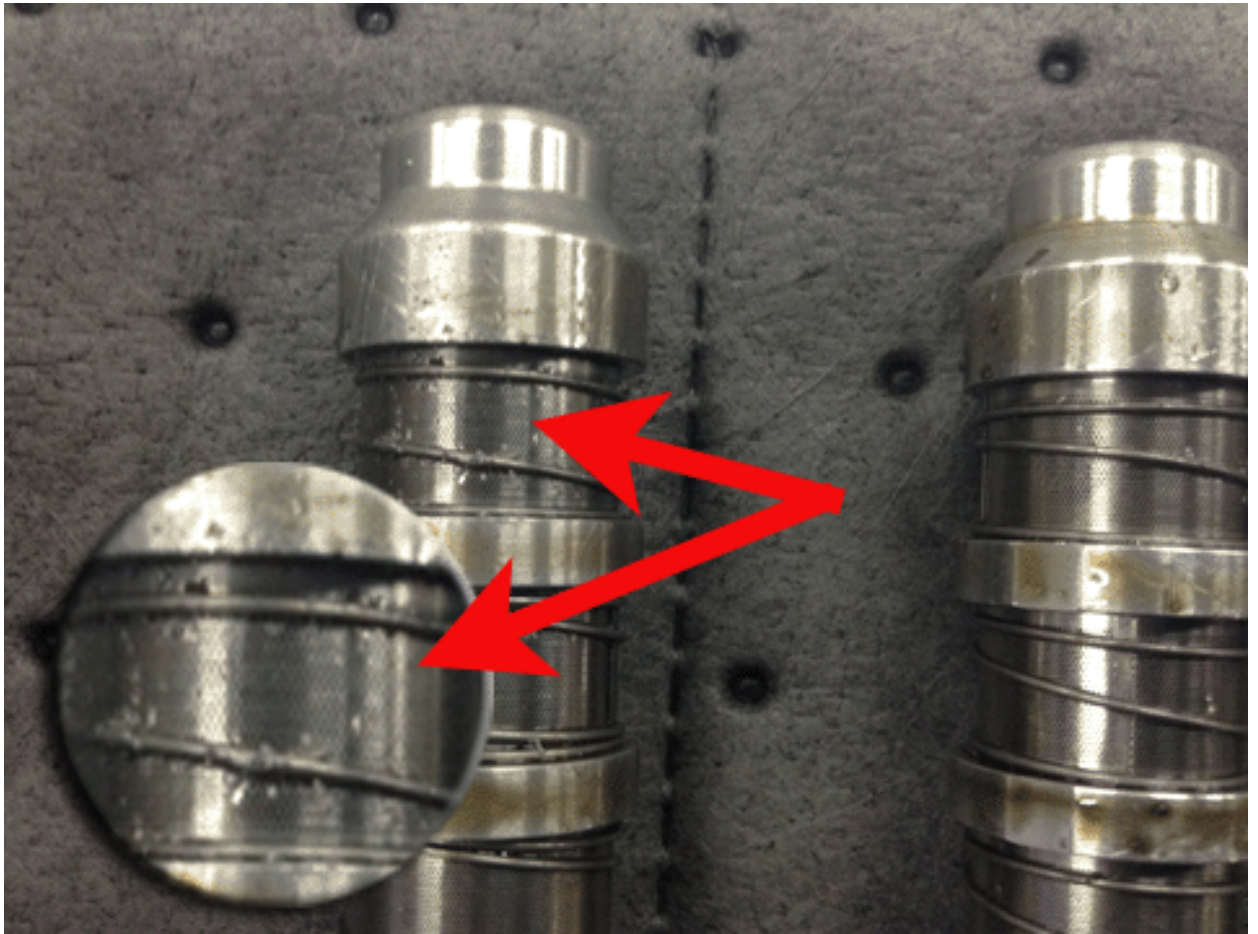
1. Inspect the oil control solenoids for metal debris. This shows the oil filter is in bypass and unfiltered oil with bearing debris was pumped into the oil lubrication galleys, throughout the engine.

Any of the above 3 instances would be cause to replace the engine instead of repair.

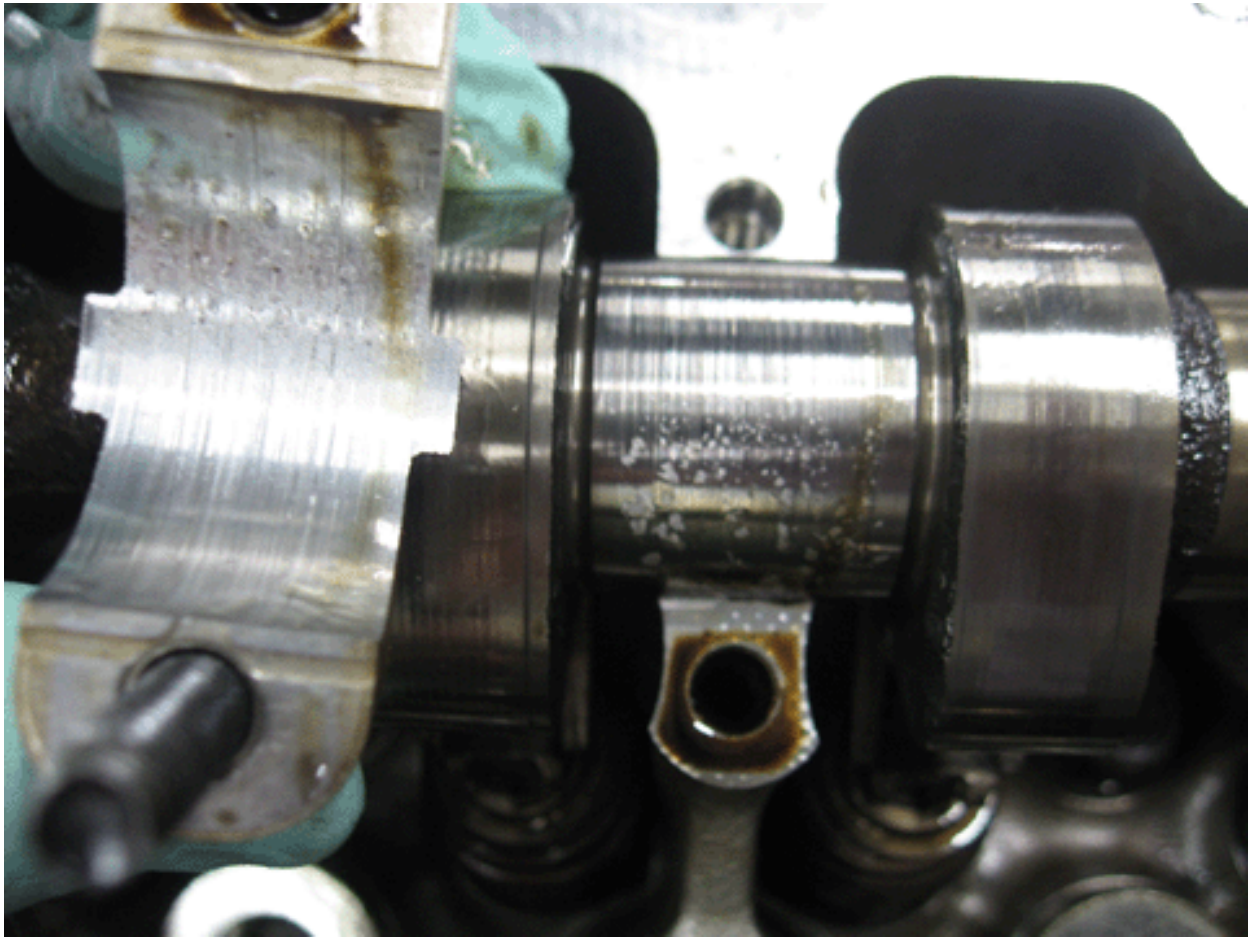
1. Inspect for damage to the cam caps journals and camshaft journals on the heads (obvious signs of metal through the cap).

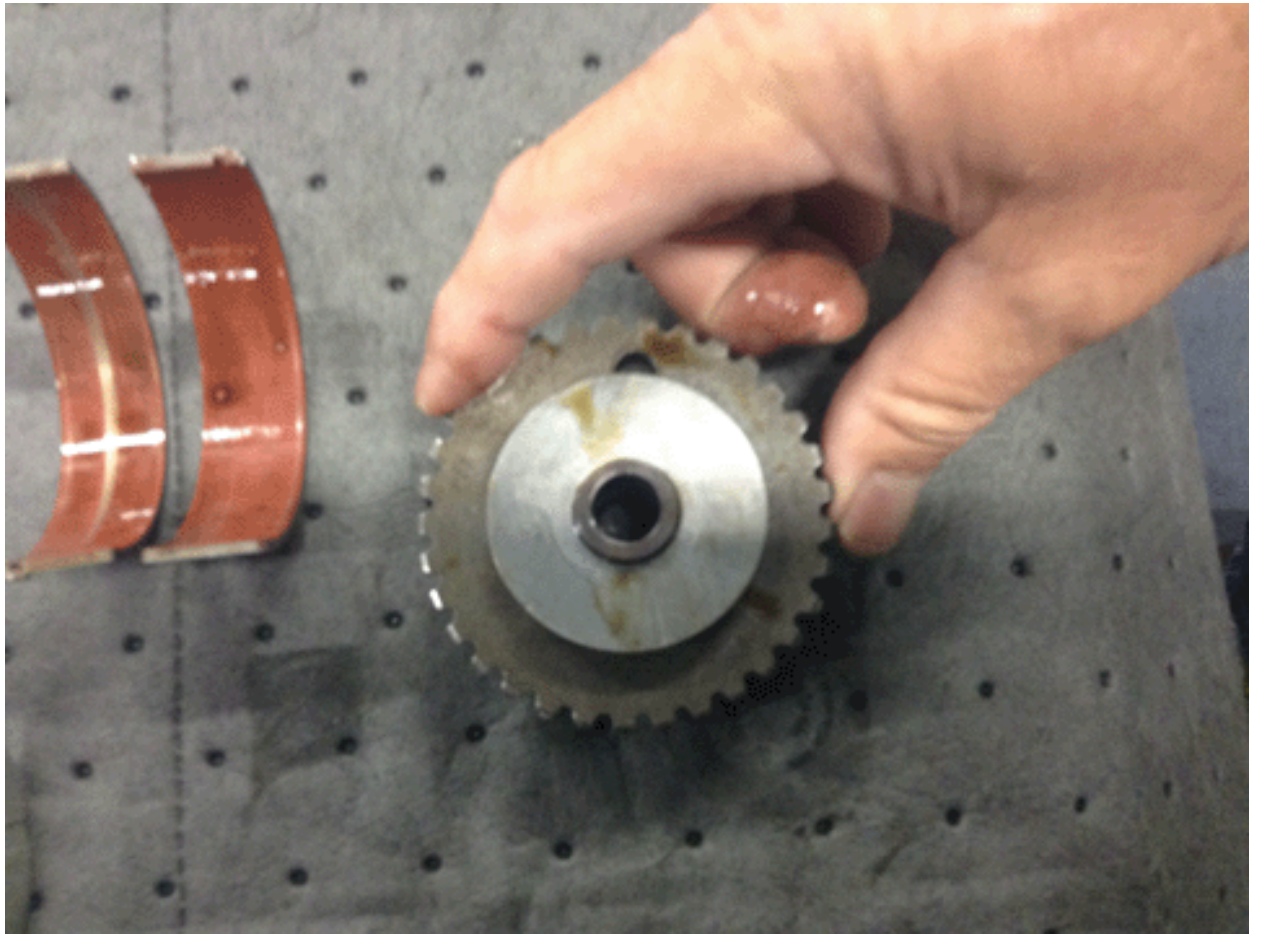
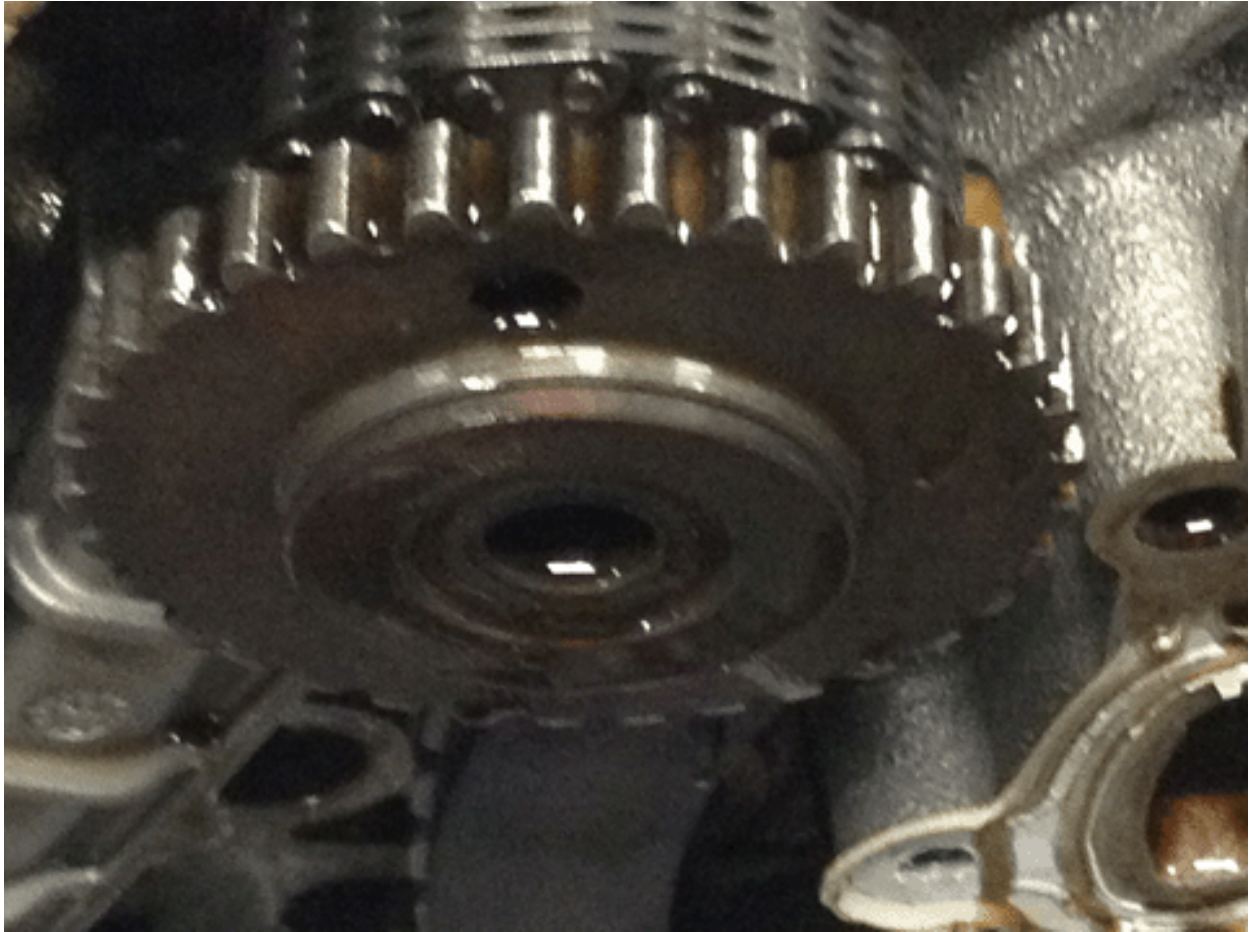
1. Inspect the timing chain idler sprockets for stiffness when turning (Should turn smooth and free).
