2014 - 2019 Cadillac ATS-V - CTS V-Sport: Service Bulletin: #19-NA-256: Diagnostic Tips for Knocking, Rattle, Squeak and/or Squeal Type Noise from Engine

Subject: Diagnostic Tips for Knocking, Rattle,
Squeak and/or Squeal Type Noise
from Engine – Engine Replacement
Recommendations for HFV6 Gen 1
and Gen 2

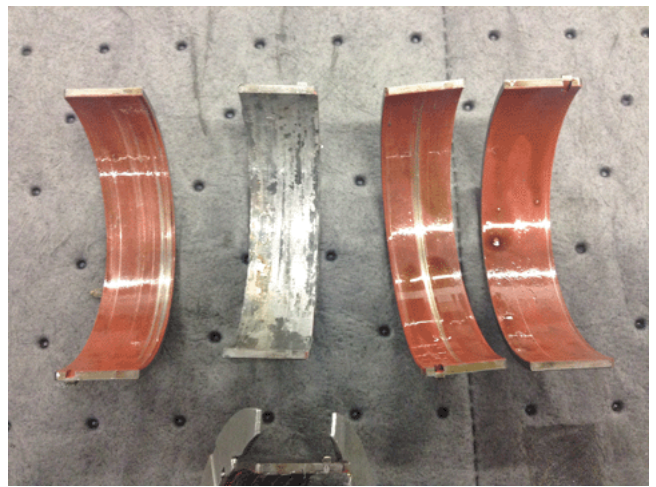
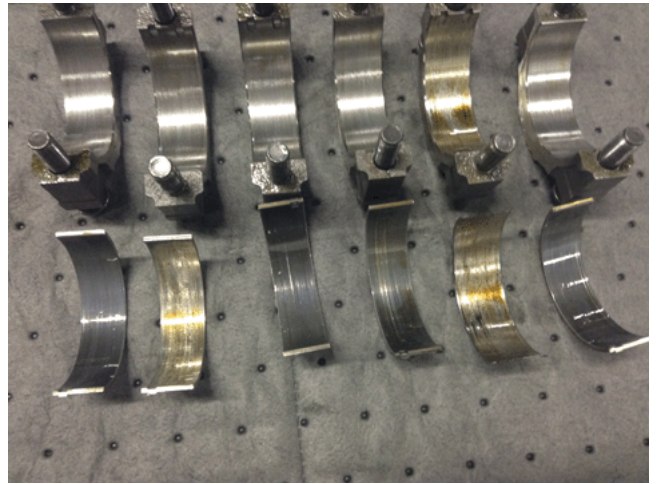
This condition may be caused by a crankshaft main or rod bearing failure.

- If the main and/or rod bearings are found to be the cause of the debris, before deciding whether to replace the engine or repair it, refer to the Service Procedure below before making that determination.

2. Remove the main or rod bearing caps:

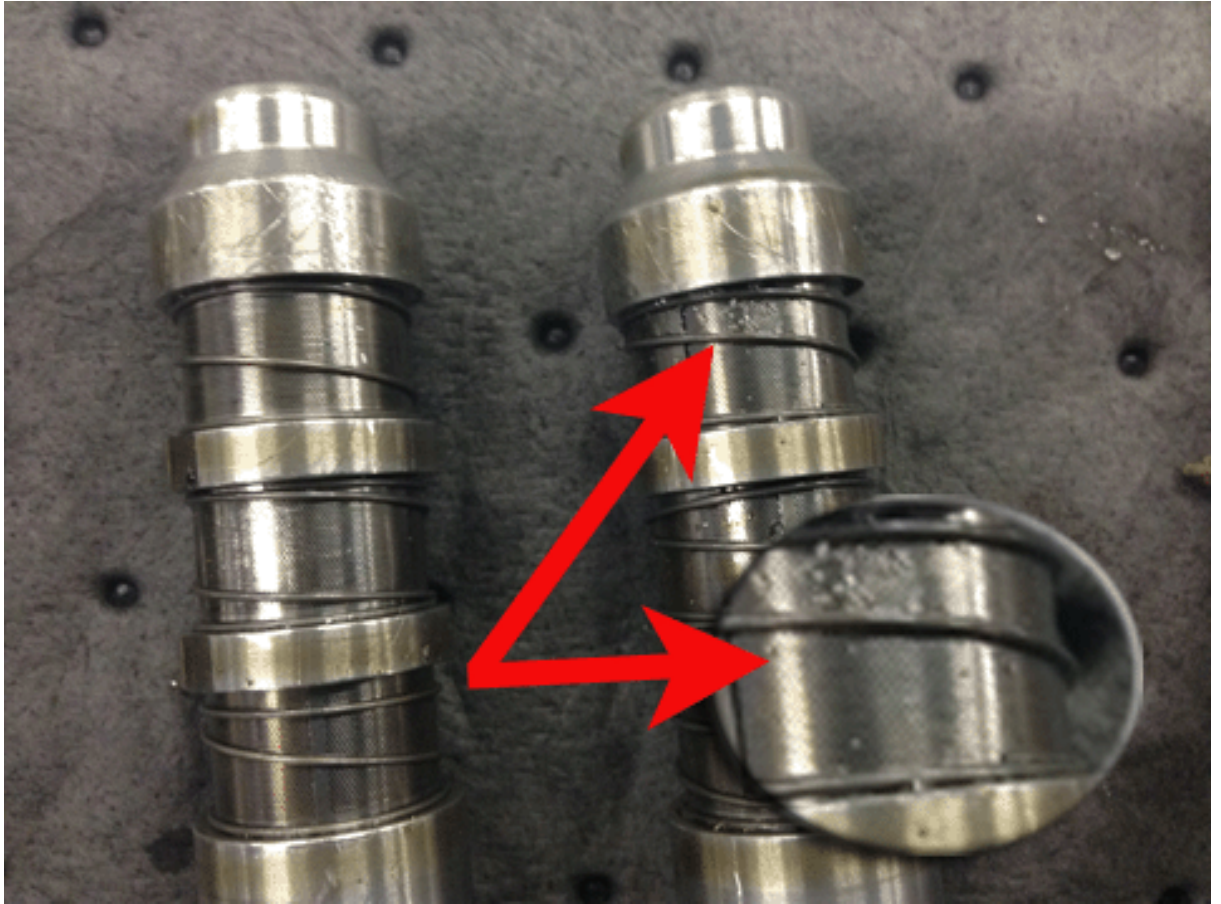
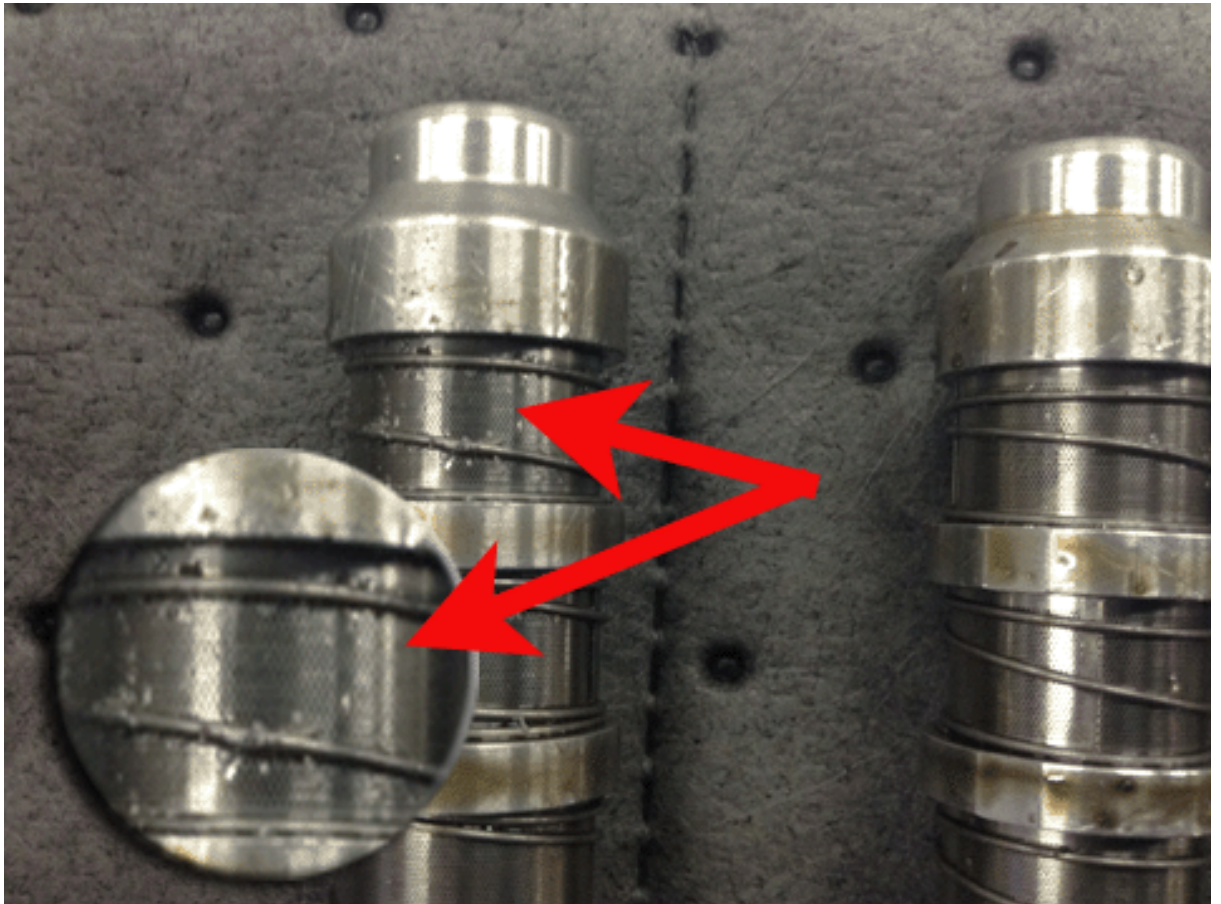
1. Inspect the oil control solenoids for metal debris. This shows the oil filter is in by-pass and unfiltered oil with bearing debris was pumped into the oil lubrication galleys, throughout the engine.

Any of the above 3 instances would be cause to replace the engine instead of repair.

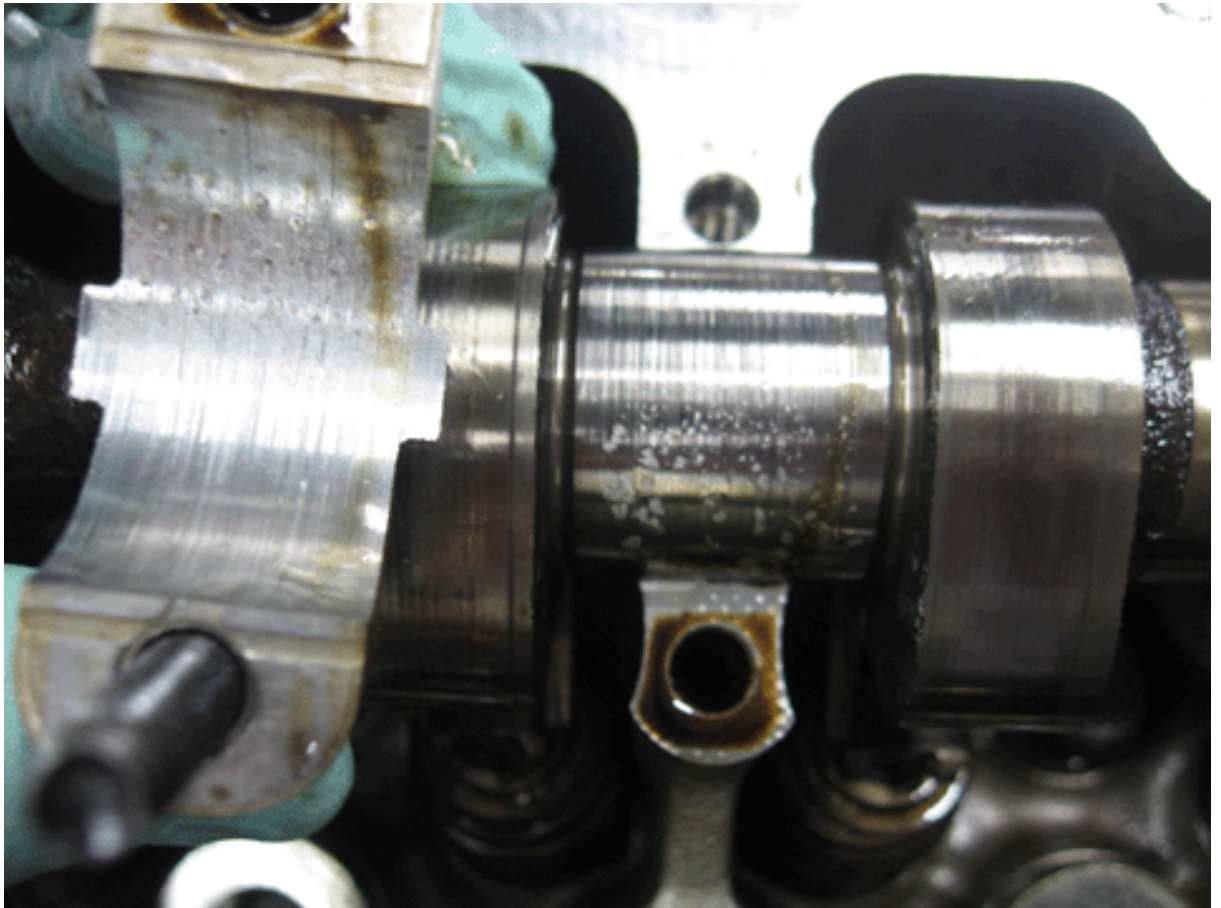
1. Inspect for damage to the cam caps journals and camshaft journals on the heads (obvious signs of metal through the cap).

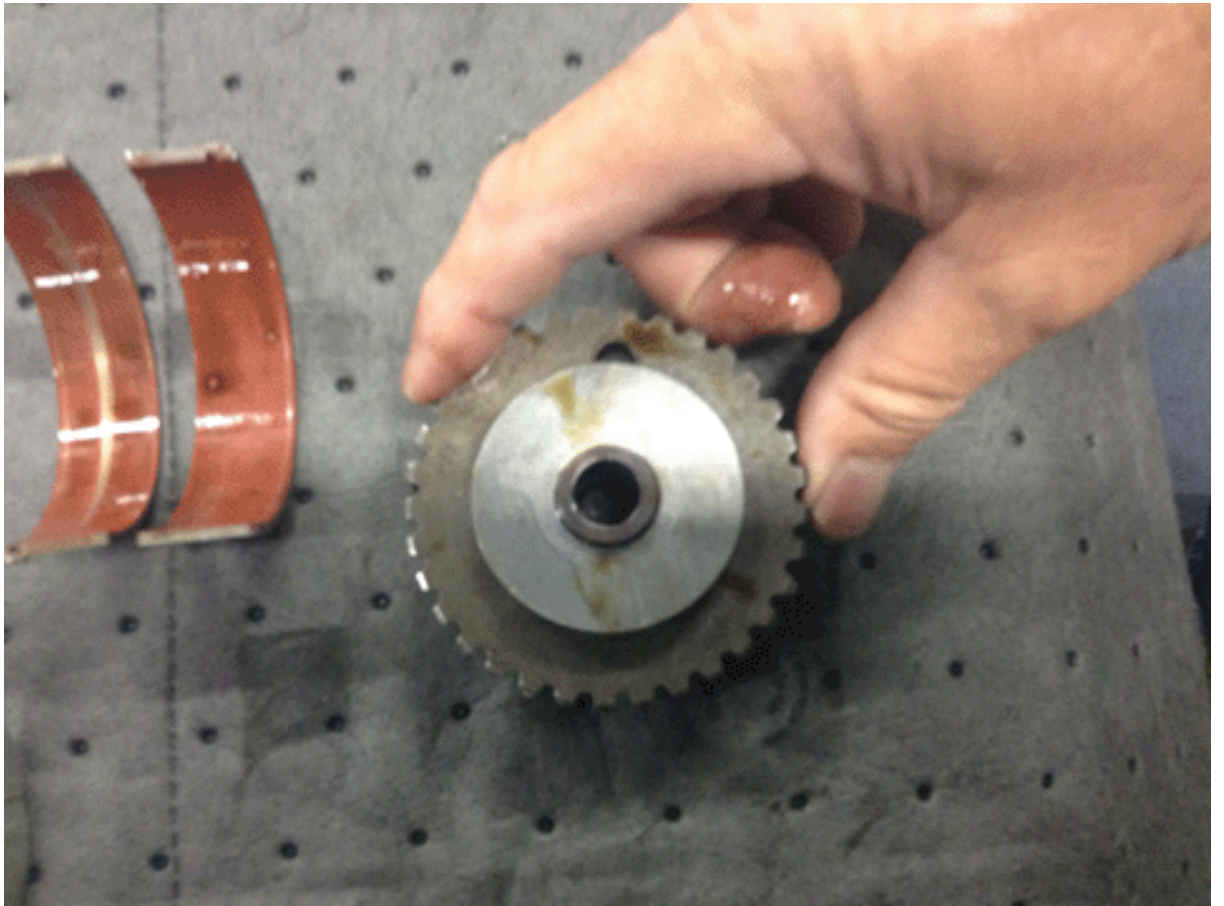
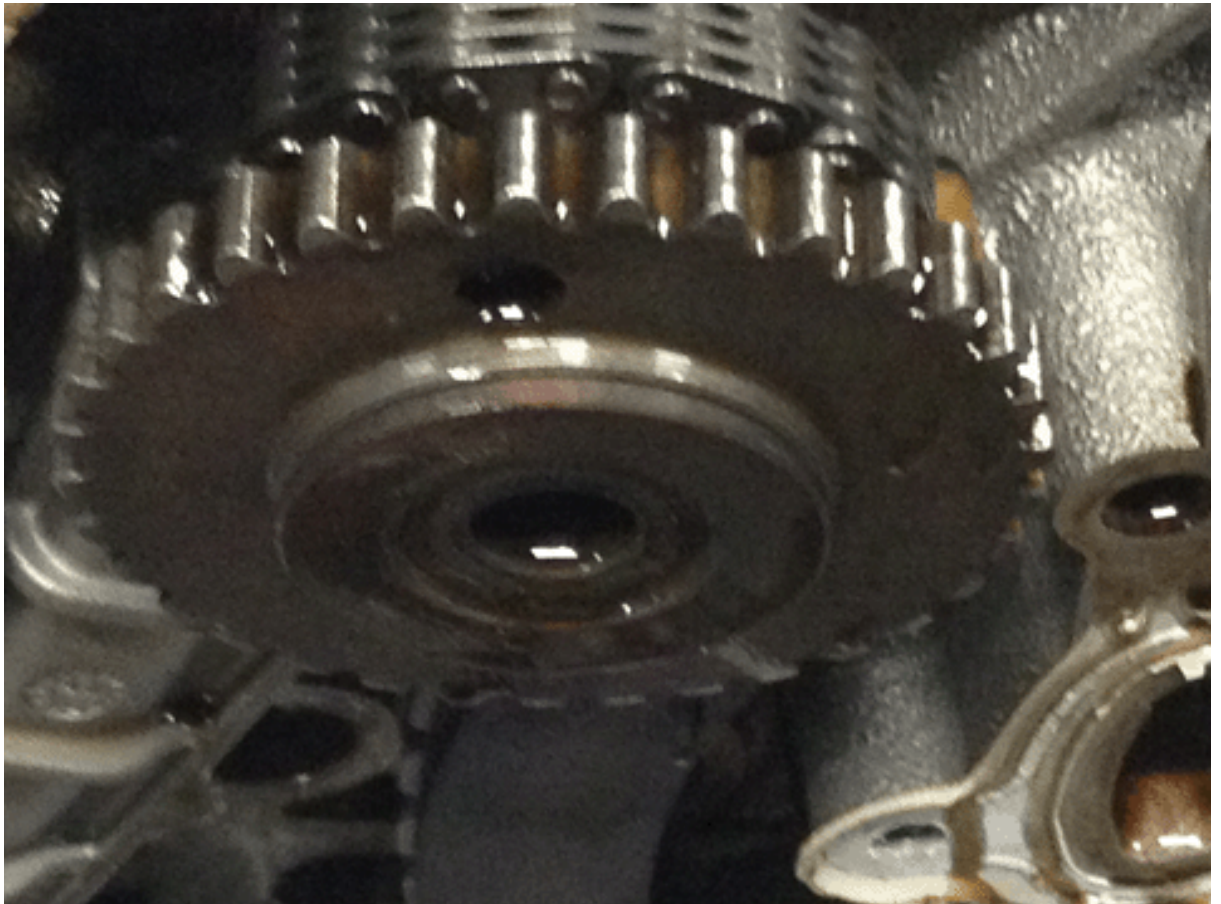
1. Inspect the timing chain idler sprockets for stiffness when turning (Should turn smooth and free).
