# 2014 - 2019 Cadillac ATS-V - CTS V-Sport: Service Bulletin: #19-NA-256: Diagnostic Tips for Knocking, Rattle, Squeak and/or Squeal Type Noise from Engine

## #19-NA-256: Diagnostic Tips for Knocking, Rattle, Squeak and/or Squeal Type Noise from Engine - Engine Replacement Recommendations for HFV6 Gen 1 and Gen 2 - (Jan 14, 2021)

**Subject:** Diagnostic Tips for Knocking, Rattle,  
Squeak and/or Squeal Type Noise  
from Engine – Engine Replacement  
Recommendations for HFV6 Gen 1  
and Gen 2

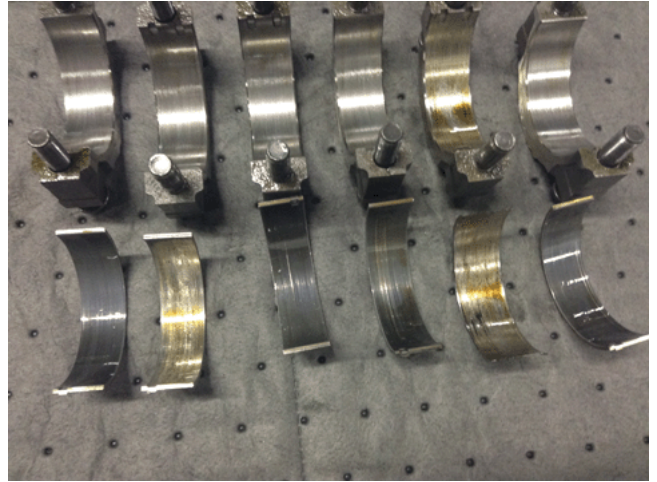
This condition may be caused by a crankshaft main or rod bearing failure.

2. Remove the main or rod bearing caps:

- If the main and/or rod bearings are found to be the cause of the debris, before deciding whether to replace the engine or repair it, refer to the Service Procedure below before making that determination.

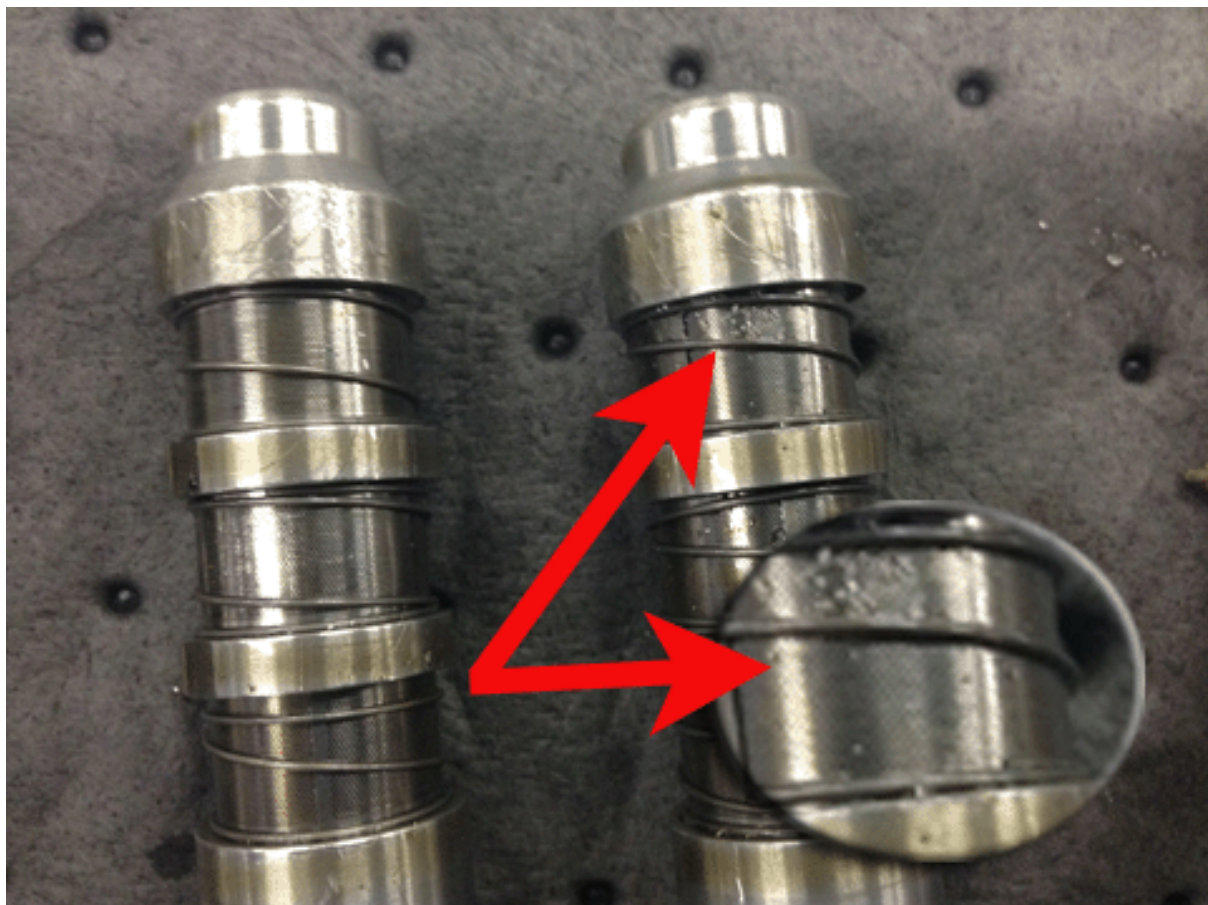
1. Inspect the oil control solenoids for metal debris. This shows the oil filter is in by-pass and unfiltered oil with bearing debris was pumped into the oil lubrication galleys, throughout the engine.

Any of the above 3 instances would be cause to replace the engine instead of repair.
