2014 - 2019 Cadillac ATS-V - CTS V-Sport: Service Bulletin: #19-NA-256: Diagnostic Tips for Knocking, Rattle, Squeak and/or Squeal Type Noise from Engine

#19-NA-256: Diagnostic Tips for Knocking, Rattle, Squeak and/or Squeal Type Noise from Engine - Engine Replacement Recommendations for HFV6 Gen 1 and Gen 2 - (Jan 14, 2021)

Subject: Diagnostic Tips for Knocking, Rattle, Squeak and/or Squeal Type Noise from Engine – Engine Replacement Recommendations for HFV6 Gen 1 and Gen 2

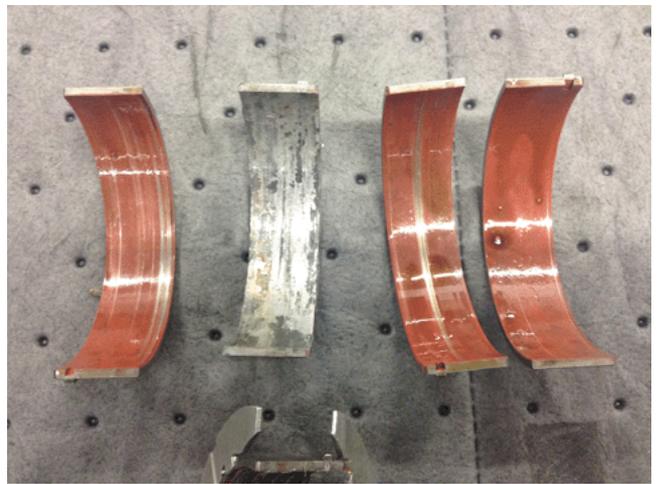
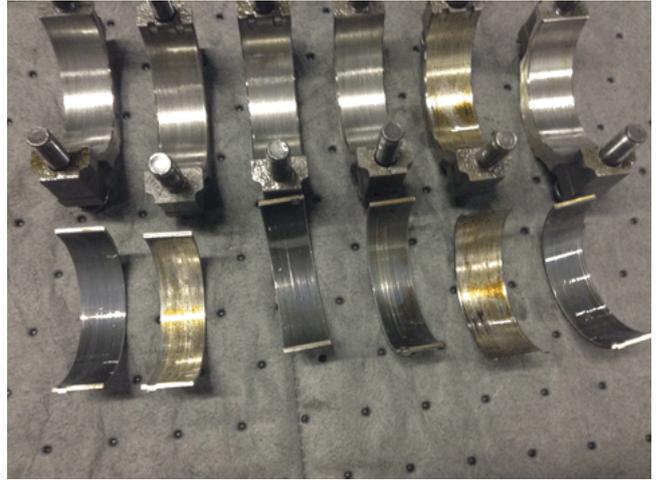
2. Remove the main or rod bearing caps:

- If the main and/or rod bearing are not the cause of the debris, refer to SI for further diagnostics.

- If the main and/or rod bearings are found to be the cause of the debris, before deciding whether to replace the engine or repair it, refer to the Service Procedure below before making that determination.

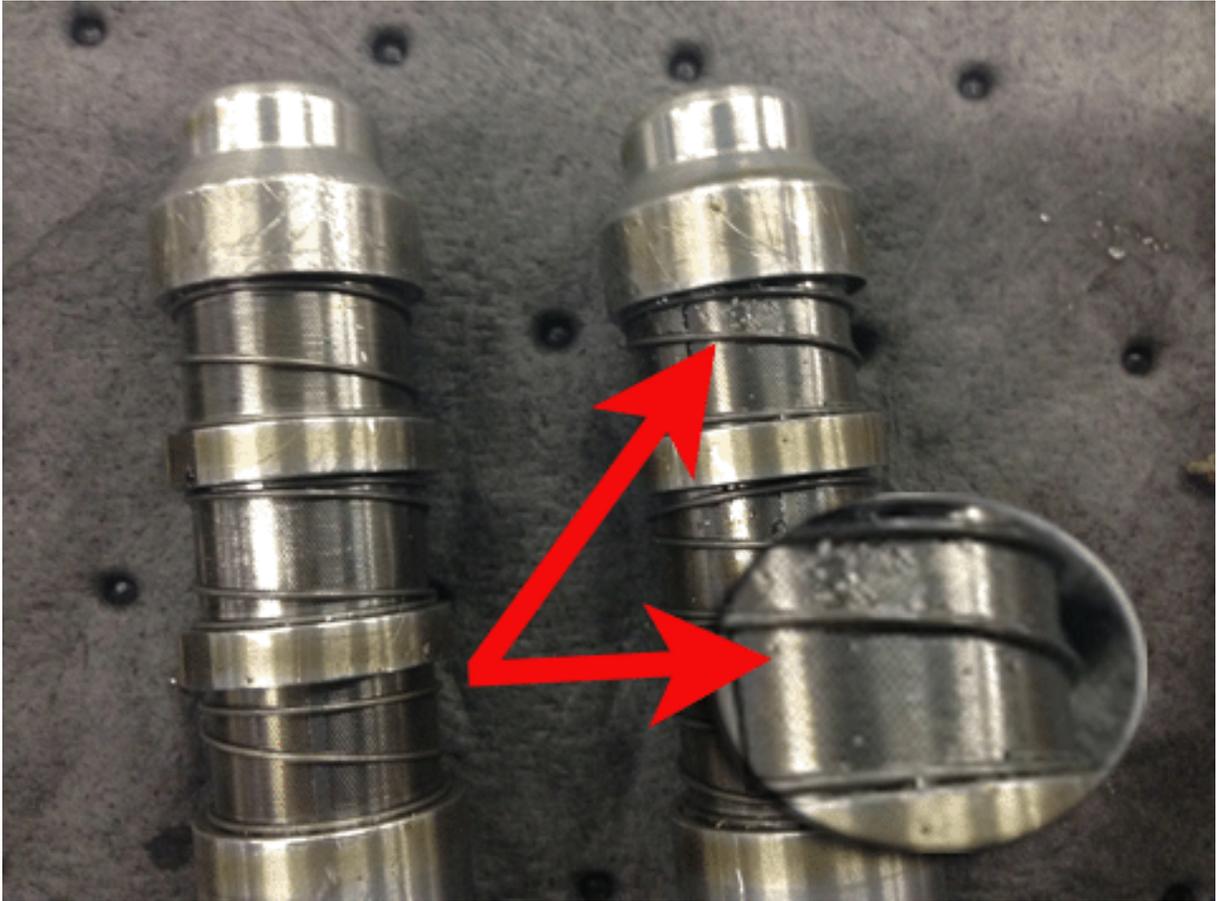
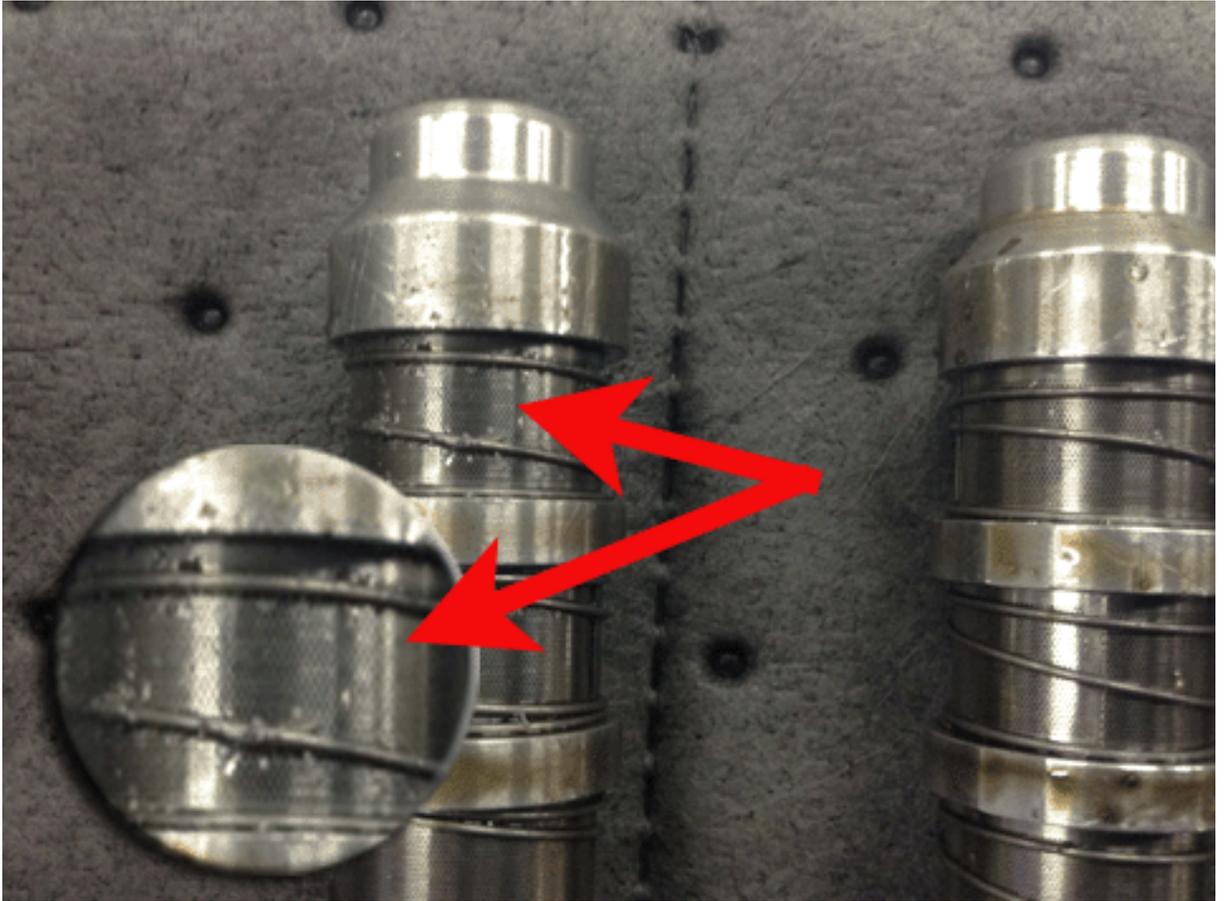
1. Inspect the oil control solenoids for metal debris. This shows the oil filter is in by-pass and unfiltered oil with bearing debris was pumped into the oil lubrication galleys, throughout the engine.

Any of the above 3 instances would be cause to replace the engine instead of repair.

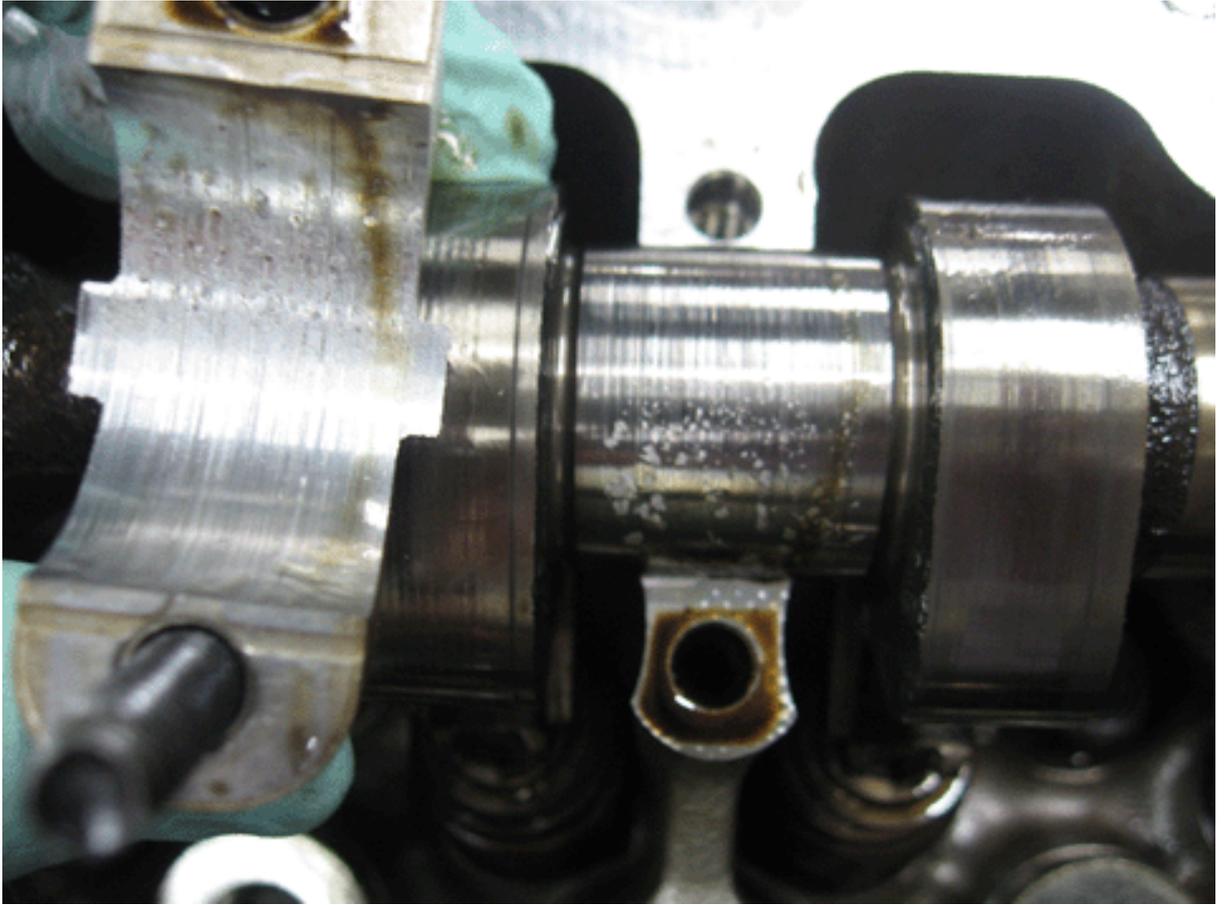
1. Inspect for damage to the cam caps journals and camshaft journals on the heads (obvious signs of metal through the cap).

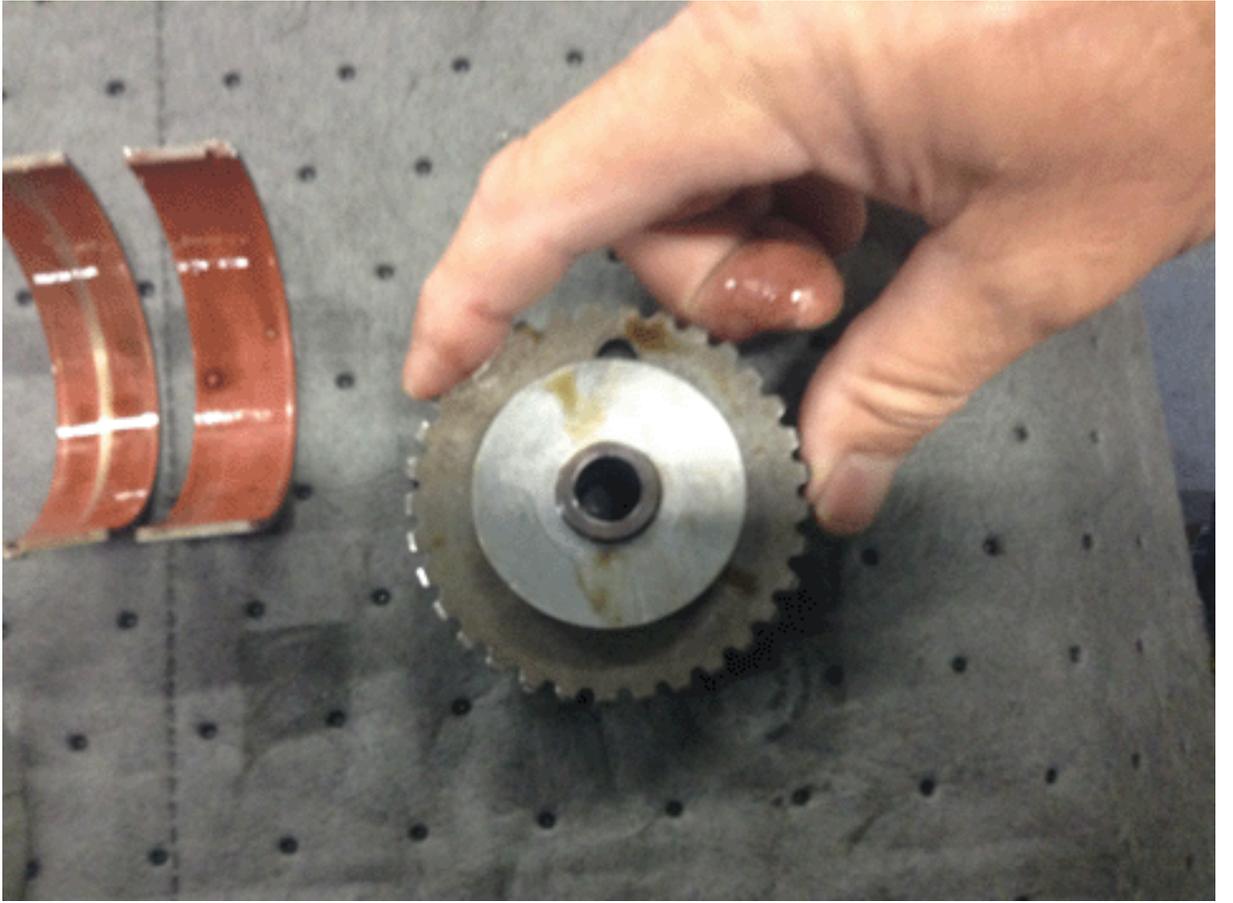
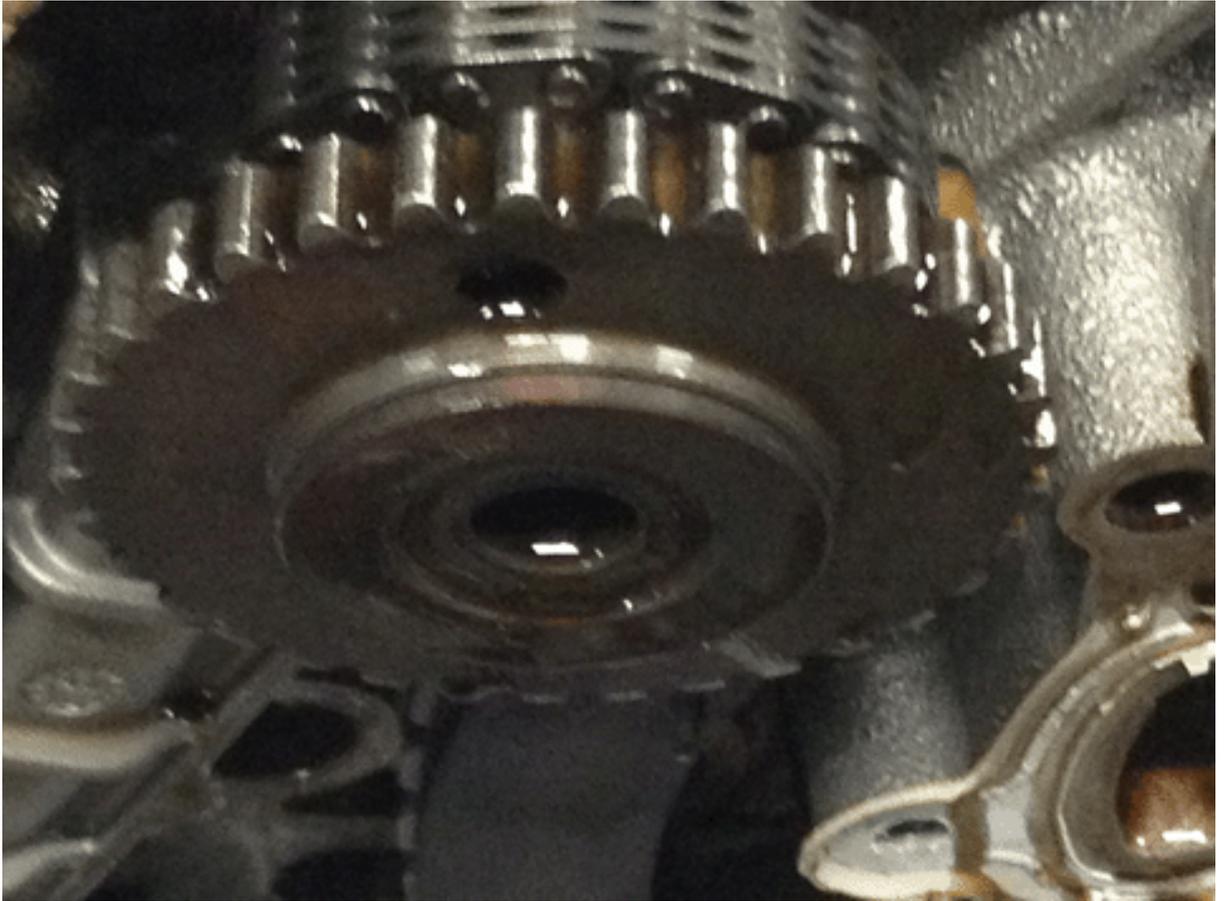
1. Inspect the timing chain idler sprockets for stiffness when turning (Should turn smooth and free).
