2016 - 2020 Cadillac ATS-V CTS-V CT6-V: Service Bulletin: #PIP5785: Whining/Whirring, Whistle, Squeaking, Groaning/Growling Noise Coming From The Front Wheel/Engine Area - (Mar 6, 2021)

Subject: Whining/Whirring, Whistle,
Squeaking, Groaning/Growling Noise
Coming From The Front
Wheel/Engine Area

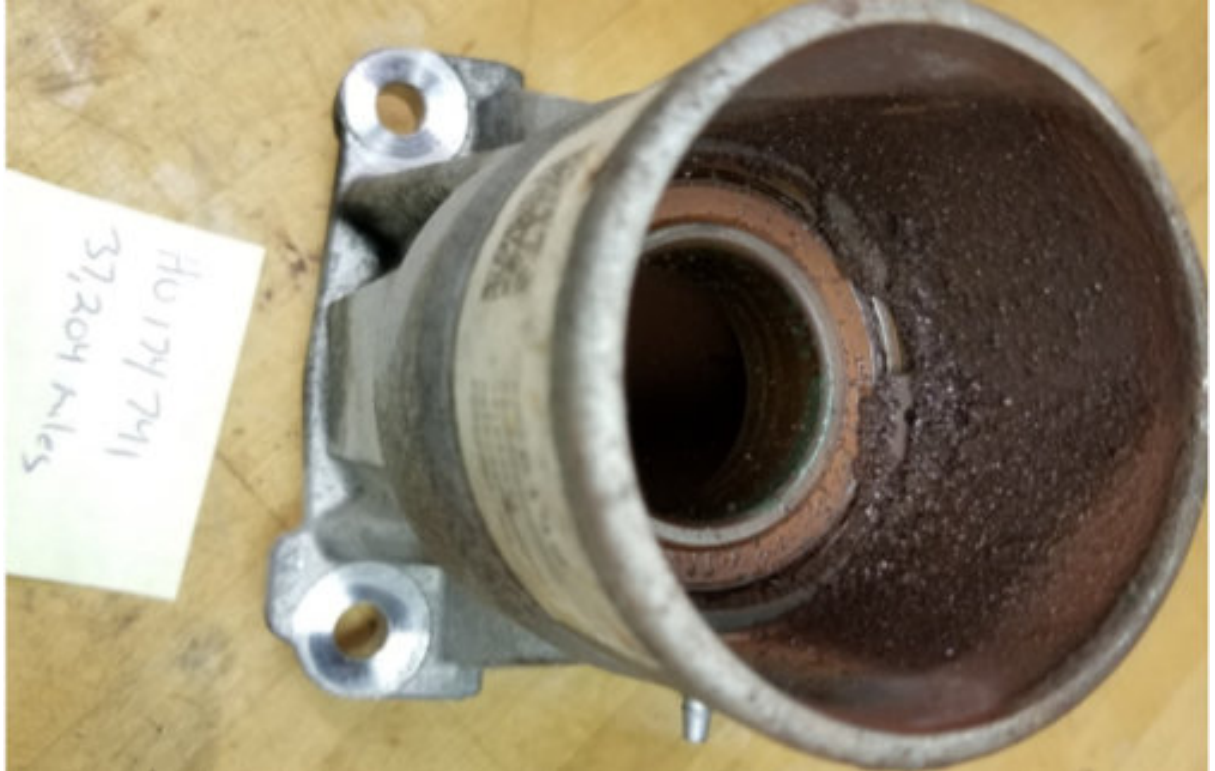
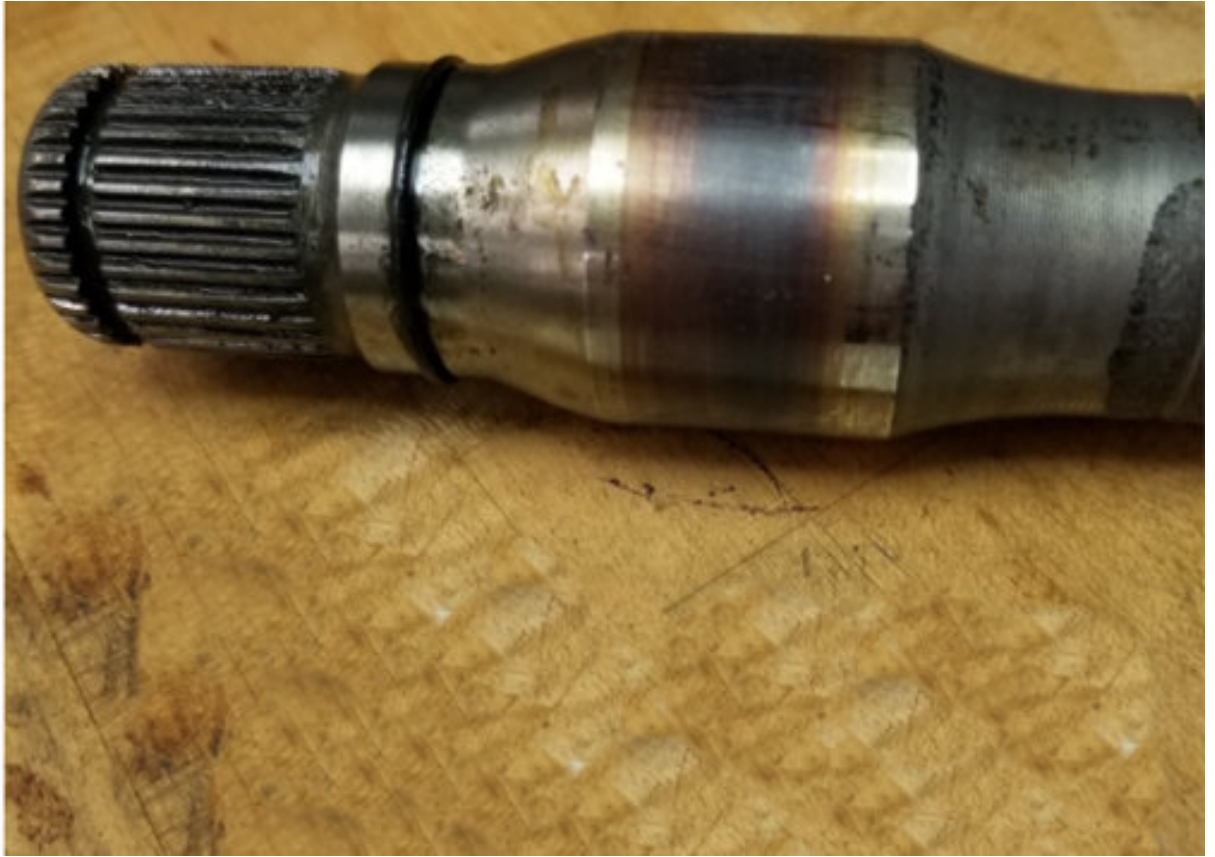
This condition may be caused by fretting between the Front Intermediate Shaft(IDS Shaft) and the Front Intermediate Shaft Bearing/Housing(IDS bearing). The fretting is the result of having a slip fit interface between the bearing and the IDS shaft, and combined with a bearing that has around 0.5Nm of torque to rotate(TTR).

1. Try and replicate the customers complaint maneuver (generally the noise is heard while coasting and without brakes being applied)
2. Install Chassis Ears
3. Identify if the noise is at the Front Intermediate Shaft Housing
4. Once the noise is confirmed and isolated at the front intermediate shaft housing
5. Replace IDS Shaft and IDS Shaft Housing, refer to Front Wheel Drive Intermediate Shaft Replacement & Front Wheel

Drive Intermediate Shaft Housing Replacement in Si.
