2016 - 2020 Cadillac ATS-V CTS-V CT6-V: Service Bulletin: #PIP5785: Whining/Whirring, Whistle, Squeaking, Groaning/Growling Noise Coming From The Front Wheel/Engine Area - (Mar 6, 2021)

Subject: Whining/Whirring, Whistle, Squeaking,
Groaning/Growling Noise Coming From The
Front Wheel/Engine Area

Brand:	Model:	Model Year:		VIN:		Engine:	Transmiss ion:
		from	to	from	to		
Cadillac	ATS	2017	2019	All	All	All	All
Cadillac	CTS	2017	2019	All	All	All	All
Cadillac	CT6	2016	2020	All	All	All	All

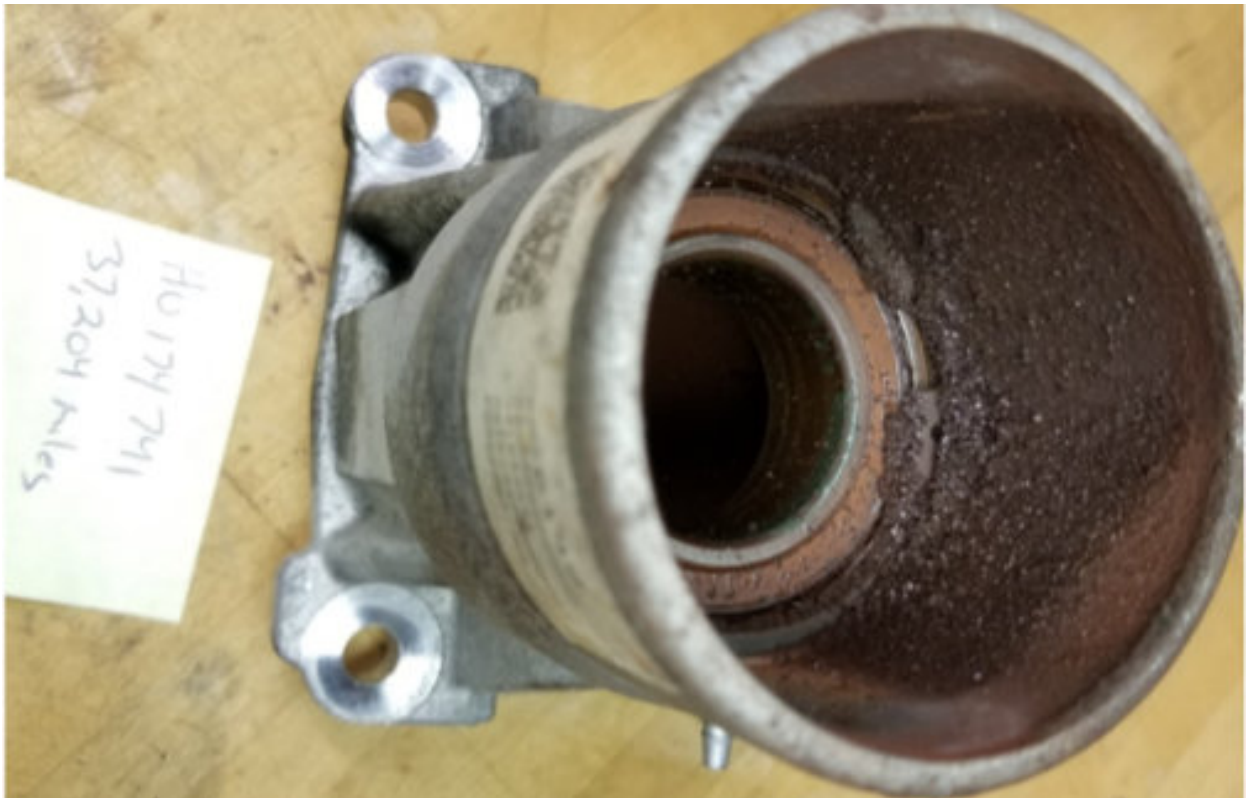
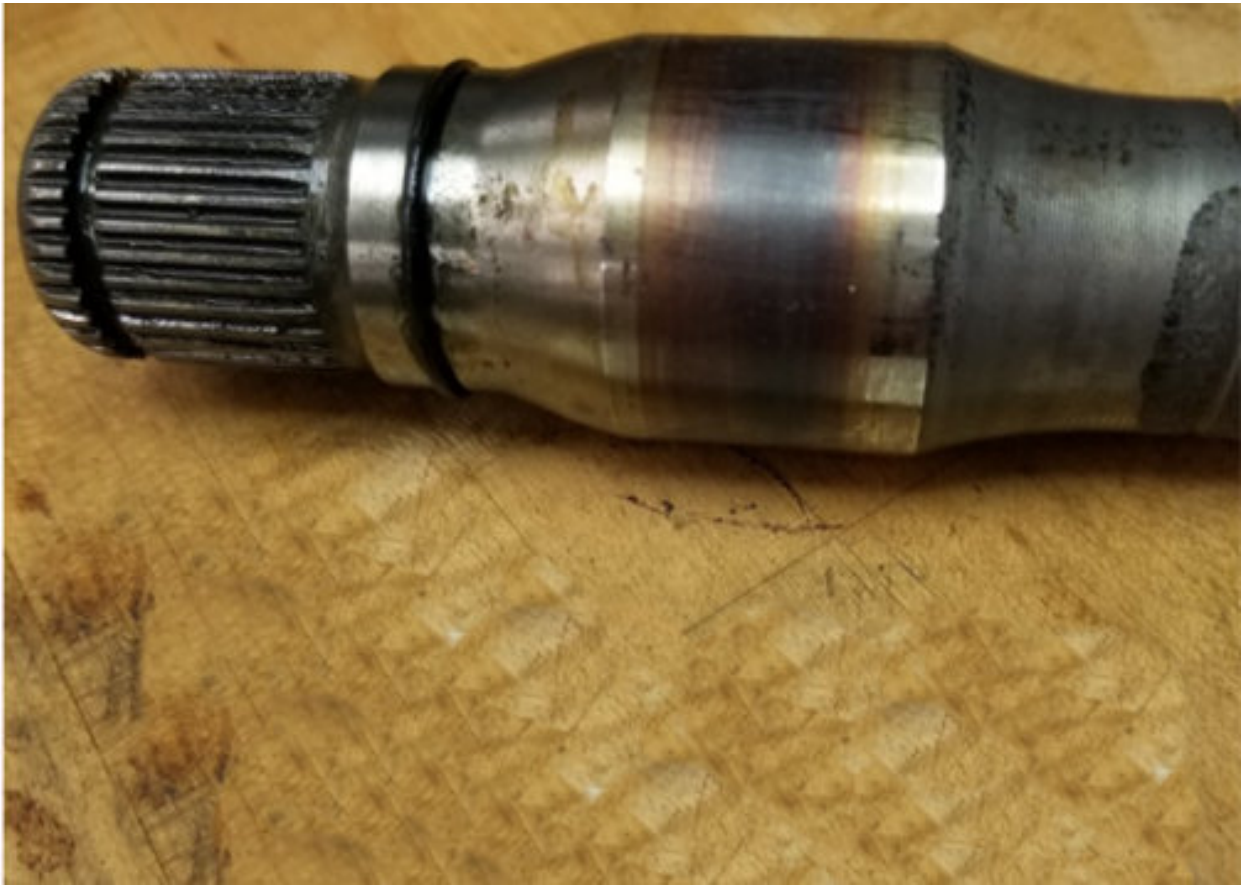
Cause This condition may be caused by fretting between
the Front Intermediate Shaft(IDS Shaft) and the
Front Intermediate Shaft Bearing/Housing(IDS
bearing). The fretting is the result of having a slip
fit interface between the bearing and the IDS

shaft, and combined with a bearing that has around 0.5Nm of torque to rotate(TTR).

1. Try and replicate the customers complaint maneuver (generally the noise is heard while coasting and without brakes being applied)
2. Install Chassis Ears
3. Identify if the noise is at the Front Intermediate Shaft Housing
4. Once the noise is confirmed and isolated at the front intermediate shaft housing
5. Replace IDS Shaft and IDS Shaft Housing, refer to Front Wheel Drive Intermediate Shaft Replacement & Front Wheel Drive Intermediate Shaft Housing Replacement in Si.
