2016 - 2019 Cadillac CTS-V: GM TechLink: Engine Oil Overfill May Lead to Engine Vibration

GM TechLink
January 16, 2020

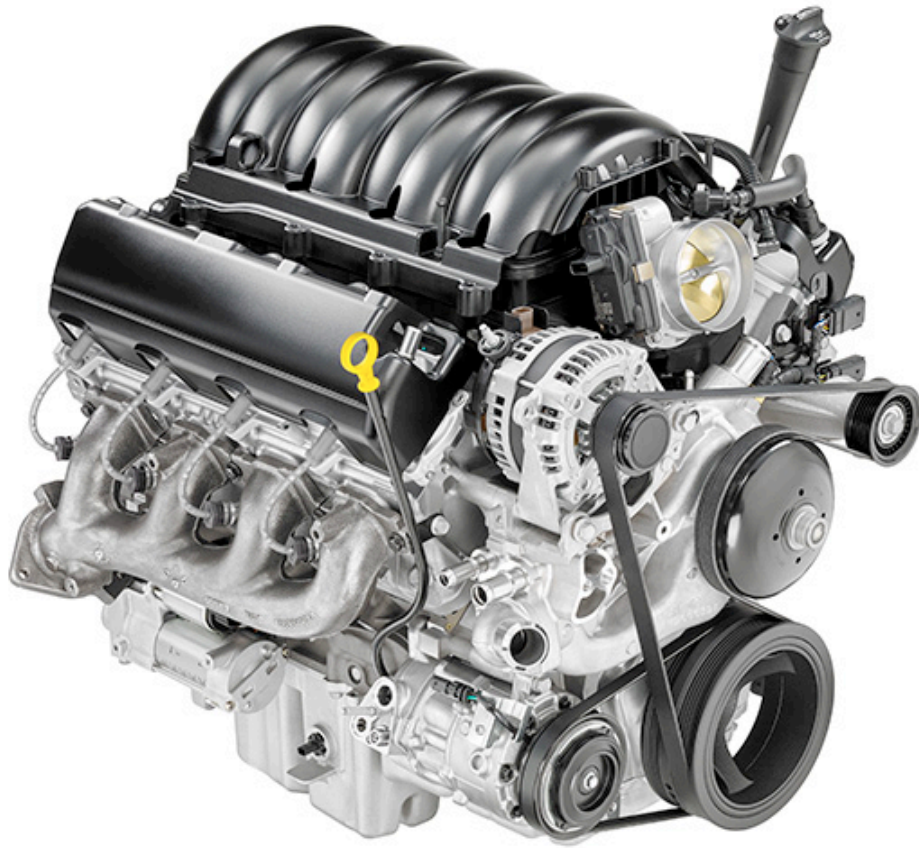
Fig. 11

The vibration may be due to an overfilled engine crankcase on the following engines: 4.3L V6 (RPO LV1, LV3); 5.3L V8 (RPO L82, L83, L84); 6.2L V8 (RPOs LT1, LT4, L86, L87). (Fig. 11) It may be found that the engine oil was recently changed.

A vibration caused by a crankcase overfilled with engine oil will typically display Engine 1 (E1) as the dominant vibration when monitoring the vibration using the CH-51450 PicoScope automotive oscilloscope.

After confirming the engine crankcase is overfilled, determine if the crankcase is overfilled with engine oil or is contaminated by an outside substance such as fuel or engine coolant.

If the engine was overfilled only with engine oil, adjust the oil level and check engine operation. It's possible that the engine was simply overfilled during an oil change or other maintenance service.

If the engine overfill was the result of contamination, diagnose the source of the contamination and make repairs as needed.

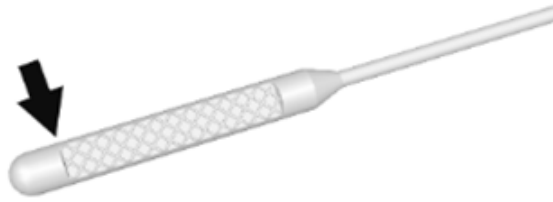
Fig. 12

If there is an engine vibration concern, check the engine oil level. Refer to the vehicle's Owner's Manual for details on correctly checking the engine oil level (Fig. 12) and the engine oil crankcase capacity.
