# 2016 - 2019 Cadillac CTS-V: GM TechLink: Engine Oil Overfill May Lead to Engine Vibration

GM TechLink

January 16, 2020

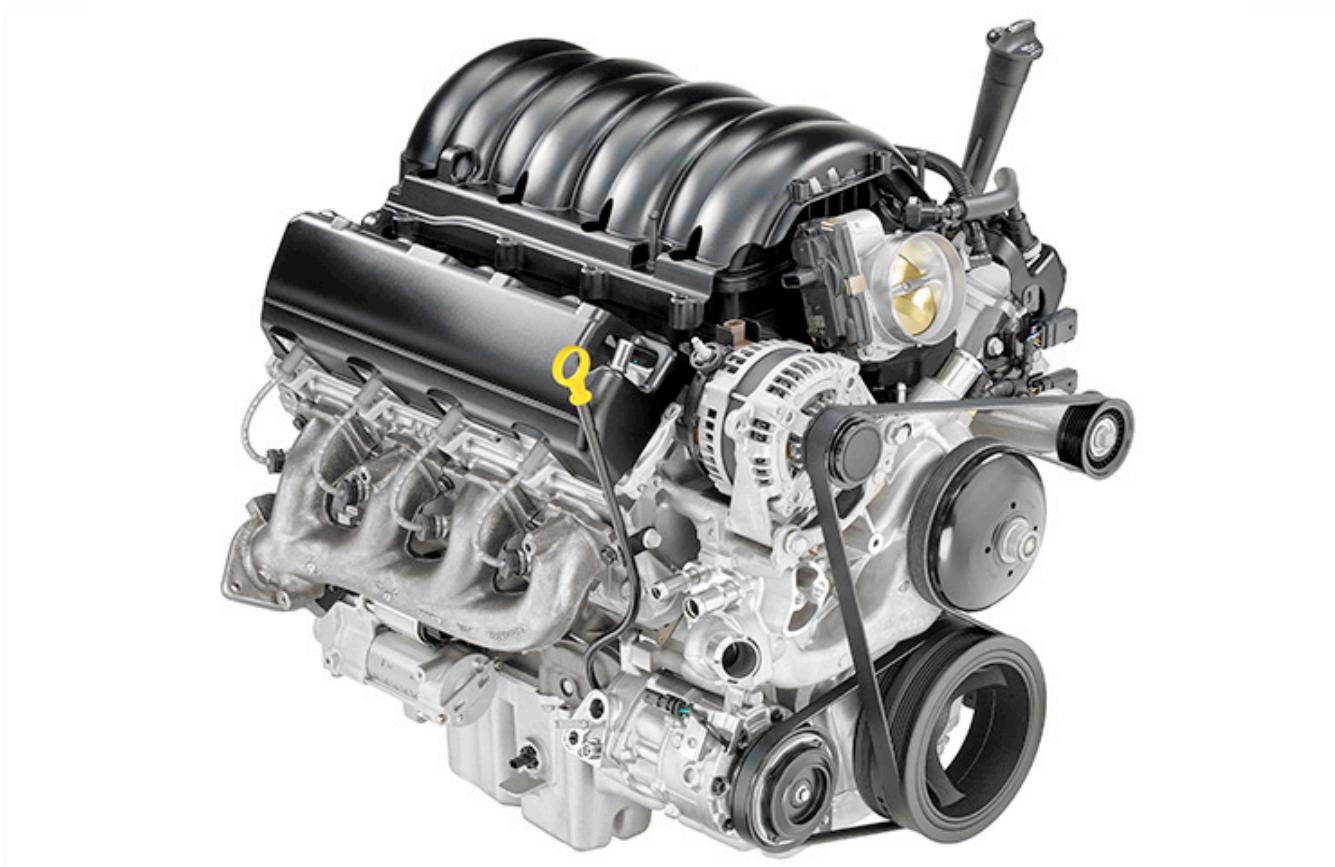
**Fig. 11**

The vibration may be due to an overfilled engine crankcase on the following engines: 4.3L V6 (RPO LV1, LV3); 5.3L V8 (RPO L82, L83, L84); 6.2L V8 (RPOs LT1, LT4, L86, L87). (Fig. 11) It may be found that the engine oil was recently changed.

If the engine was overfilled only with engine oil, adjust the oil level and check engine operation. It's possible that the engine was simply overfilled during an oil change or other maintenance service.

If the engine overfill was the result of contamination, diagnose the source of the contamination and make repairs as needed.

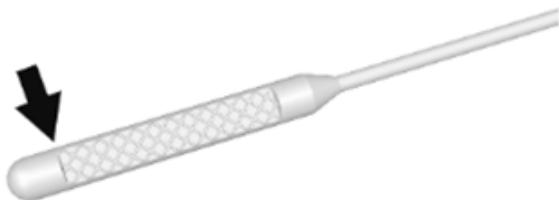
**Fig. 12**

If there is an engine vibration concern, check the engine oil level. Refer to the vehicle's Owner's Manual for details on correctly checking the engine oil level (Fig. 12) and the engine oil crankcase capacity.
