2016 - 2019 Cadillac CTS-V: GM TechLink: Engine Oil Overfill May Lead to Engine Vibration

GM TechLink
January 16, 2020

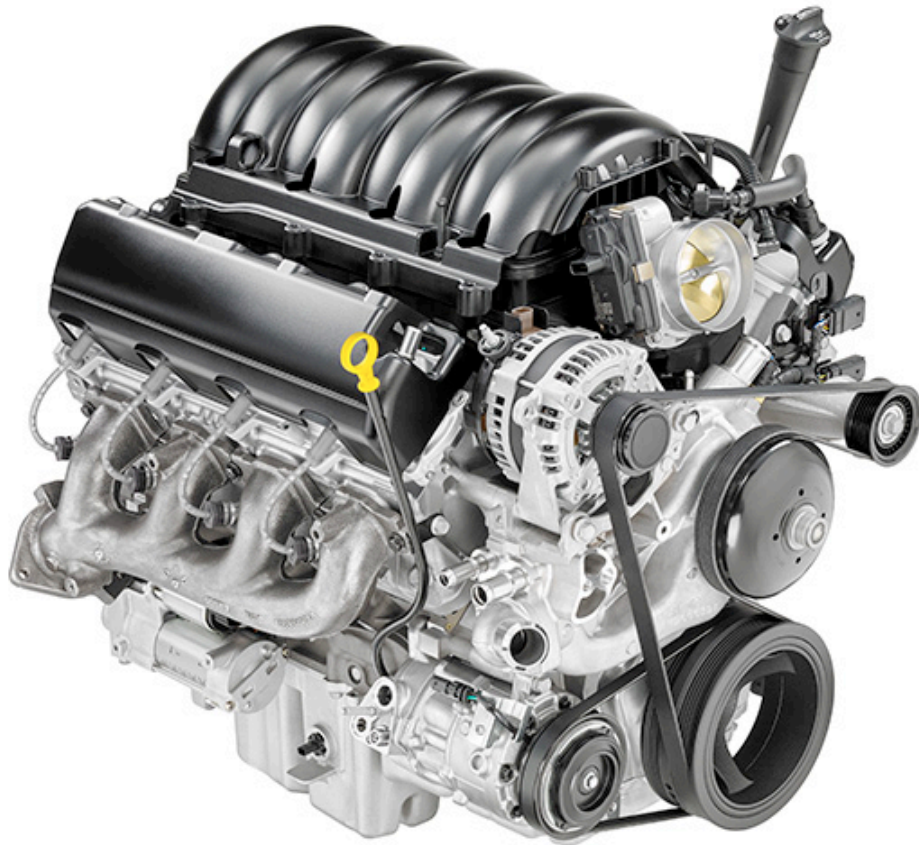
Fig. 11

The vibration may be due to an overfilled engine crankcase on the following engines: 4.3L V6 (RPO LV1, LV3); 5.3L V8 (RPO L82, L83, L84); 6.2L V8 (RPOs LT1, LT4, L86, L87). (Fig. 11) It may be found that the engine oil was recently changed.

A vibration caused by a crankcase overfilled with engine oil will typically display Engine 1 (E1) as the dominant vibration when monitoring the vibration using the CH-51450 PicoScope automotive oscilloscope.

After confirming the engine crankcase is overfilled, determine if the crankcase is overfilled with engine oil or is contaminated by an outside substance such as fuel or engine coolant.

If the engine was overfilled only with engine oil, adjust the oil level and check engine operation. It's possible that the engine was simply overfilled during an oil change or other maintenance service.

If the engine overfill was the result of contamination, diagnose the source of the contamination and make repairs as needed.
