2016 - 2019 Cadillac CTS-V: GM TechLink: Engine Oil Overfill May Lead to Engine Vibration

GM TechLink
January 16, 2020

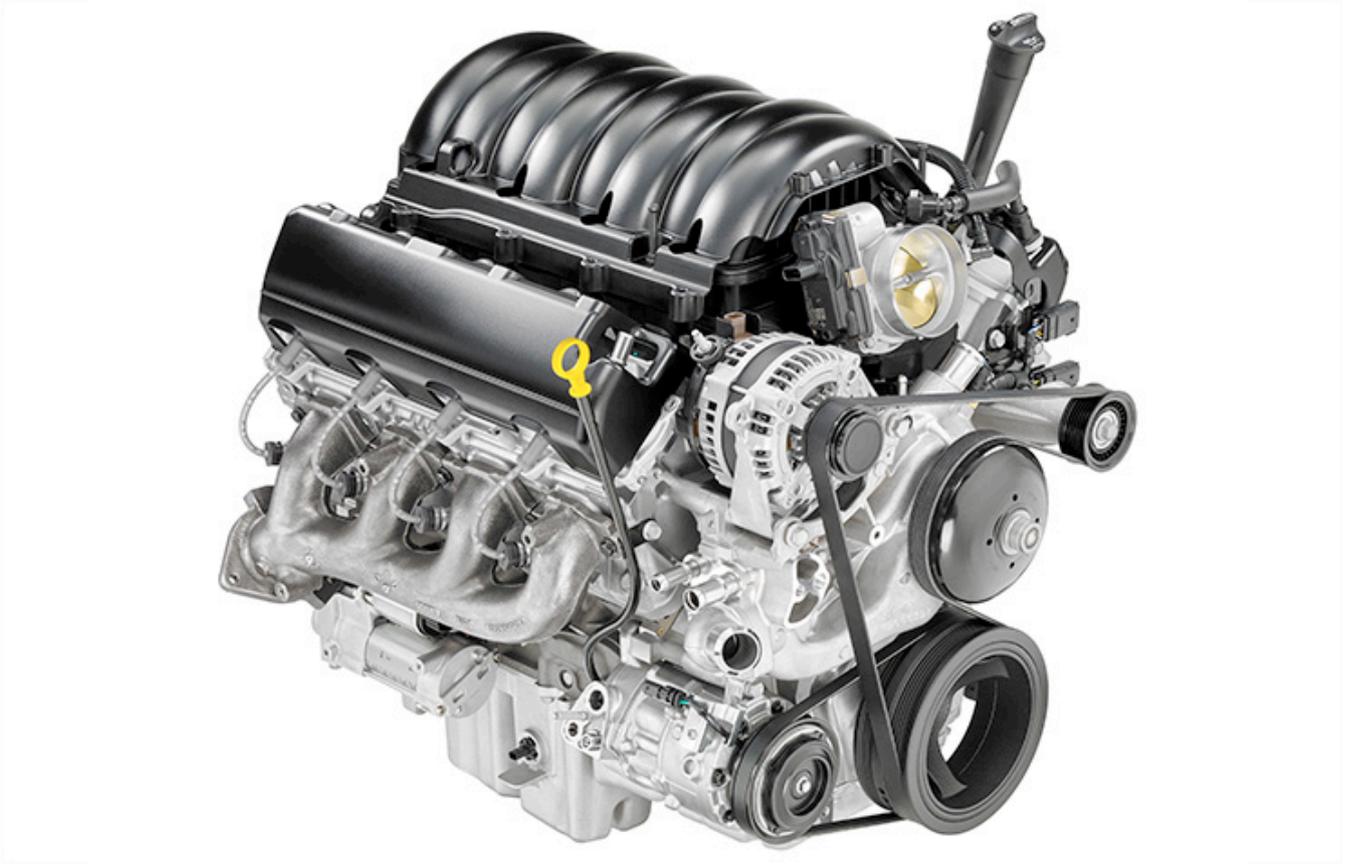
Fig. 11

The vibration may be due to an overfilled engine crankcase on the following engines: 4.3L V6 (RPO LV1, LV3); 5.3L V8 (RPO L82, L83, L84); 6.2L V8 (RPOs LT1, LT4, L86, L87). (Fig. 11) It may be found that the engine oil was recently changed.

After confirming the engine crankcase is overfilled, determine if the crankcase is overfilled with engine oil or is contaminated by an outside substance such as fuel or engine coolant.

If the engine was overfilled only with engine oil, adjust the oil level and check engine operation. It's possible that the engine was simply overfilled during an oil change or other maintenance service.

If the engine overfill was the result of contamination, diagnose the source of the contamination and make repairs as needed.

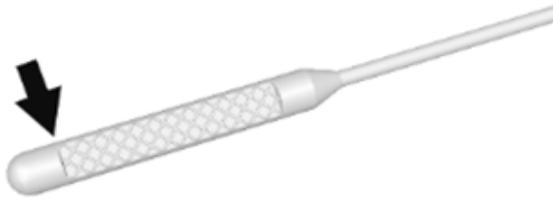
Fig. 12

If there is an engine vibration concern, check the engine oil level. Refer to the vehicle's Owner's Manual for details on correctly checking the engine oil level (Fig. 12) and the engine oil crankcase capacity.
