2016 - 2019 Cadillac CTS-V: Service Bulletin: #PIP5212C: Concern Of An Engine Thermostat Tick Noise And/Or Running Hot - (Mar 30, 2021)

Subject: Concern Of An Engine Thermostat
Tick Noise And/Or Running Hot

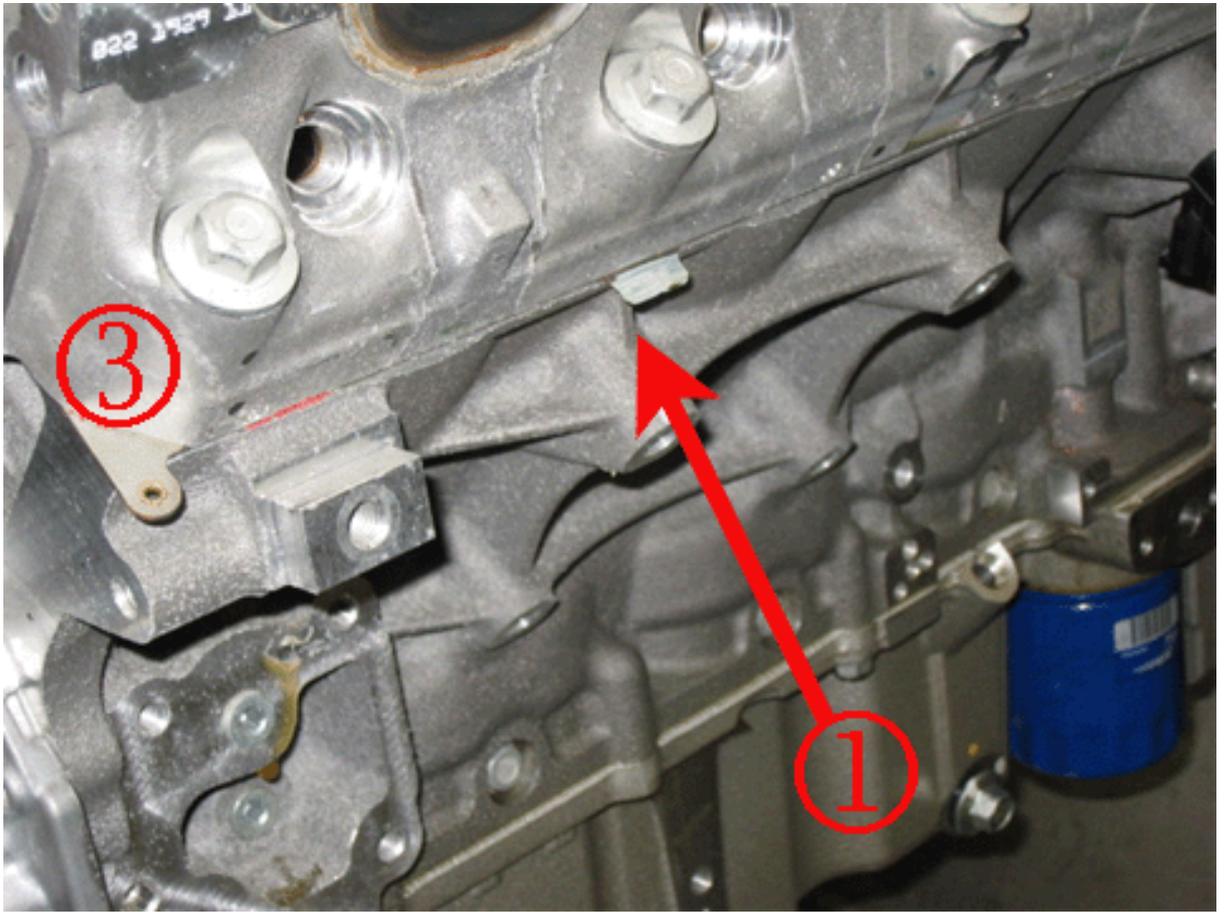
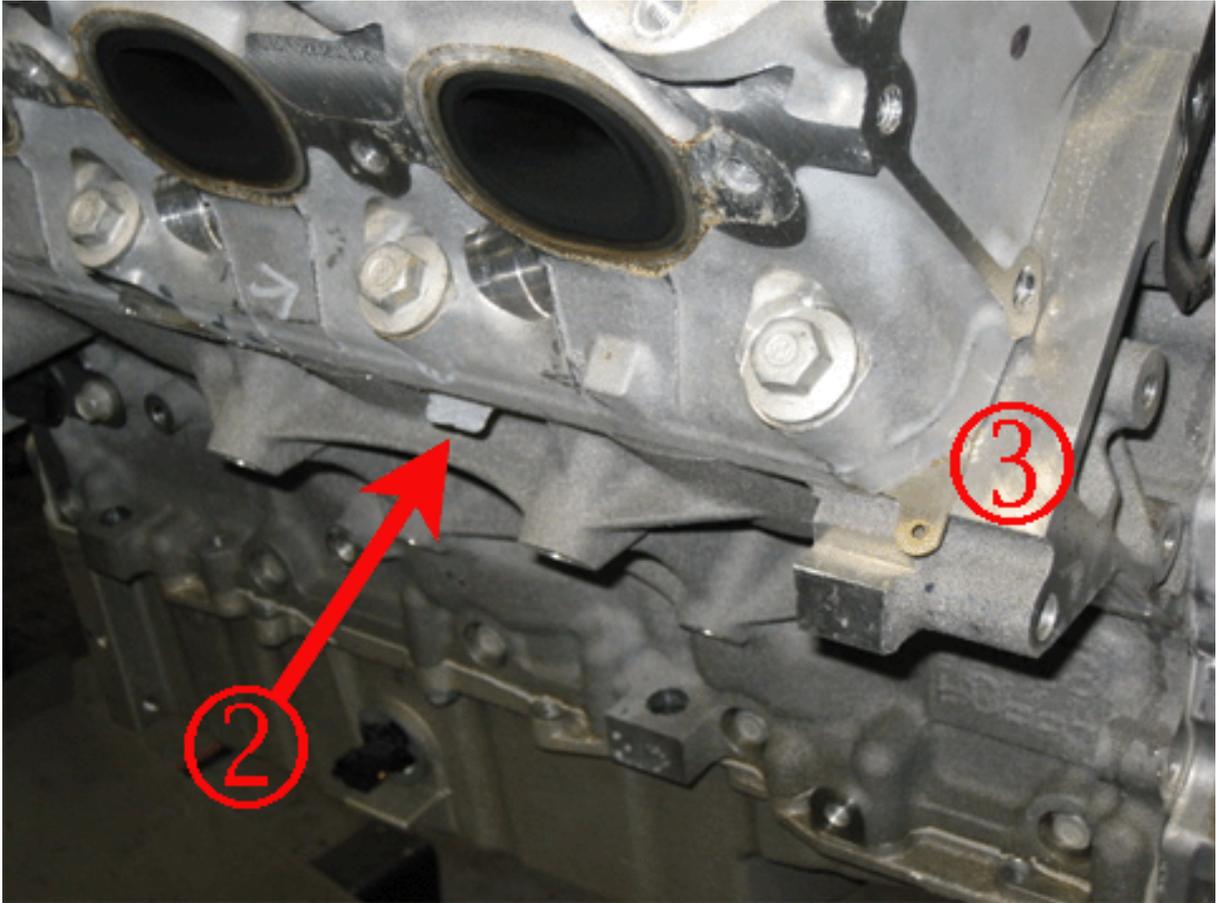
Per the attached pictures, the head gasket locating tabs for both of the engine cylinder banks should be toward the front of the engine.

1. Bank 1 tab near cylinder 3

2. Bank 2 tab near cylinder 4

3. Is the front of the engine

If the head gasket locating tabs are found to be closer to cylinders 5 or 6, this indicates the head gaskets were installed incorrectly restricting the engine coolant flow.

Replace the head gasket to repair for this concern.
