# 2016 - 2019 Cadillac CTS-V: Service Bulletin: #PIP5212C: Concern Of An Engine Thermostat Tick Noise And/Or Running Hot - (Mar 30, 2021)

Subject:	Concern Of An Engine Thermostat
	Tick Noise And/Or Running Hot

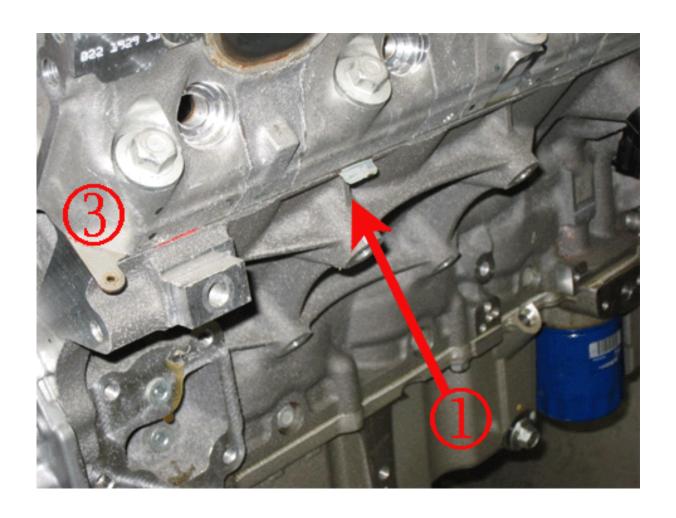
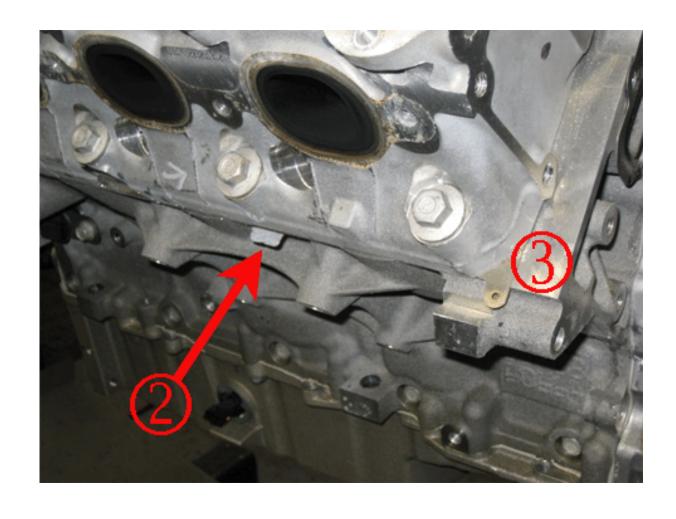
Per the attached pictures, the head gasket locating tabs for both of the engine cylinder banks should be toward the front of the engine.

- 2. Bank 2 tab near cylinder 4
- 3. Is the front of the engine

If the head gasket locating tabs are found to be closer to cylinders 5 or 6, this indicates the head gaskets were installed incorrectly restricting the engine coolant flow.

Replace the head gasket to repair for this concern.
