2016 - 2019 Cadillac CTS-V: Service Bulletin: #PIP5212C: Concern Of An Engine Thermostat Tick Noise And/Or Running Hot - (Mar 30, 2021)

Subject: Concern Of An Engine Thermostat
Tick Noise And/Or Running Hot

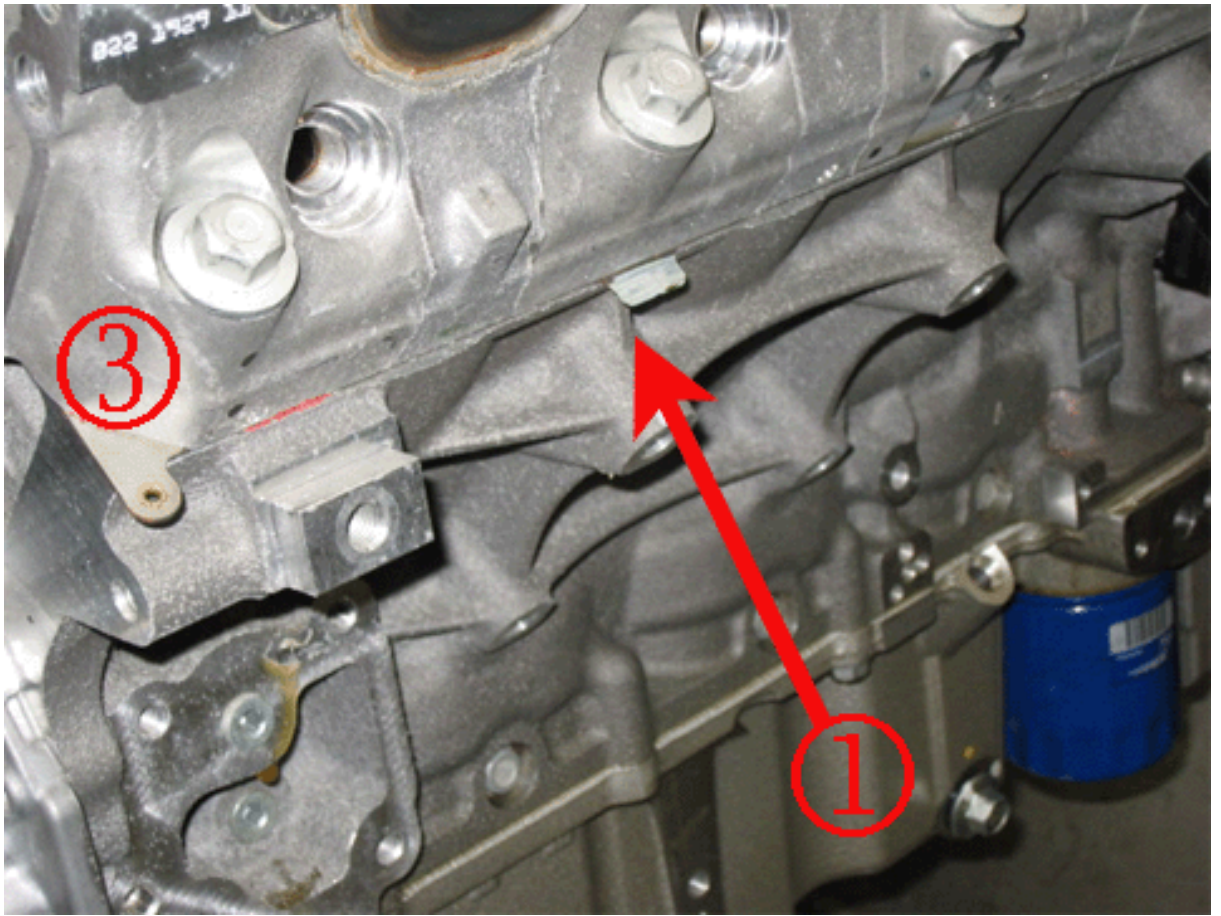
Per the attached pictures, the head gasket locating tabs for both of the engine cylinder banks should be toward the front of the engine.

1. Bank 1 tab near cylinder 3

2. Bank 2 tab near cylinder 4

3. Is the front of the engine

If the head gasket locating tabs are found to be closer to cylinders 5 or 6, this indicates the head gaskets were installed incorrectly restricting the engine coolant flow.

Replace the head gasket to repair for this concern.
