# 2016 - 2019 Cadillac CTS-V: Service Bulletin: #PIP5212C: Concern Of An Engine Thermostat Tick Noise And/Or Running Hot - (Mar 30, 2021)

## **#PIP5212C: Concern Of An Engine Thermostat Tick** Noise And/Or Running Hot - (Mar 30, 2021)

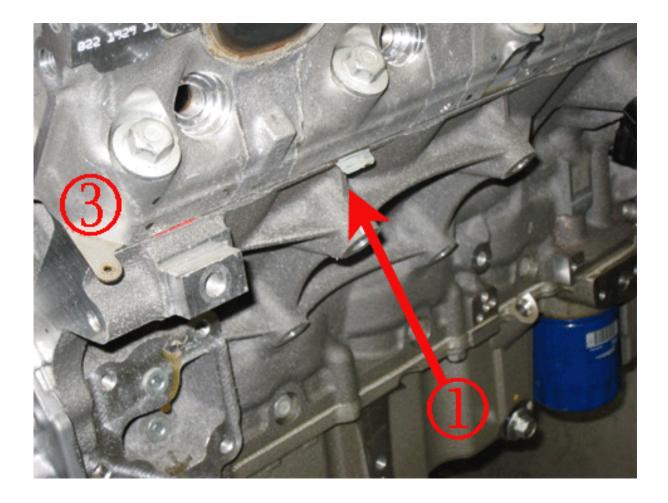
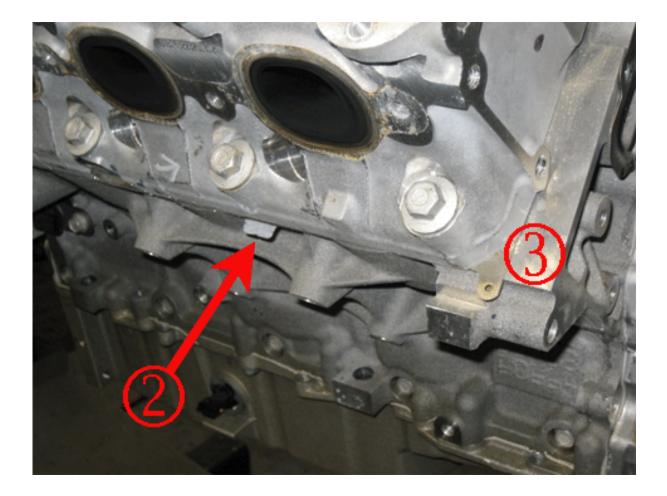
Per the attached pictures, the head gasket locating tabs for both of the engine cylinder banks should be toward the front of the engine.

1. Bank 1 tab near cylinder 3

- 2. Bank 2 tab near cylinder 4
- 3. Is the front of the engine

If the head gasket locating tabs are found to be closer to cylinders 5 or 6, this indicates the head gaskets were installed incorrectly restricting the engine coolant flow.

Replace the head gasket to repair for this concern.
