2006 Cadillac STS-V: Service Bulletin: #07-07-30-031D: Malfunction Indicator Lamp (MIL) On - Check Engine Light, DTC P0751

#07-07-30-031D: Malfunction Indicator Lamp (MIL) On - Check Engine Light, DTC P0751 (Diagnose and Repair as Necessary) - (Feb 20, 2009)

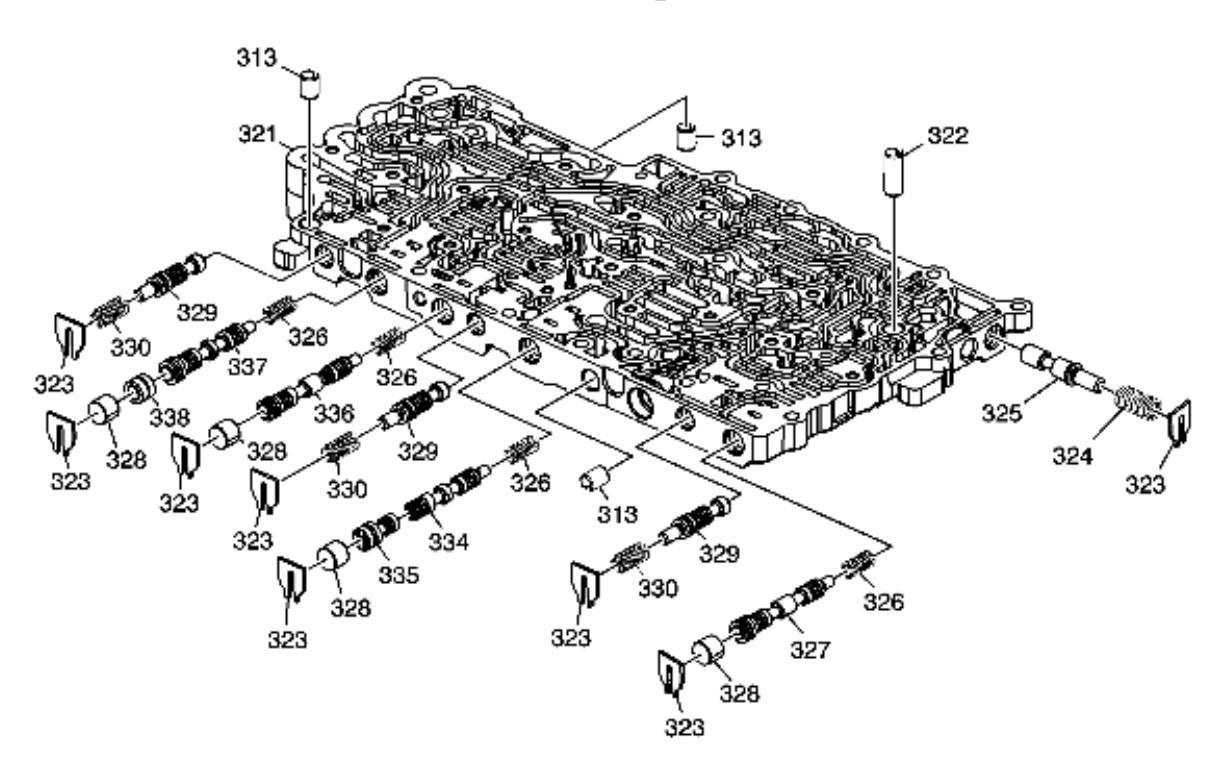
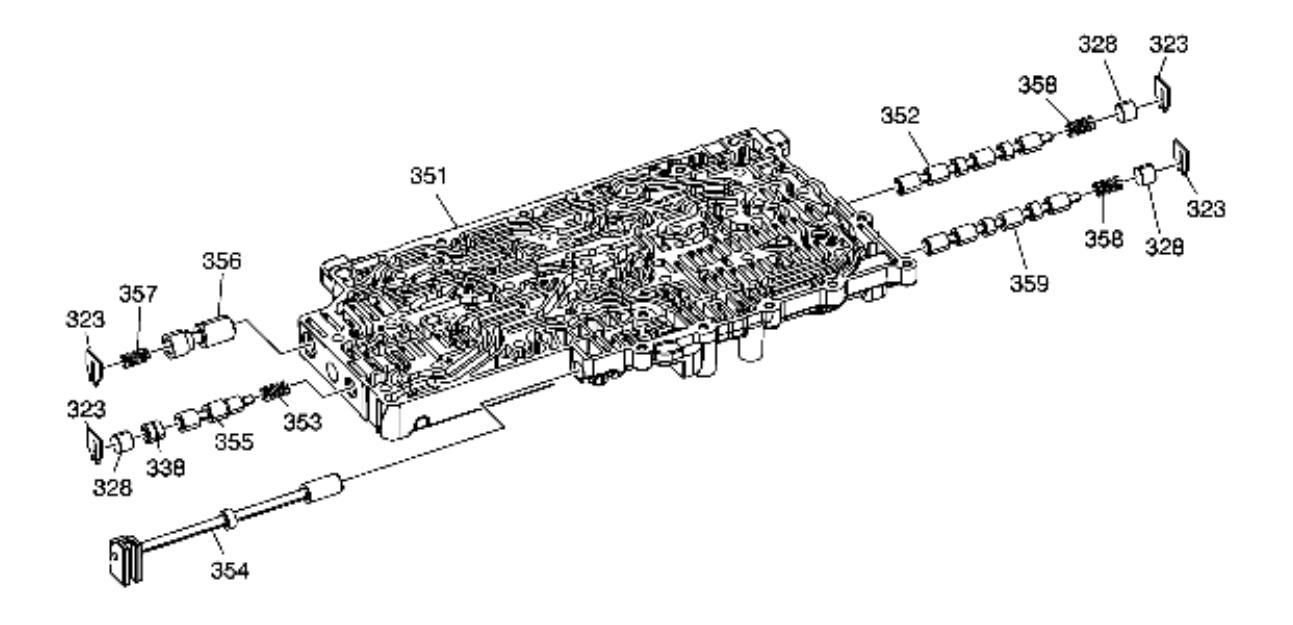
- 1. Disassemble the valve body to:
- Inspect transmission filter for any cracks, holes or split seams that may allow air to be sucked into the pump.
- Inspect the check balls for roundness ensuring that there are no flat spots.
- Measure all the valve body bore plugs (328) for diameter. The specification is 11.502 mm +/- 0.004 mm. Undersize bore plugs should be replaced.
- Inspect clutch select valve 2 (352) (Closest to the manual valve) in the lower valve body (351) for freedom of movement and travel.
- Inspect CBR1/ C456 Reg Valve (327) in the upper valve body (321) for freedom of movement and travel.
- Perform Control Solenoid Valve and Transmission Control Module Assembly Solenoid Performance Test (SI Document ID #1618572) to determine if shift solenoid #1 is functioning properly.

Important: The seals included in plate kit, P/N 24236934, should be replaced when the valve body is assembled. Do not reuse the old seals.

• Replace the spacer plate with P/N 24245720. This spacer plate makes use of a revised gasket to help reduce the occurrence of DTC P0751.
