Service Update

17096 Engine Stall During Aggressive Driving

Reference Number: N162069020

Condition	Certain 2016-2017 model year Cadillac CTS-V vehicles, equipped with 6.2L engine (RPO LT4), may have a condition in which the engine air filter element does not have glue beads across the paper pleating. If this condition is present the pleats can fold over on themselves during high-RPM aggressive driving, and restrict the airflow, which may collapse the air duct and cause the engine to stall. Additionally, the air duct could be cut and a malfunction indicator lamp could illuminate with diagnostic trouble codes P0121-00, P2101-00 and P2119-00 stored.
Correction	Replace the air filter element and, if necessary, replace the air duct.

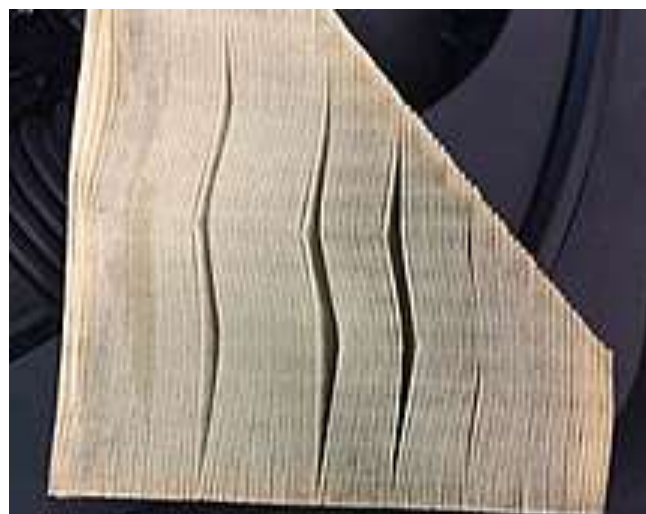
4733221

Glue Beads Missing

Use the following steps to inspect the air cleaner filter element for the installation of glue beads. If the glue beads are present replace only the air cleaner filter element. If the glue beads are missing, the air cleaner outlet duct may have collapsed, replace both the air cleaner filter element and the air cleaner outlet duct.

- If the glue **beads are installed**, install a new air cleaner filter element only.
- If the **glue beads are missing** install a new air cleaner filter element and a new air cleaner outlet duct assembly. Refer to *Air Cleaner Outlet Duct Replacement* in SI.
