## 2022 Cadillac CT5-V: #N212346870: Service Update - Front Brake Rotors Improperly Installed - (Sep 13, 2021)

<b>Subject:</b>	N212346870 — Front Brake Rotors Improperly Installed
<b>Models:</b>	2022 Cadillac CT5
<b>Release Date:</b> September 2021	<b>Revision:</b> 00

<i>Condition</i>	Certain 2022 model year Cadillac CT5 vehicles, equipped with carbon ceramic rotors (RPO J57), may have the front rotors installed on opposite sides.
<i>Correction</i>	Dealers are to visually inspect the front rotors and if necessary, swap the front rotors.

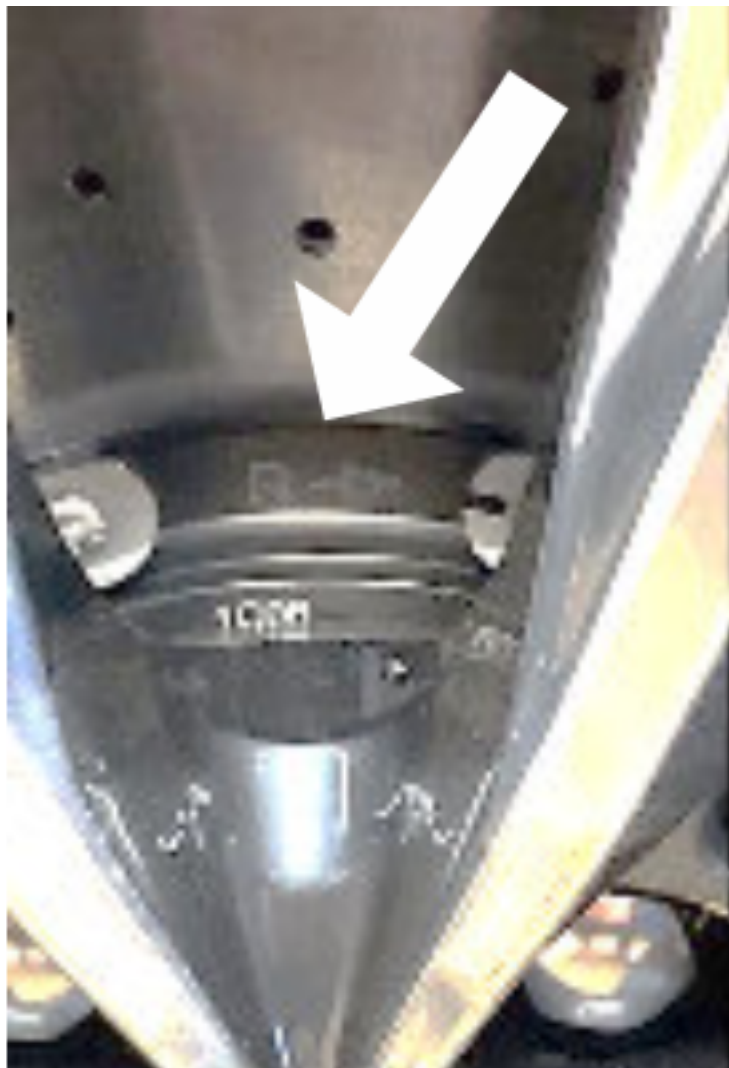
### *Right Rotor Example*

1. Inspect the left and right front brake rotors for proper installation. They are marked with a directional arrow as well as a letter indicator (L or R). This inspection can be performed by looking between the spokes of the wheel, no disassembly or wheel removal is required.

- If the rotors are installed properly, L on the left side of the vehicle and R on the right side of the vehicle, no further action is required.
- If the rotors are installed in the incorrect location, proceed to step #2.
- Remove the left and right front brake rotors and install them on the correct side of the vehicle. Refer to *Front Brake Rotor Replacement (J57)* in SI.
