2015 - 2018 Cadillac CTS-V: Hard Shifting into 1st Gear or Reverse

GM TechLink
June 10, 2017

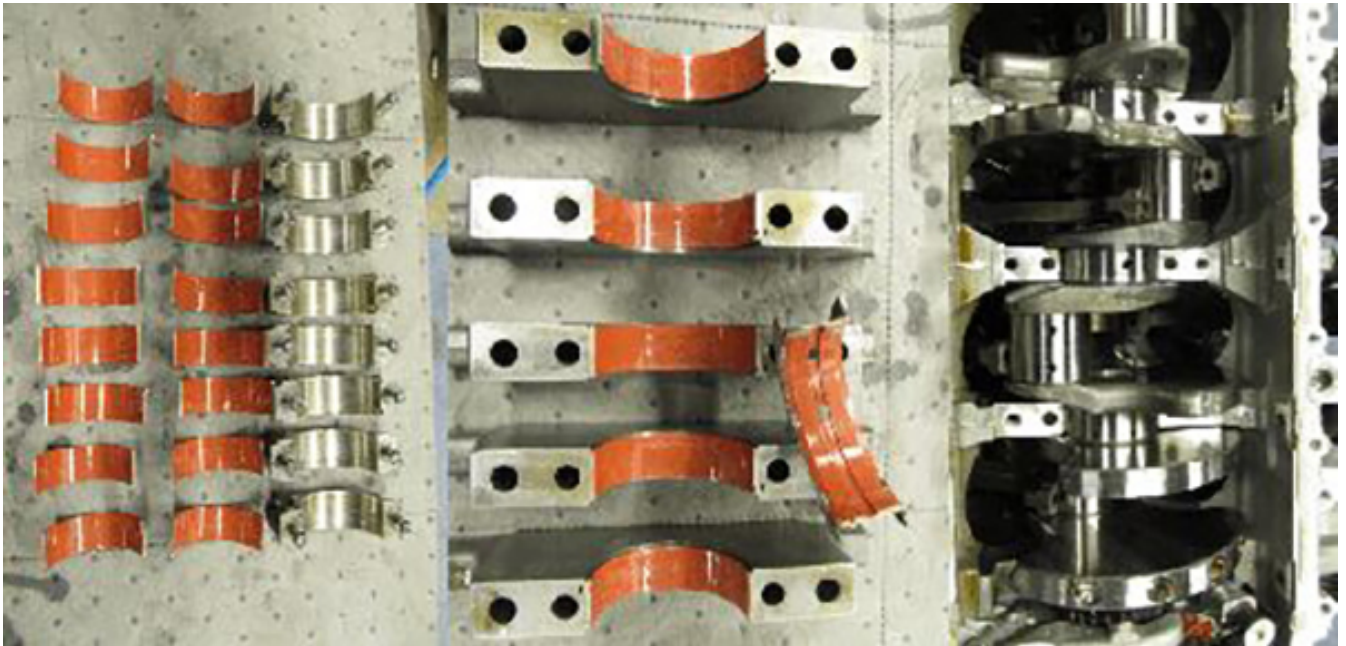
Fig. 10

If end play is found to be out of specification, remove the engine and check for possible crankshaft thrust bearing or crankshaft wear. The crankshaft and bearings should not show signs of excessive wear. (Fig. 10) Inspect the thrust bearing for wear on one side and the crankshaft on the mating surface.

If wear is evident — the three vertical channels may be worn off — replace the connecting rods, main bearings, thrust bearing and crankshaft.

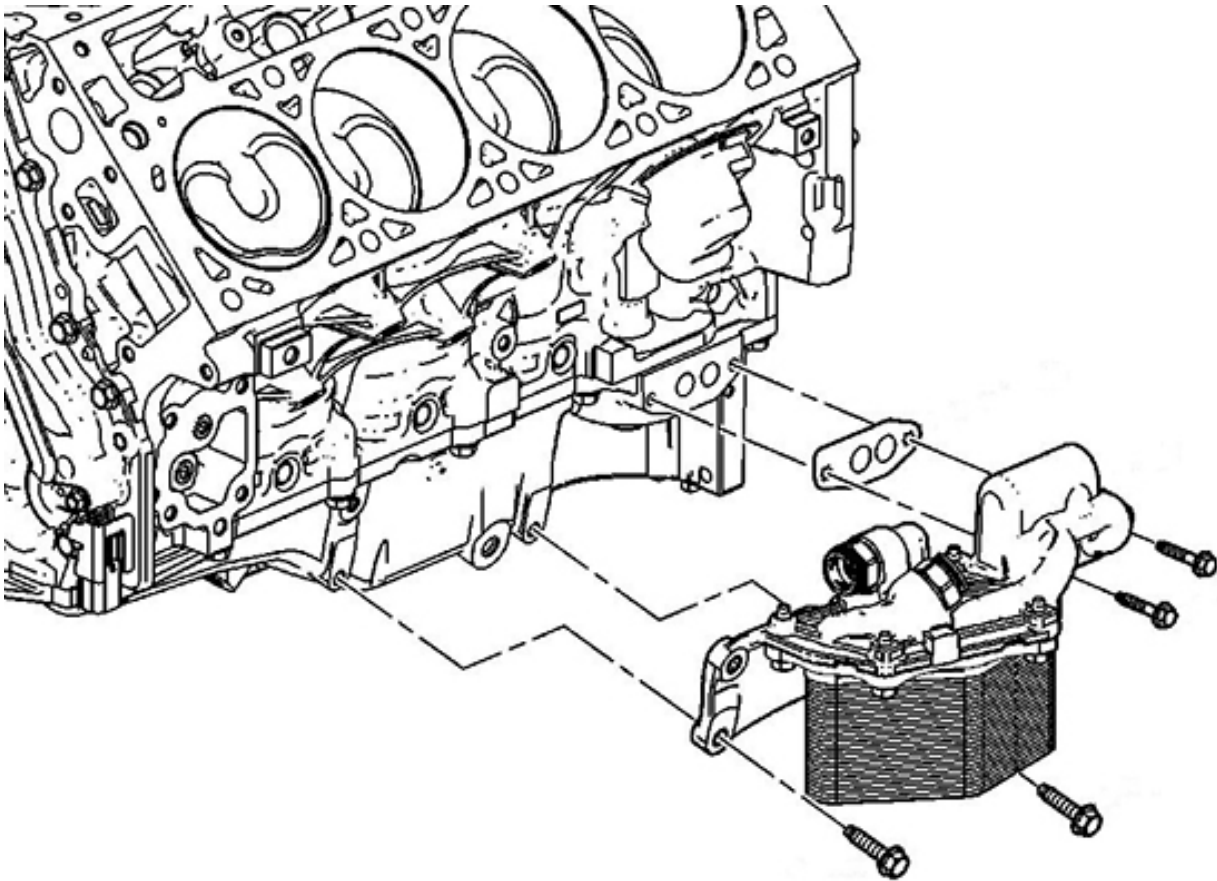
Fig. 11

TIP: On engines with a dry sump oil system, the oil tank and lines, and the oil cooler (if equipped) (Fig. 11), should be replaced when repairing the engine.
