2015 - 2018 Cadillac CTS-V: GM TechLink: Hard Shifting into 1st Gear or Reverse

2015 - 2018 Cadillac CTS-V: Hard Shifting into 1st Gear or Reverse

GM TechLink
June 10, 2017

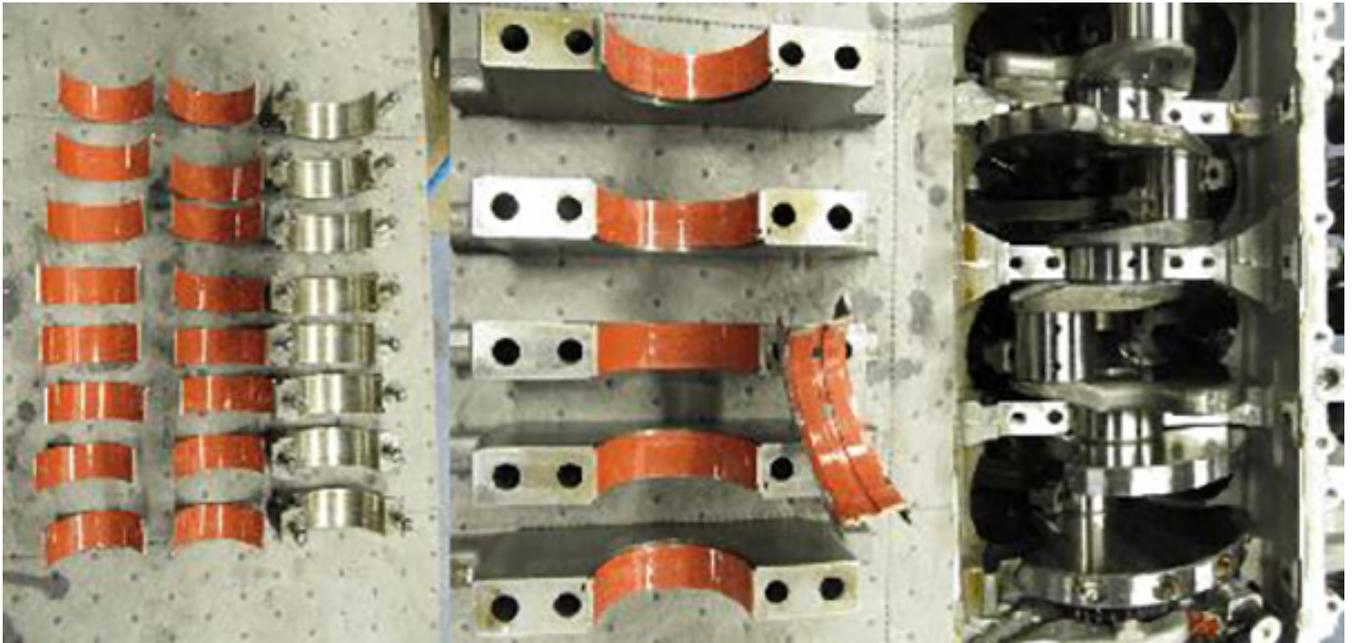
Fig. 10

If end play is found to be out of specification, remove the engine and check for possible crankshaft thrust bearing or crankshaft wear. The crankshaft and bearings should not show signs of excessive wear. (Fig. 10) Inspect the thrust bearing for wear on one side and the crankshaft on the mating surface.

If wear is evident — the three vertical channels may be worn off — replace the connecting rods, main bearings, thrust bearing and crankshaft.

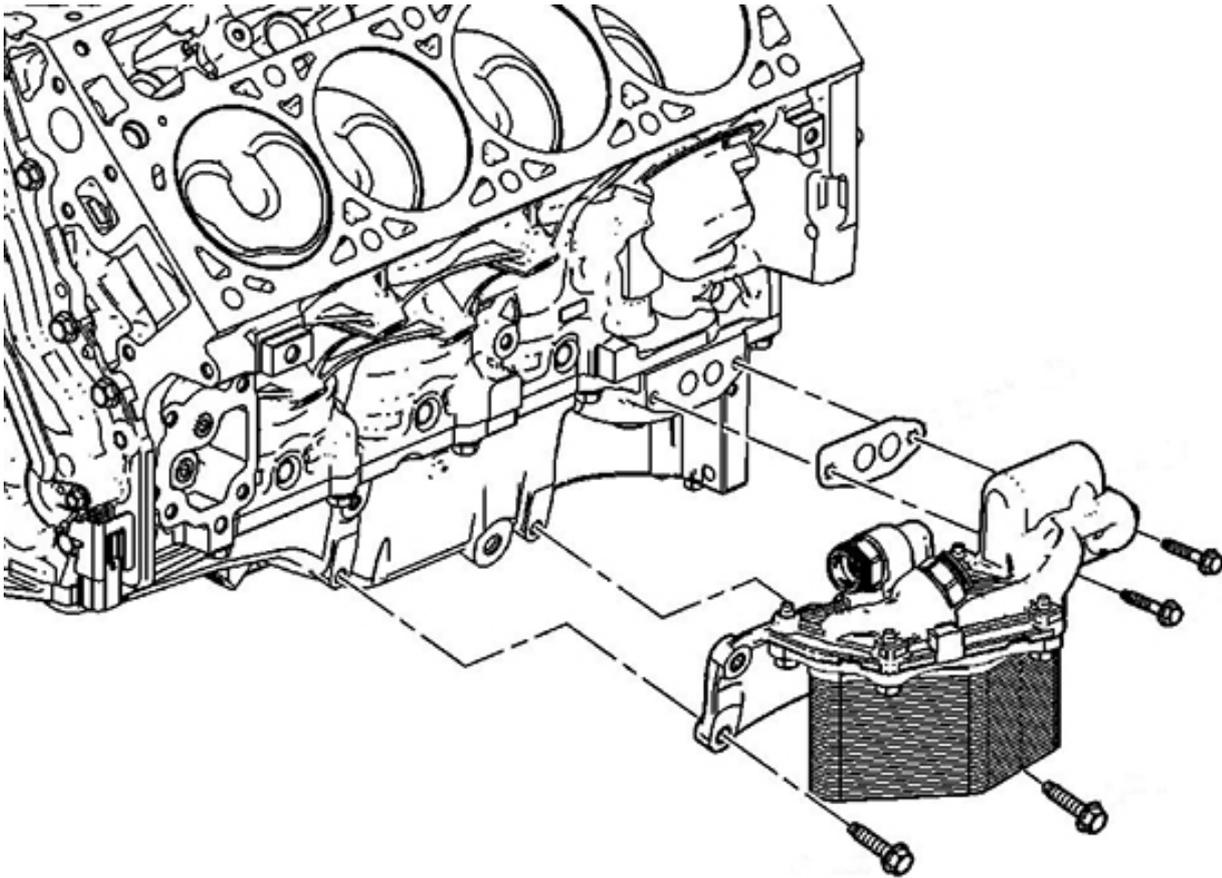
Fig. 11

TIP: On engines with a dry sump oil system, the oil tank and lines, and the oil cooler (if equipped) (Fig. 11), should be replaced when repairing the engine.
