2016 - 2017 Cadillac CTS-V: GM TechLink: Fuel Line Pulsation Sound

2016 - 2017 Cadillac CTS-V: Fuel Line Pulsation Sound

GM TechLink

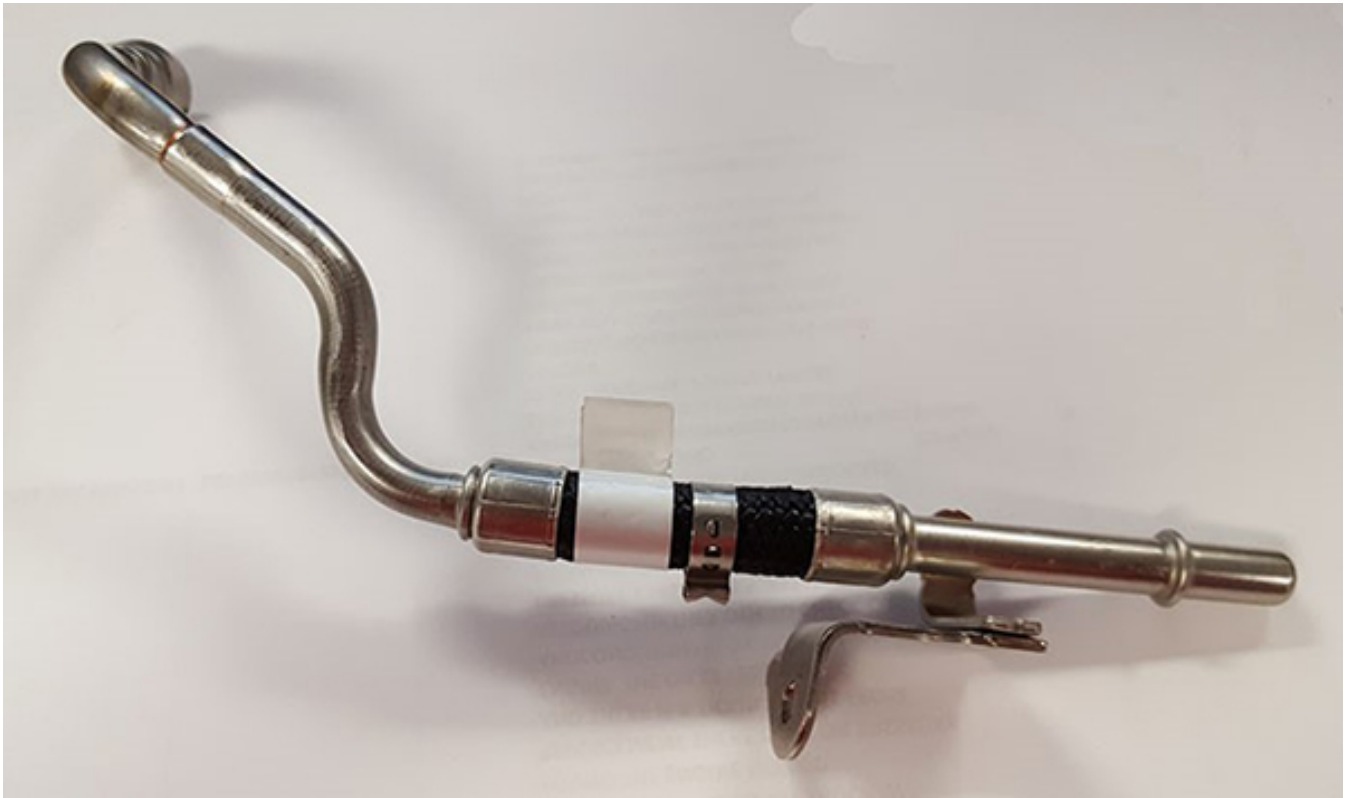
FIG. 9

There are two different types of fuel lines that contain a check valve. The lines vary by model. Only one line should be used on Corvette, truck and SUV models. (Fig. 9) The line connects the chassis fuel line to the high pressure fuel pump. (Fig. 10)

Listen to the fuel line connection at the left side of the engine. The fuel feed line between the high pressure fuel pump and chassis fuel line may be allowing high pressure pulsation back to the low side of the fuel system. If the sound is heard, the line will need to be replaced. On some trucks and SUVs, a vibration also may be observed in the fuel line at the fuel tank.
