# 2016 - 2017 Cadillac CTS-V: GM TechLink: Fuel Line Pulsation Sound

## 2016 - 2017 Cadillac CTS-V: Fuel Line Pulsation Sound

### GM TechLink

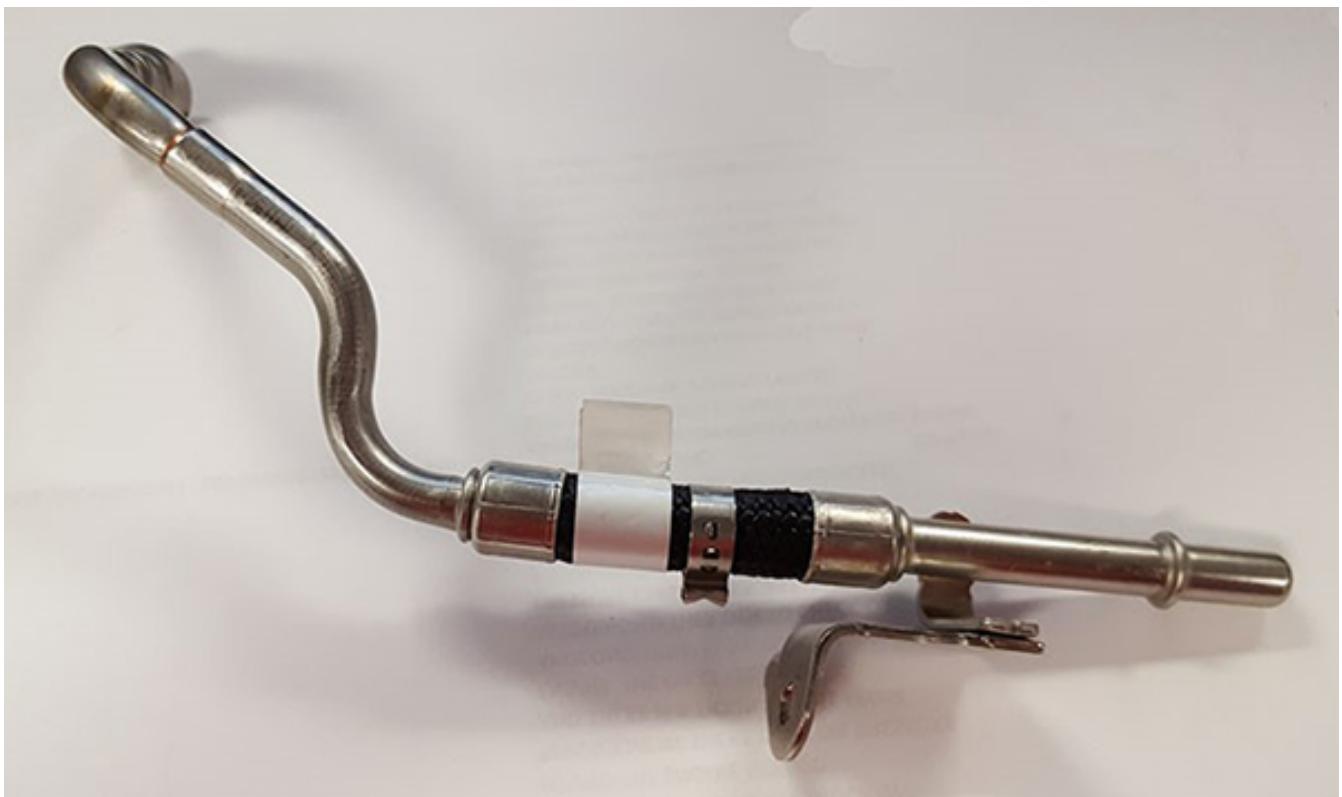
FIG. 9

There are two different types of fuel lines that contain a check valve. The lines vary by model. Only one line should be used on Corvette, truck and SUV models. (Fig. 9) The line connects the chassis fuel line to the high pressure fuel pump. (Fig. 10)

Listen to the fuel line connection at the left side of the engine. The fuel feed line between the high pressure fuel pump and chassis fuel line may be allowing high pressure pulsation back to the low side of the fuel system. If the sound is heard, the line will need to be replaced. On some trucks and SUVs, a vibration also may be observed in the fuel line at the fuel tank.
