2016 - 2017 Cadillac CTS-V: Harsh Shift and Rough Idle Conditions

GM TechLink October 9, 2016

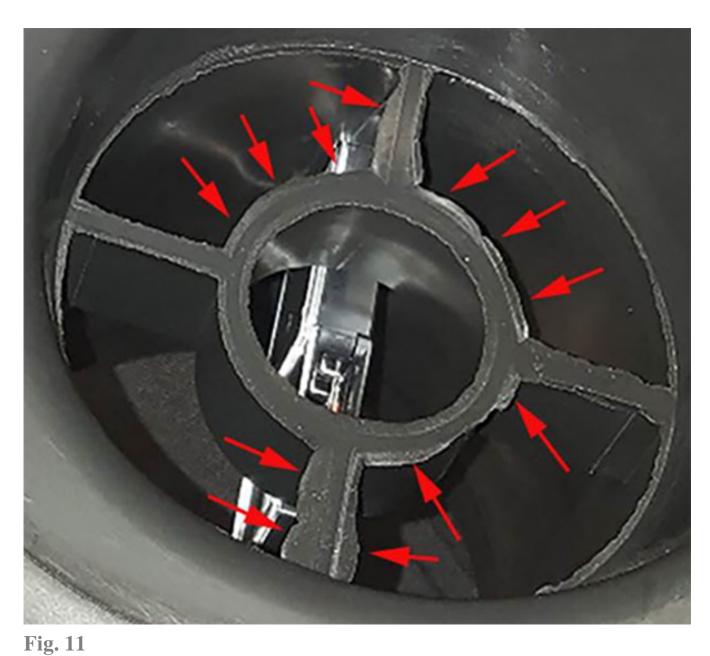
Inspect for cast flashing in the air filter housing near the Mass Air Flow (MAF) sensor for excessive flashing. (Fig. 11) If excessive flashing is found, replace the air filter housing lid. Be sure to check the flashing in the new lid as well.
