# 2016 Cadillac ATS-V: GM TechLink: Vehicle Time Out for Parasitic Draw Testing

**GM TechLink**

**September 18, 2016**

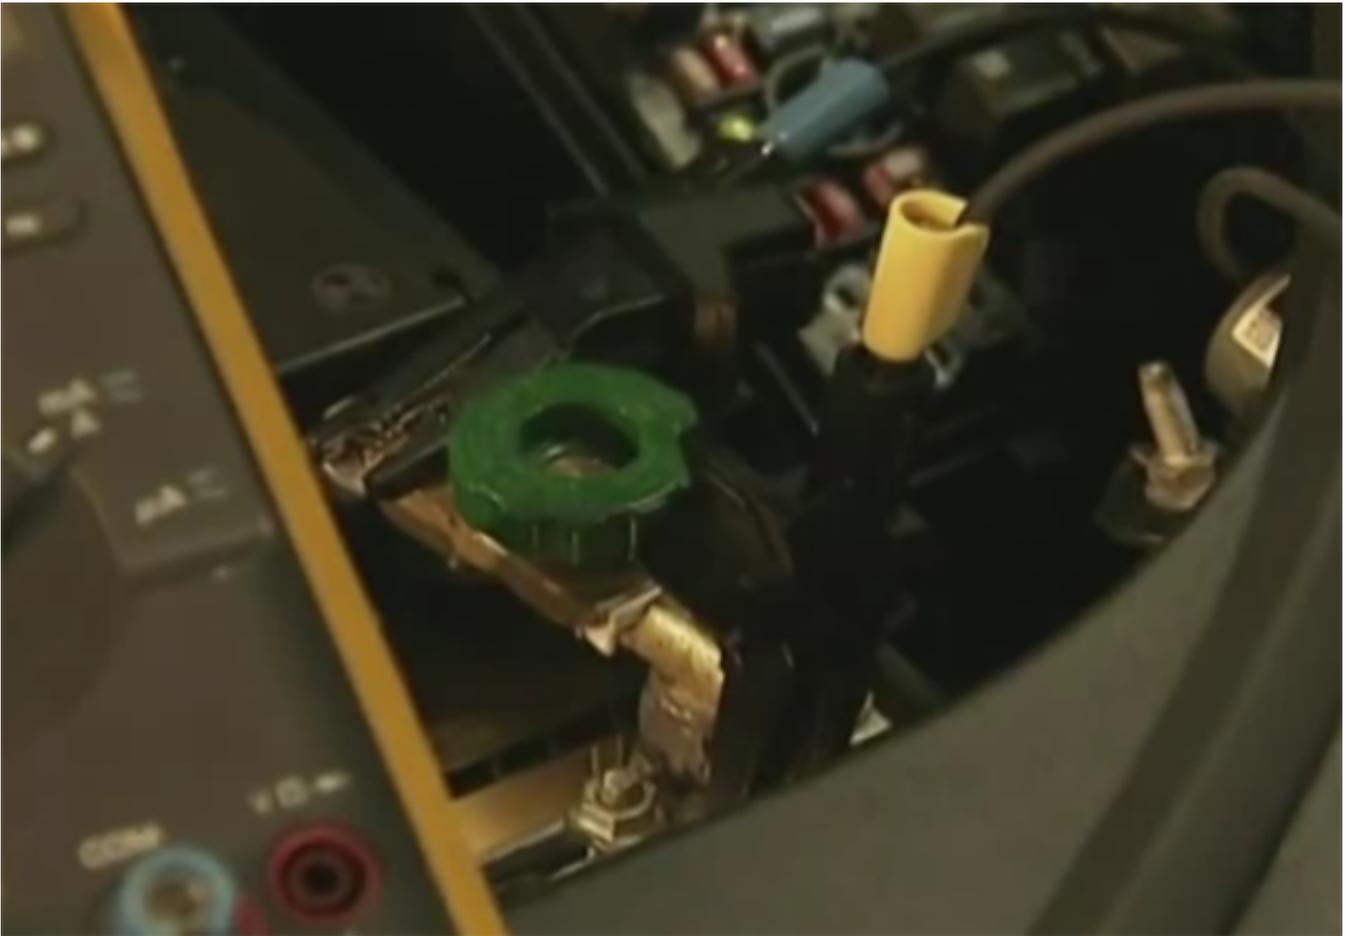
**Fig. 27**

There are many things that can prevent a vehicle from completely going to sleep and passing the parasitic draw test. Make sure all the following conditions are met before performing the parasitic current draw test using the EL 38758 parasitic draw test switch. (Fig. 27)

- Ignition off
  - Key out of the ignition switch – when not equipped with keyless access and start
  - Retained Accessory Power off – open and close the driver's door after turning off the ignition
  - Scan tool not communicating with a vehicle control module – in some cases it may need to be disconnected from the DLC
  - All access doors closed
  - Headlamps off – Auto headlamps disabled
  - Any delay lighting off
  - Disable any underhood lamp, if equipped
  - HVAC afterblow off
  - Any accessory that can work with ignition off is inactive or off
  - Wait up to two minutes or longer, after all other listed conditions are met
