2006 Cadillac STS-V: Service Bulletin: #07-07-30-002: 6L80 Automatic Transmission Busy Shifting, MIL Illuminated, DTC P1751 Set

#07-07-30-002: 6L80 Automatic Transmission Busy Shifting, MIL Illuminated, DTC P1751 Set (Replace Control Valve Body Spacer Plate) - (Jan 30, 2007)

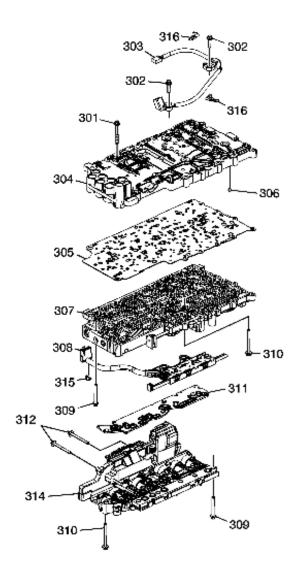
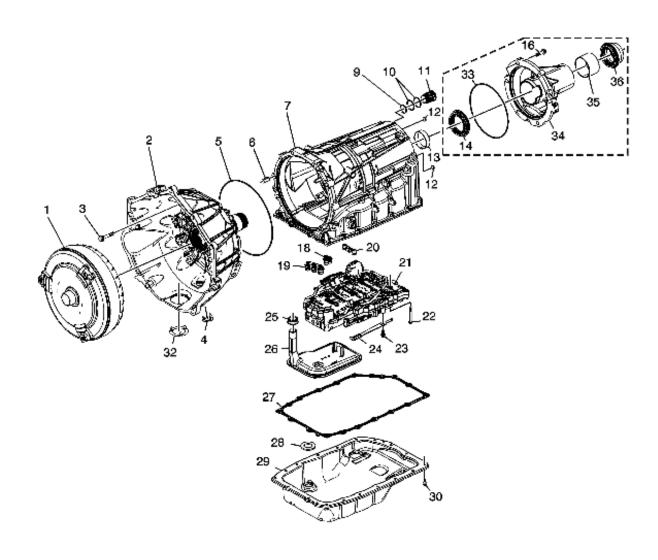
This condition may be caused by an undersized hole or debris in the control valve body spacer plate (305).

To correct this condition the control valve body spacer plate (305) must be replaced. The electrical connector seals (9, 10), fluid pump seals (18, 19), center support seal (20) and the filter plate assembly (311) should also be replaced. These parts are included in the filter plate kit listed below.

Changes to the control valve body spacer plate were implemented November 4, 2006 in transmission assemblies to prevent this condition.

Refer to the Control Valve Body Assembly Disassemble and Assemble procedures in the Unit Repair information of SI.
